PRECURSOR DESCRIPTION AND DATA

NSIC Accession Number: 149450

Title: Loss of Feedwater Transient at Oyster Creek

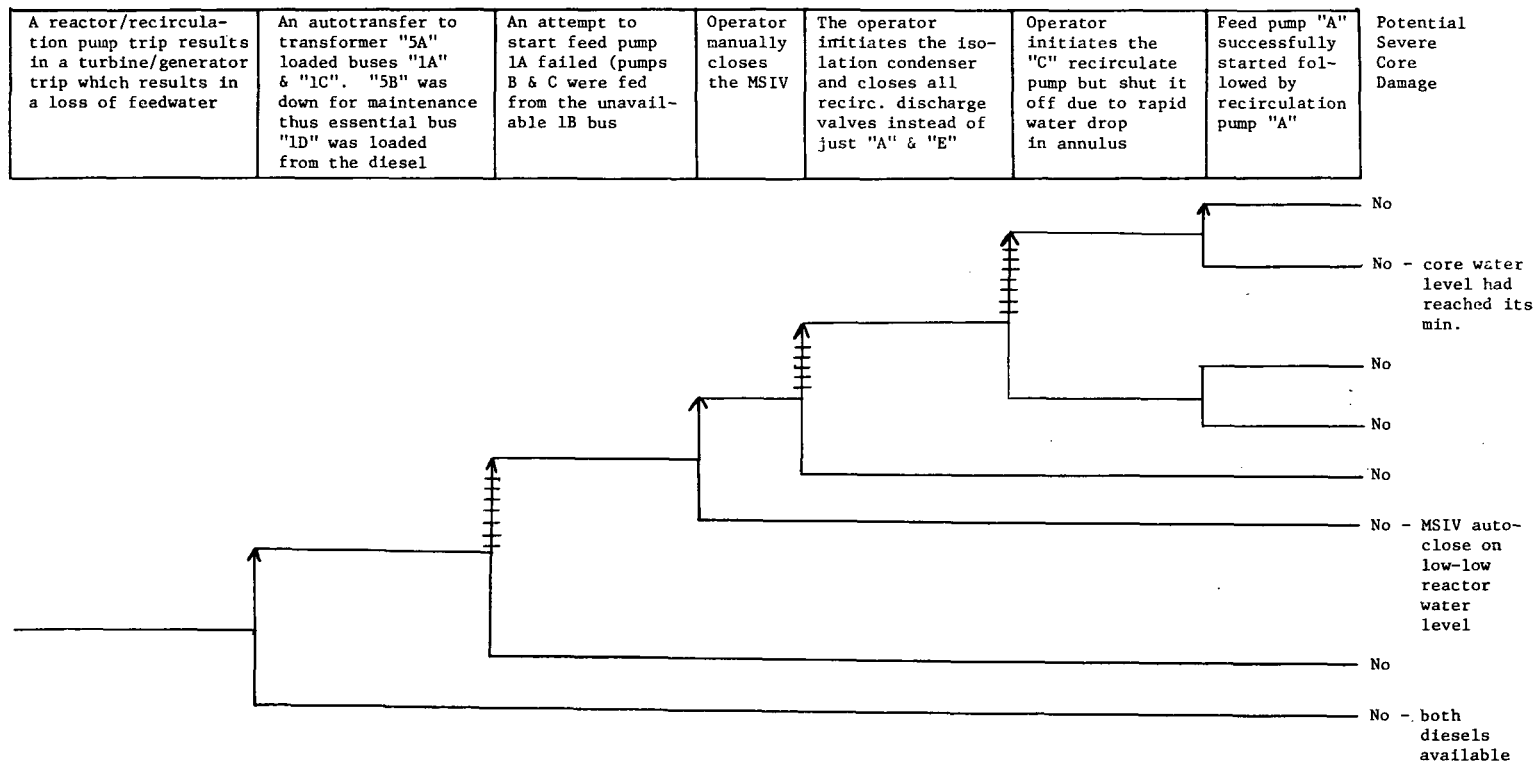
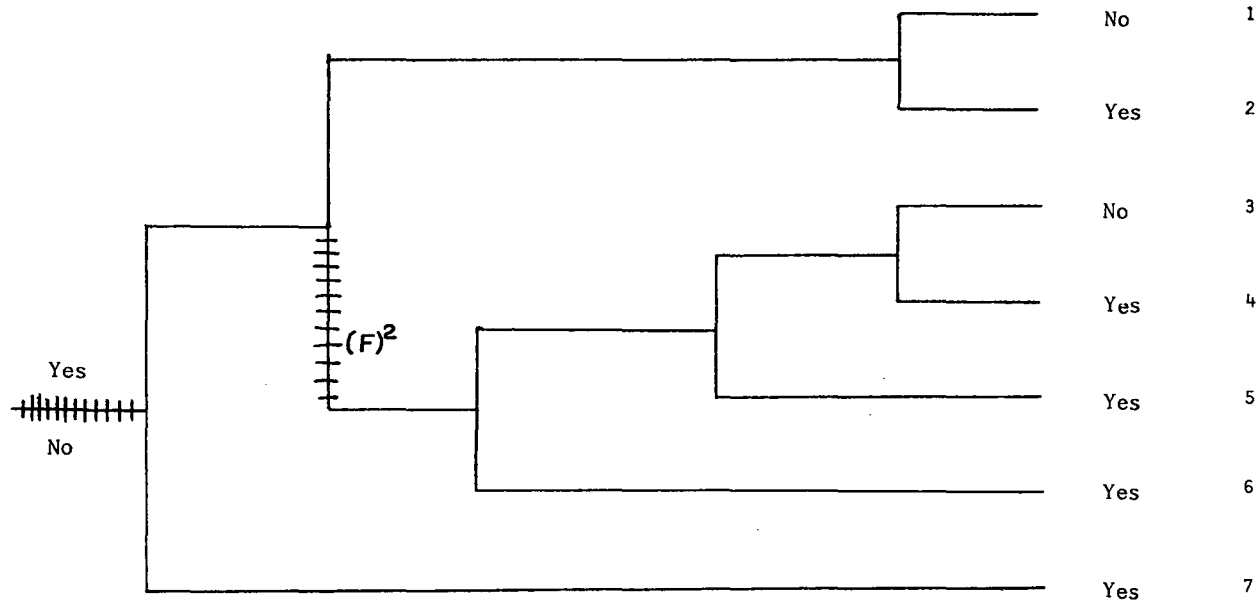
NSIC 149450 — Sequence of Interest for a Loss of Feedwater Flow at Oyster Creek

Oyster Creek utilizes Isolation condensers rather than RCIC

Success requires proper operation of either FWCT or IC.
