NSIC Accession Number: 61565

Date: September 2, 1971

Title: Loss of Offsite Power and Failure of a Diesel Generator to Load at Palisades

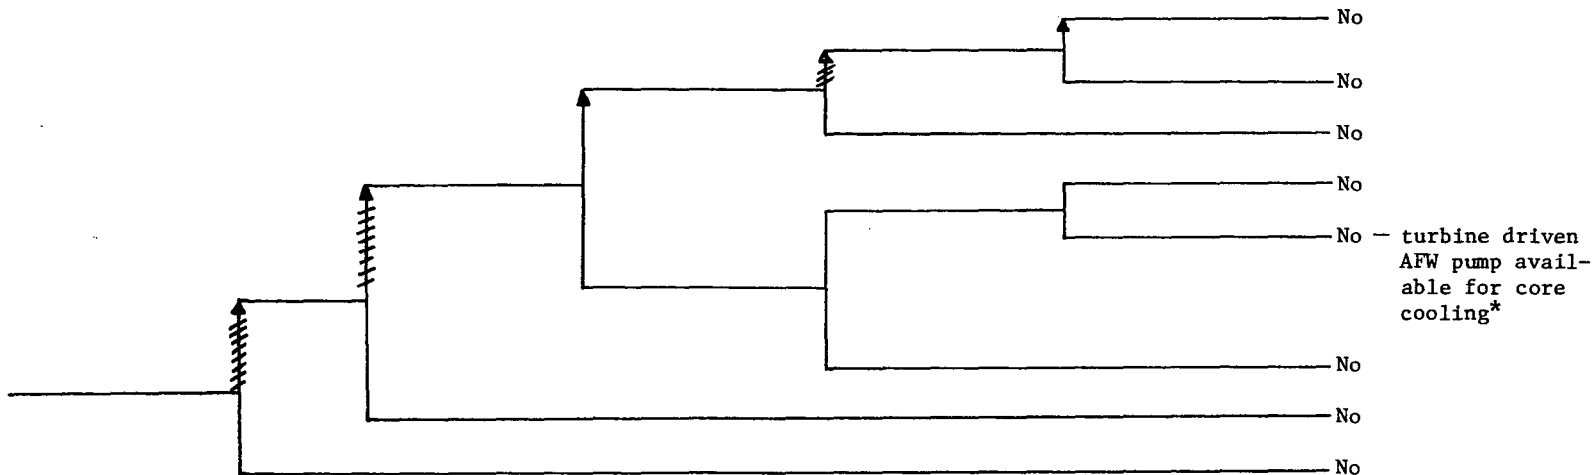
NSIC 61565 - Actual Occurrence for Loss of Offsite Power and Failure of a Diesel Generator to Load at Palisades

The failure sequence was:

1. The Argenta No. 2 345KV line (one of three 345KV lines at the switchyard) tripped.
2. Failure of a "breaker failure relay" associated with the tripped line breaker resulted in the tripping of two other breakers on the ring bus, which caused a loss of offsite power.
3. Diesel generator No. 1 started and loaded its safety-related bus.
4. Diesel generator No. 2 started but its breaker did not close until the operator adjusted the synchroscope in preparation to close the breaker manually.

(Reactor Status Unspecified)	Loss of No. 2 Argenta 345KV Line	Line No. 2 Breaker Relay Failure Trips Two Additional Ring Bus Breakers, Resulting in a Loss of Off-site Power	Diesel Generator No. 1 Starts and Closes onto its Safety-Related Bus	Diesel Generator No. 2 Starts but Fails to Close Onto its Safety-Related Bus	Diesel Generator No. 2 Closes Onto its Bus When Operator Adjusts Synchroscope in Preparation for Closing D.G. Breaker Manually	Potential Severe Core Damage
------------------------------	----------------------------------	--	--	--	--	------------------------------

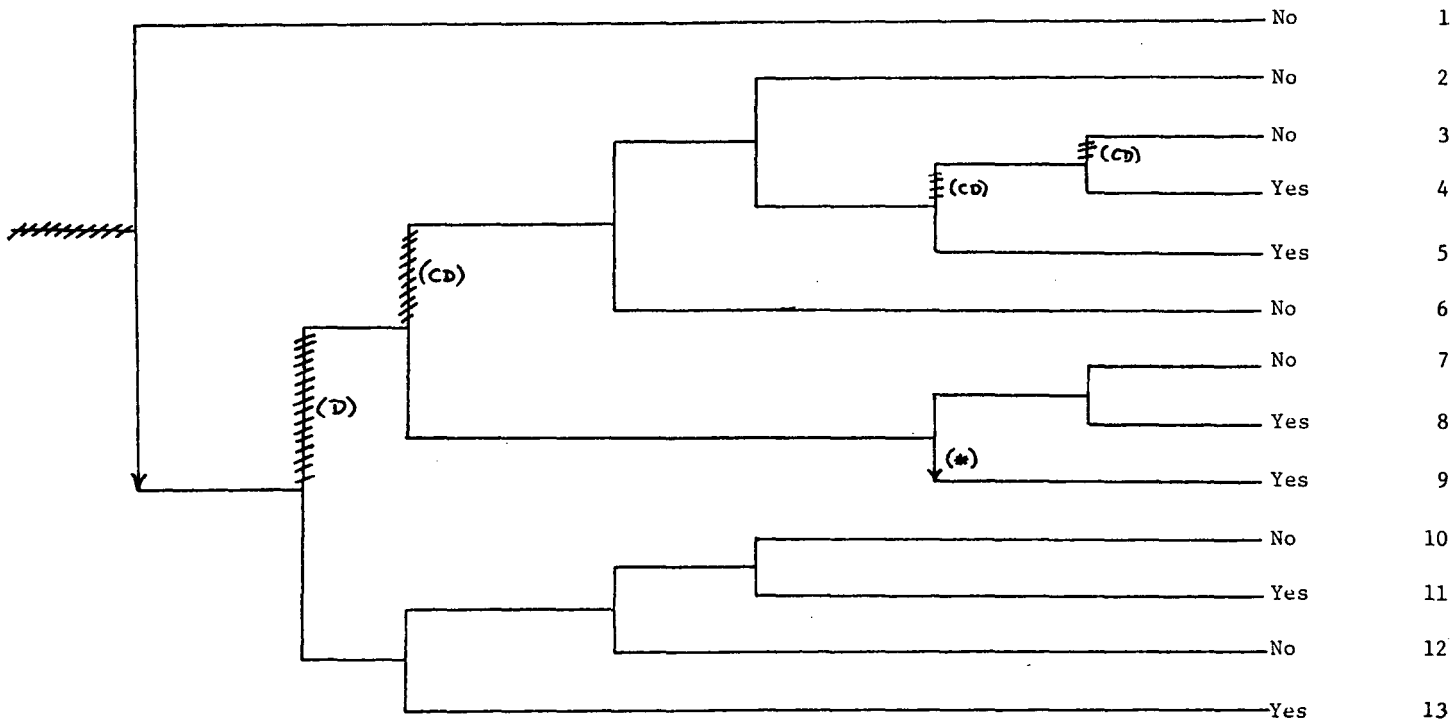
NSIC 61565 - Sequence of Interest for Loss of Offsite Power and Failure of a Diesel Generator to Load at Palisades

* provided the turbine-driven AFW pump is not dependent on A.C. power

Loss of Offsite Power	Turbine Generator Runs Back and Assumes House Loads	Emergency Power	Auxiliary Feedwater and Secondary Heat Removal	PORV Demanded	PORV or PORV Isolation Valve Closure	High Pressure Injection	Long Term Core Cooling	Potential Severe Core Damage	Sequence No.
-----------------------	---	-----------------	--	---------------	--------------------------------------	-------------------------	------------------------	------------------------------	--------------

* Use of HPI following AFW failures not included in mitigation procedures.
