PRECURSOR DESCRIPTION AND DATA

NSIC Accession Number: 71694

Date: May 26, 1972

Title: Loss of Offsite Power at Palisades

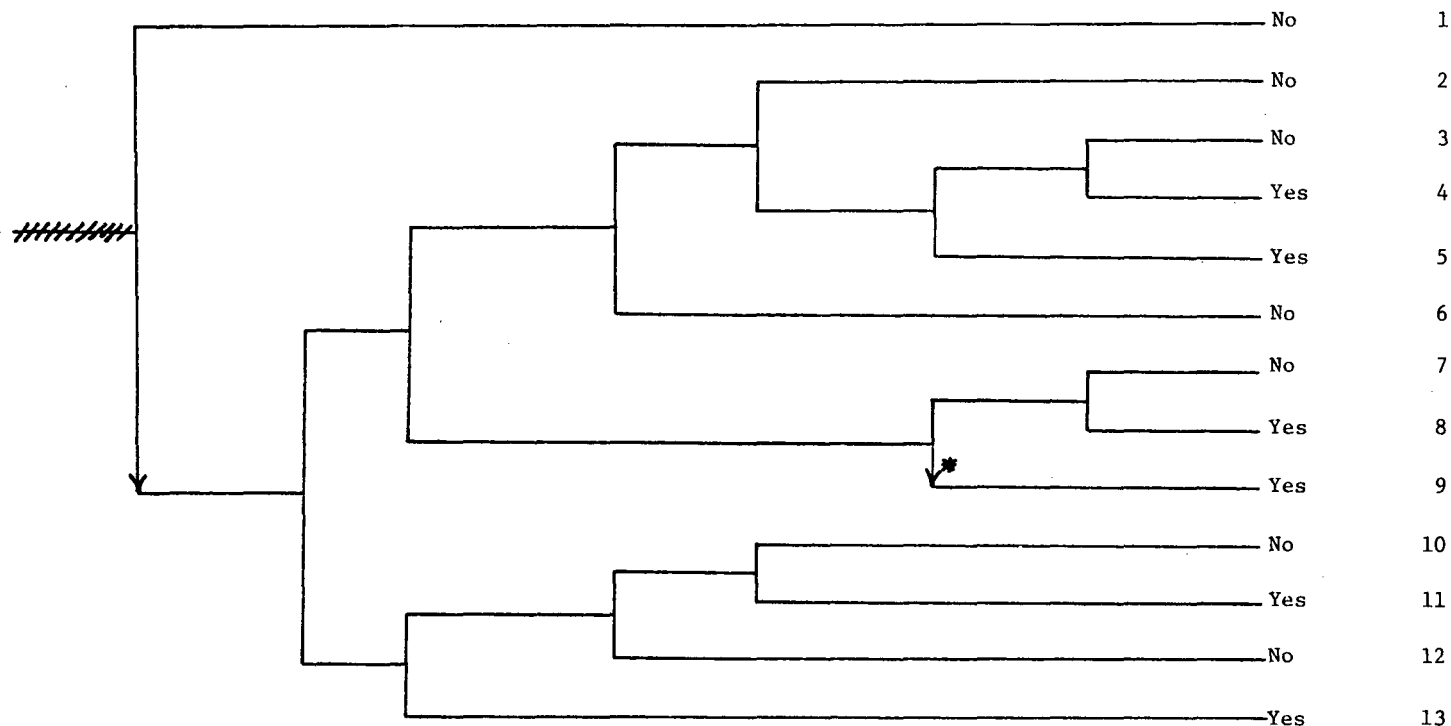
NSIC 71694 — Sequence of Interest for Loss of Offsite Power at Palisades

1. With the plant in a hot standby condition, the left channel safety injection system test button was pushed to initiate a quarterly test.
2. This resulted in a loss of offsite power due to the spurious operation of a differential relay on the 1-2 startup transformer. The actuation of the relay was due to unbalanced sensing currents from a current transformer — a result of the incompatibility of the installed current transformer with the 345 KV - 2.4 KV step-down situation.

CAUSE: Improperly chosen differential relay

The differential relays were removed from startup transformers 1-1 and 1-2. High-side overcurrent and instantaneous overcurrent relays were installed.
