PRECURSOR DESCRIPTION AND DATA

NSIC Accession Number: 97578

Title: Loss of Offsite Power During SIS Testing at Palisades

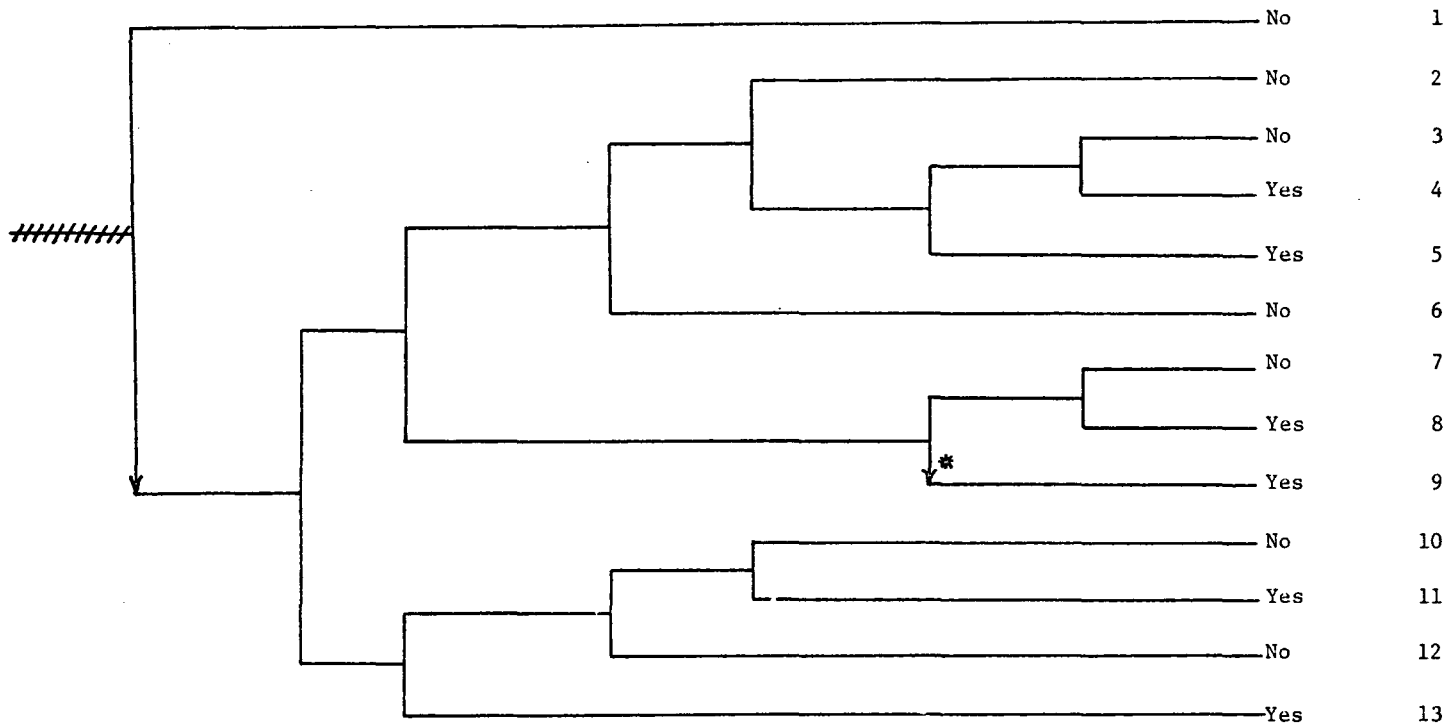
NSIC 97578 - Sequence of Interest for Loss of Offsite Power During SIS Testing at Palisades

The failure sequence was:

1. With the plant in a hot standby condition, the right channel safety injection test button was pushed to initiate a quarterly test.
2. Offsite power was lost due to the inadvertent operation of the differential relay system.
3. The diesel generators started and powered safety-related loads.

CAUSE: Improperly designed Differential Relay System

The three-phase differential relays were removed from service pending a review and potential redesign of the system. Over-current protection devices remained installed to provide transformer protection.
