PRECURSOR DESCRIPTION AND DATA

NSIC Accession Number: 131225

Title: Two Diesel Generators Fail to Start at Peach Bottom 2

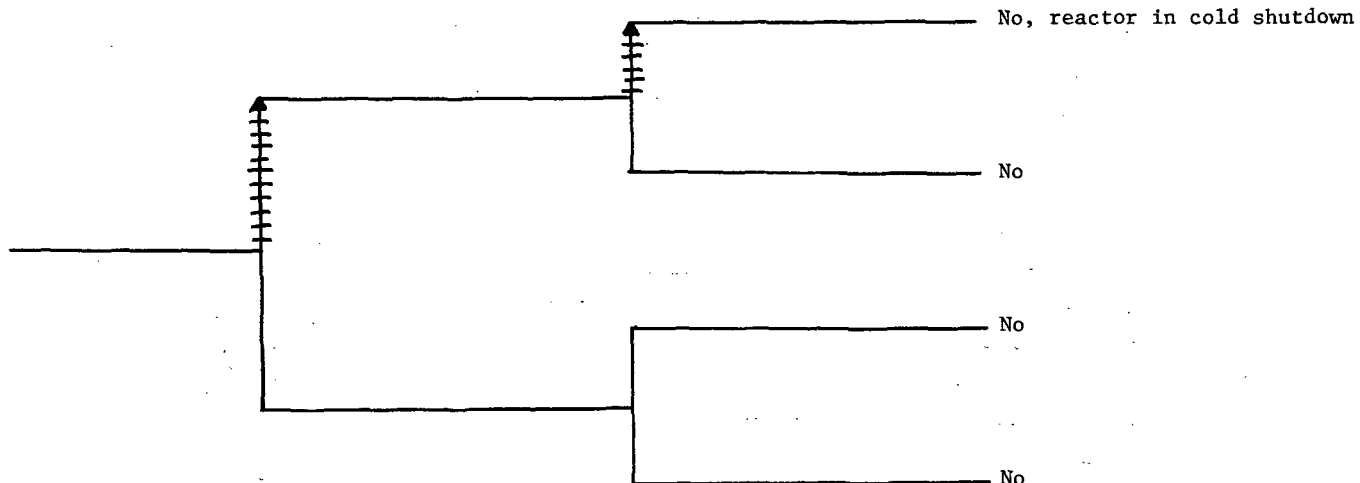
A Loss Of Offsite Power Test Was Underway	Diesel E-1 Failed To Start Due To A Tripped Jacket Temperature Alarm	Diesel E-4 Tripped After Starting Due To A Failed Overspeed Trip	Potential Severe Core Damage
---	--	--	------------------------------

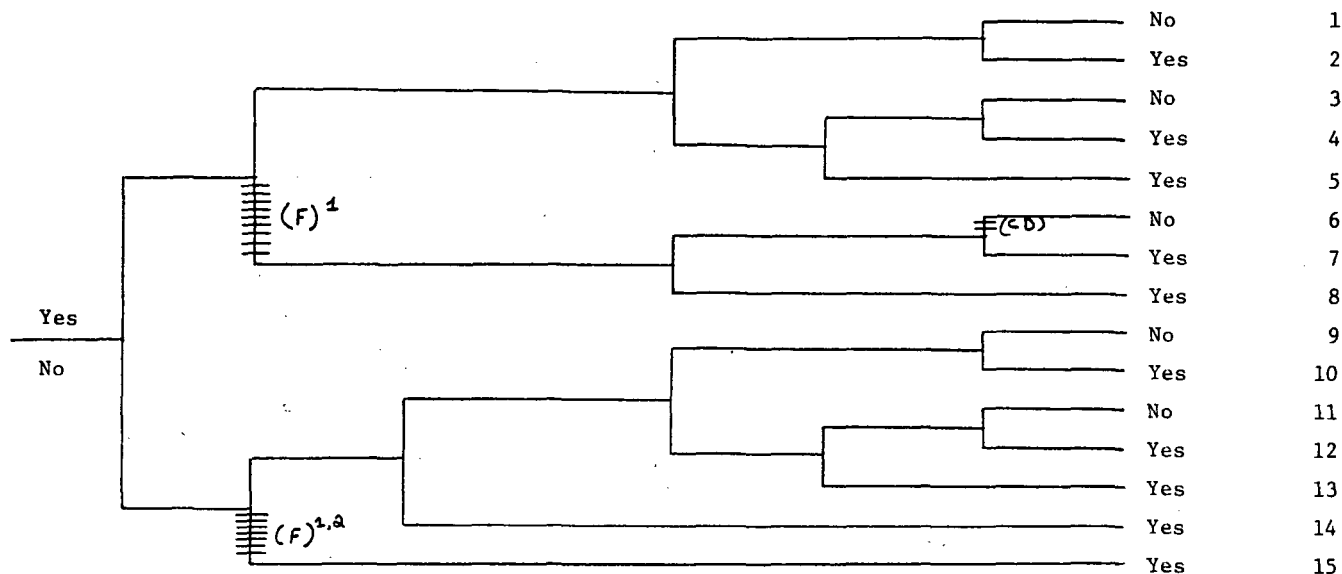
NSIC 131225 — Sequence of Interest for Two Diesel Generators Fail to Start at Peach Bottom 2

Loss of Offsite Power	Reactor Scram	Diesel Start and Load	Reactor Made Sub-critical by the SBLCS Or Rods Are Manually Driven In	RCIC/HPCI Initiates	ADS/LPCI CS Initiates	Long Term Core Cooling	Potential Severe Core Damage	Sequence No.
-----------------------	---------------	-----------------------	---	---------------------	-----------------------	------------------------	------------------------------	--------------

¹Resetting the jacket temperature alarm would result in a success.

²Proper loading of the operating diesels would allow success of alternate shutdown procedures or systems.
