PRECURSOR DESCRIPTION AND DATA

NSIC Accession Number: 150742

Title: Main Stock Sampling System Lost at Peach Bottom 2

NSIC 150742 — Actual Occurrence of Main Stack Sampling System Lost at Peach Bottom 2

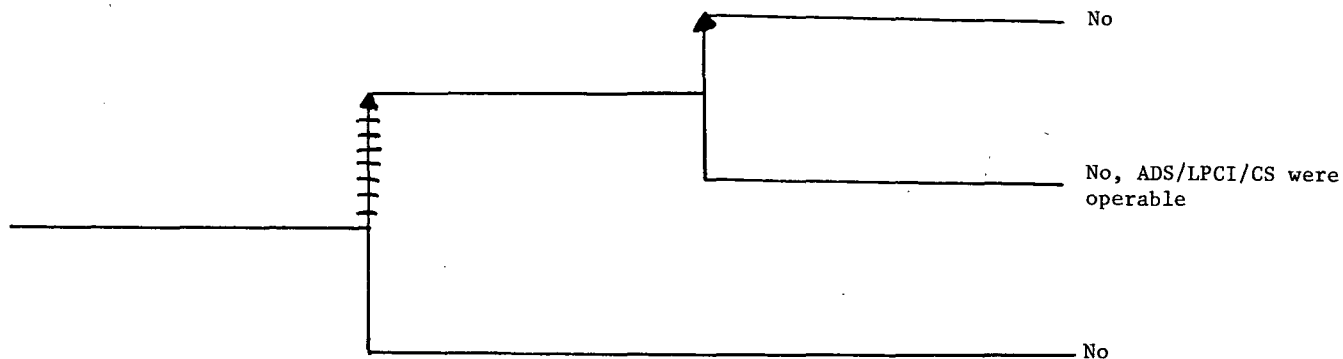
Lightning Struck The Main Stack During An Electrical Storm	This Caused The Fuse In The Inverter Feeding HPCI/RCIC To Blow	HPCI/RCIC Was Not Demanded During The 45 Minutes Requires To Replace The Fuses	Potential Severe Core Damage
--	--	--	------------------------------
