PRECURSOR DESCRIPTION AND DATA

NSIC Accession Number: 106616

Date: September 13, 1975

Title: Loss of Offsite Power and a Relief Valve Sticks Open at Pilgrim 1

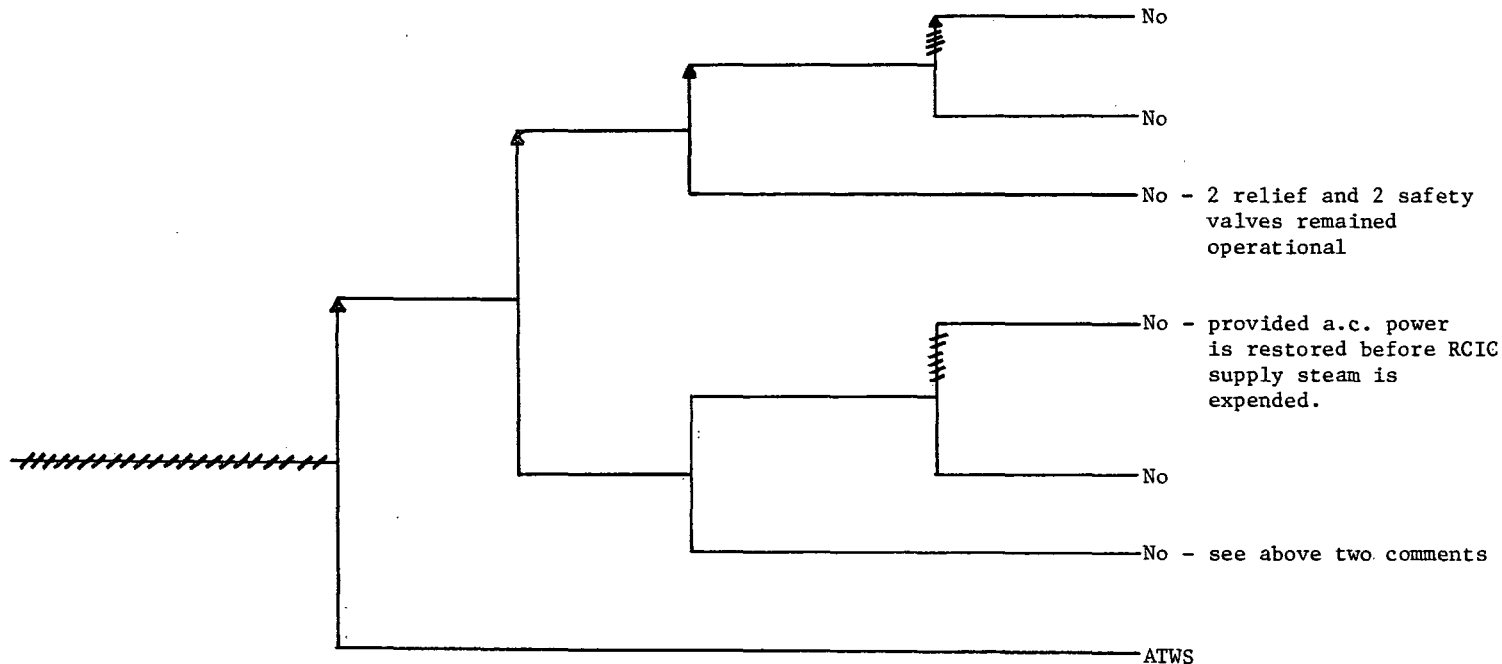
As the reactor was experiencing a shutdown, a turbine trip occurred which caused the start-up and auxiliary buses to trip	The reactor scrambled	The diesel generators started and loaded	A relief valve opened for pressure control	The relief valve failed to reseal	Potential Severe Core Damage
---	-----------------------	--	--	-----------------------------------	------------------------------
