PRECURSOR DESCRIPTION AND DATA

NSIC Accession Number: 135932

Title: All Offsite Transmission Lines Lost at Pilgrim 1

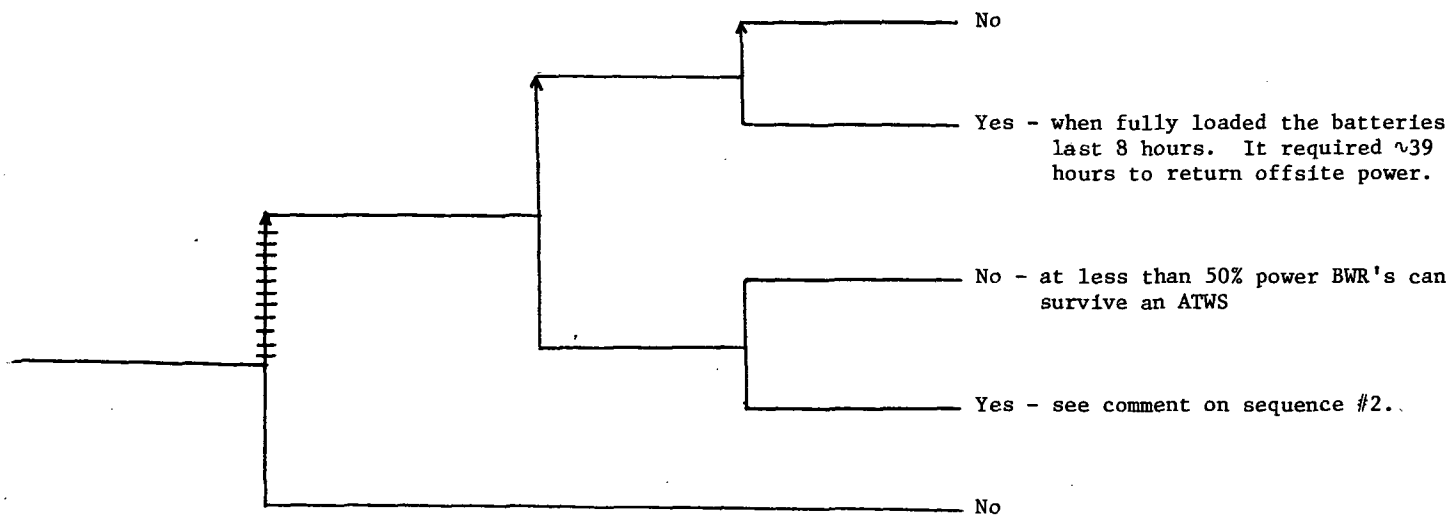
NSIC 135932 - Actual Occurrence of the Loss of All Transmission Lines at Pilgrim 1

The reactor was operating at 24% power when high winds and ice caused all the transmission lines to fail. This event caused the reactor to trip.

Reactor operating at 24% power	All offsite transmission lines lost due to inclement weather	Reactor scram due to load rejection	Diesels start ¹ and load	Potential Severe Core Damage
--------------------------------	--	-------------------------------------	-------------------------------------	------------------------------

¹
It is presumed the diesels started and loaded properly.

CAUSE: insulator flashover due to inclement weather

The insulators were washed with fresh water and the reactor was returned to service. A plant design change was issued to resolve the flashover problem on standoff insulators.

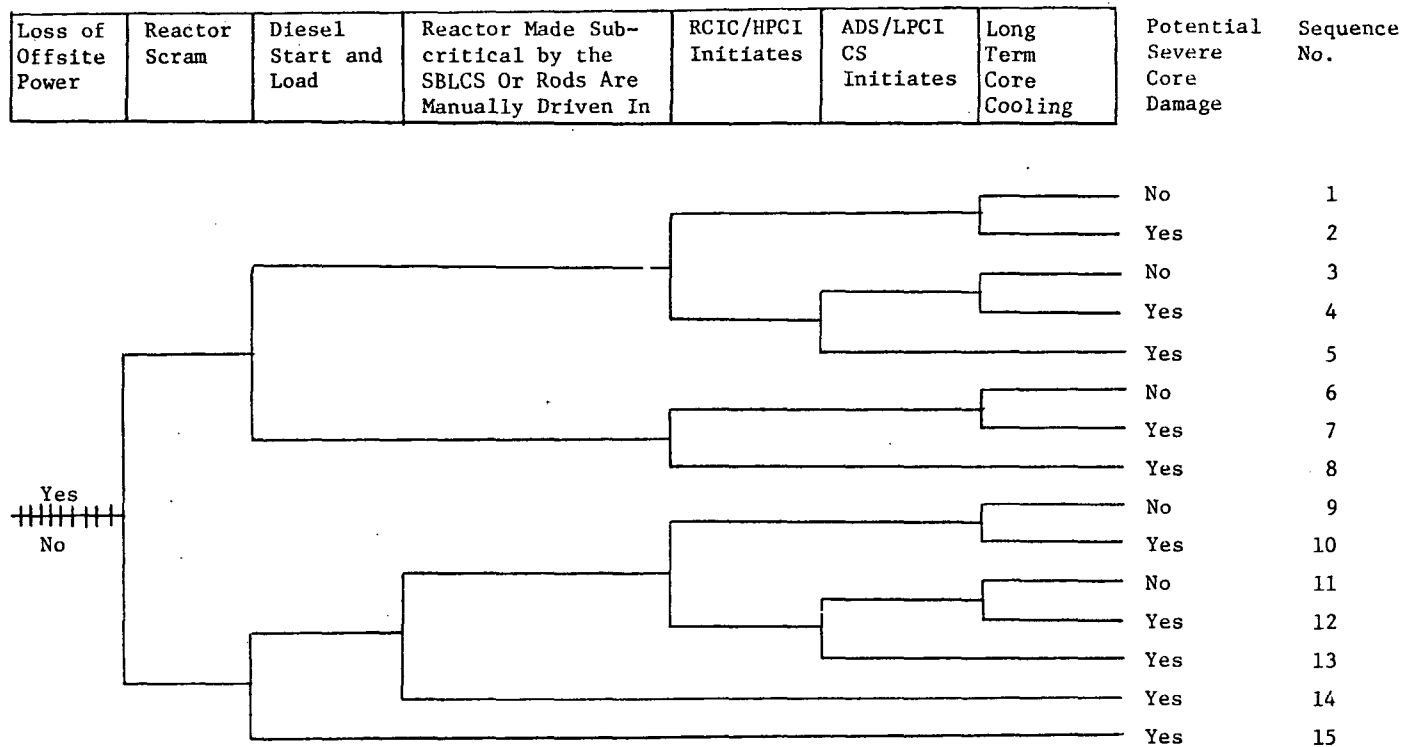
NSIC 135932 - Sequence of Interest of the Loss of All Transmission Lines at Pilgrim 1

SEQUENCE OF INTEREST: loss of offsite power
