PRECURSOR DESCRIPTION AND DATA

NSIC Accession Number: 150943

Title: Reactor Scram From Loss of Offsite Power at Pilgrim 1

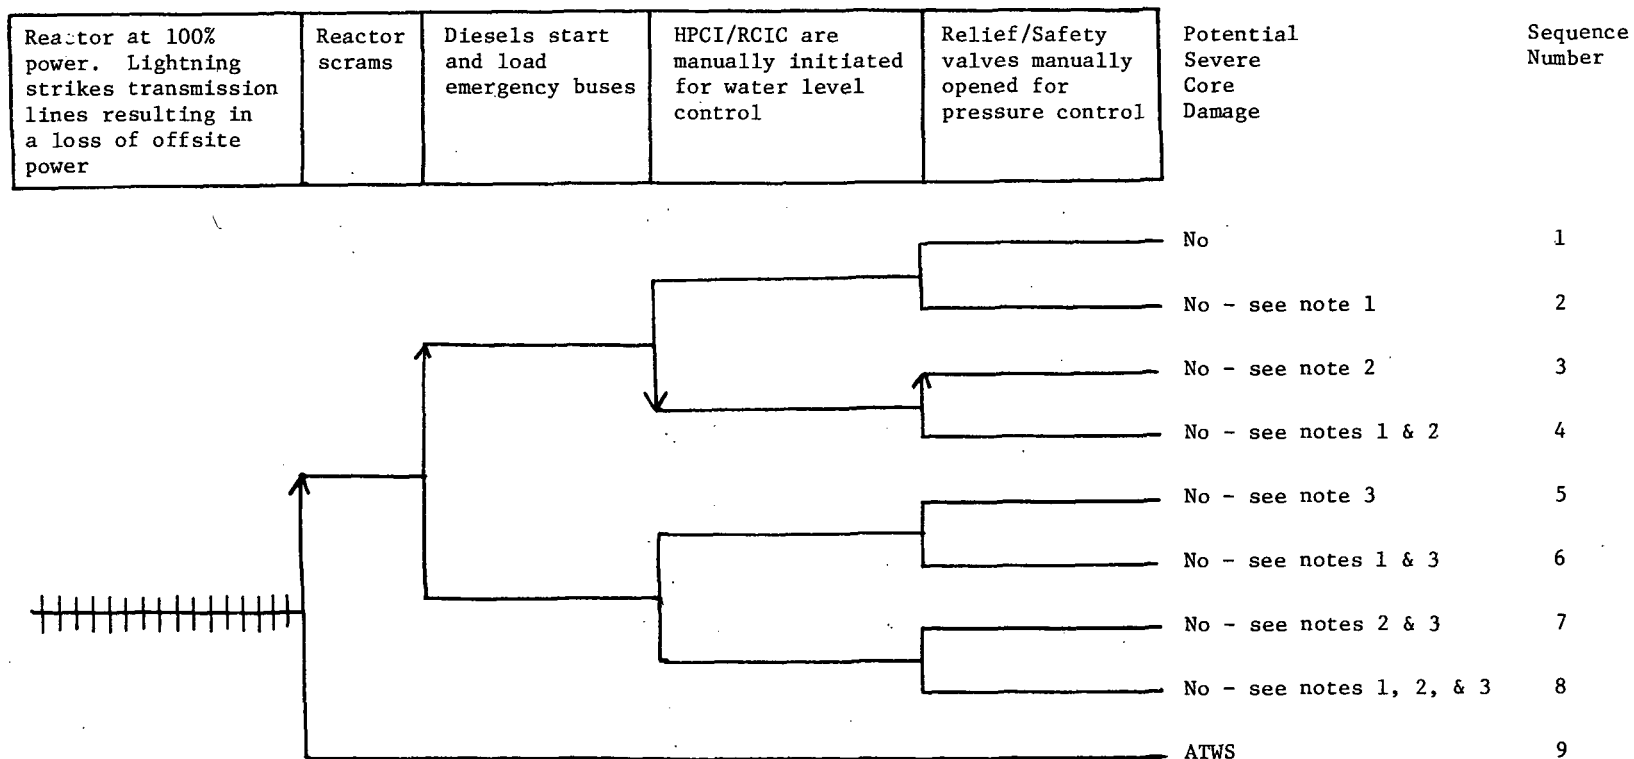
The failure sequence was:

1. The reactor was operating at 100% when lightning struck the offsite transmission lines.
2. This caused backflashing which resulted in a high speed relay operation for a line to ground fault.
3. The reactor tripped.
4. The diesel generators started and loaded properly.
5. Relief/Safety valve 203-3D was manually actuated to control pressure.

Notes

1. The safety and safety/relief valves automatically opened at the following set points:

No. of Valves	Set Pressure (PSIG)
Relief valves	3	1090 to 1100
Safety valves	2	1240

2. The HPCI and the RCIC autoactuate at either low-low reactor water inventory or high dry well pressure. See note 1.
3. The HPCI and RCIC are capable of initiation without an a.c. power source. The safety and relief valves also have this capability. The battery system is capable of 8 hours at 77°F operation without recharge. Since offsite power was restored within $\sim 1\frac{1}{2}$ hour, a potential core damage situation did not exist.

Corrective action:

1. Offsite power was restored in $\approx 1\frac{1}{2}$ hours.
