NSIC Accession Number: 151635

Title: All Offsite Power Lost at Pilgrim 1

CATEGORIZATION OF ACCIDENT SEQUENCE PRECURSORS

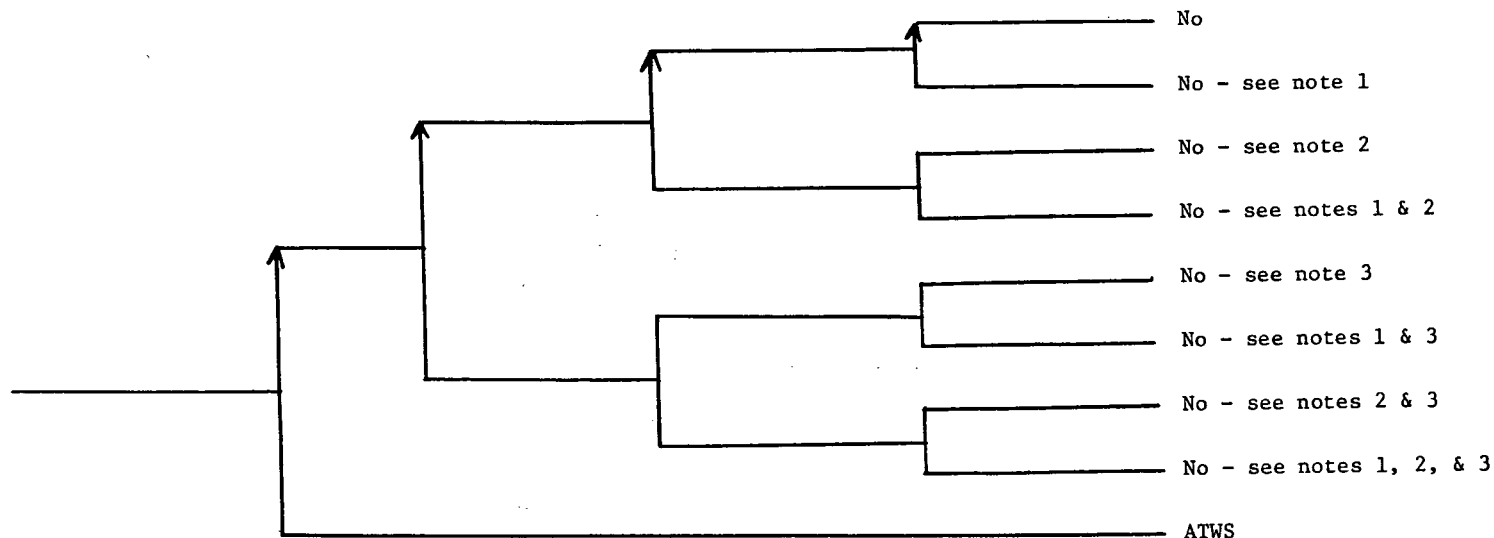
NSIC 151635 -- Actual Occurrence of the Loss of Offsite Power at Pilgrim 1

1. Pilgrim 1 was operating at 100% power when lightning struck the switchyard causing a ground fault. This resulted in a total loss of offsite power.
2. The reactor tripped due to the load rejection.
3. The diesels started and loaded the vital buses.
4. A relief valve was manually opened for pressure control.
5. The reactor was brought to a safe shutdown.

Reactor at 100% power. Lightning strikes switchyard resulting in a loss of offsite power	Reactor scrams	Diesels start and load emergency buses	HPCI/RCIC are manually initiated for water level control ¹	Relief/Safety valves manually opened for pressure control
--	----------------	--	---	---

Potential
Severe
Core
Damage

1. Offsite power was returned to the station in $\sim 1/2$ hour.

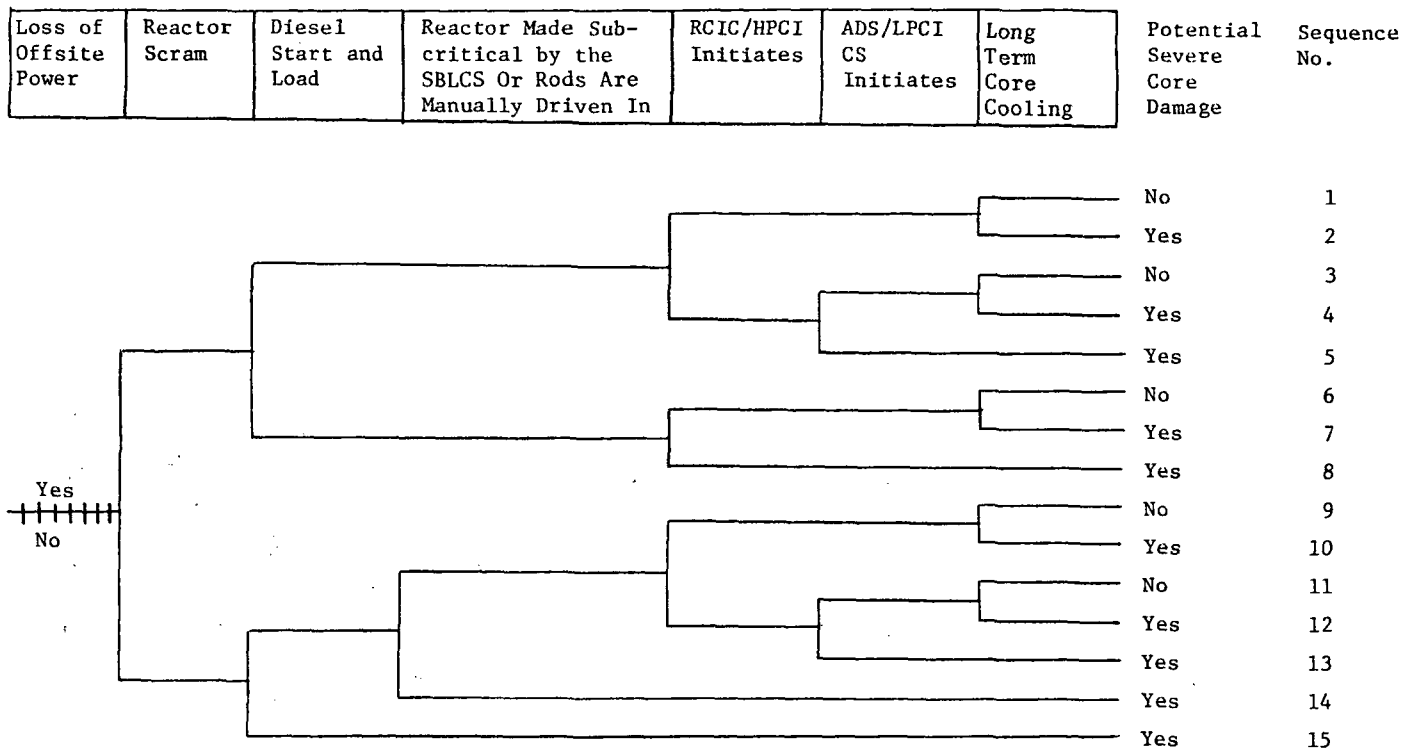
NSIC 151635 — Sequence of Interest for the Loss of Offsite Power at Pilgrim 1

2. The HPCI and the RCIC autoactuate at either low-low reactor water inventory or high dry well pressure. See note 1.
3. The HPCI and RCIC are capable of initiation without an a.c. power source. The safety and relief valves also have this capability. The battery systems are capable of 8 hour operation without recharge. Since offsite power was restored within $\frac{1}{2}$ hour, a potential core damage situation did not exist.
