PRECURSOR DESCRIPTION AND DATA

NSIC Accession Number: 65757

Title: Loss of Offsite Power at Point Beach 1 (Semi-Annual Operations Report for January-June, 1971)

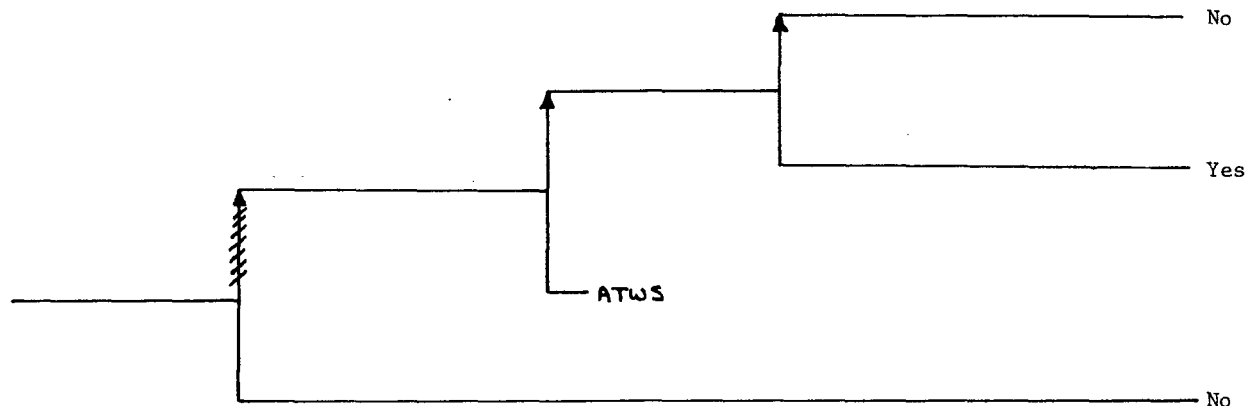
1. With the reactor at hot standby during an ice storm, breakers on all three high lines opened (reason unspecified).
2. A reactor trip occurred.
3. Both diesel generators started and supplied safety-related loads.
4. In view of the continuing storm conditions, the reactor coolant system was borated to the cold shutdown level and cooled down to 300°F.

NSIC 65757 — Actual Occurrence for Loss of Offsite Power at Point Beach 1.

The unit was returned to power two days after the event.

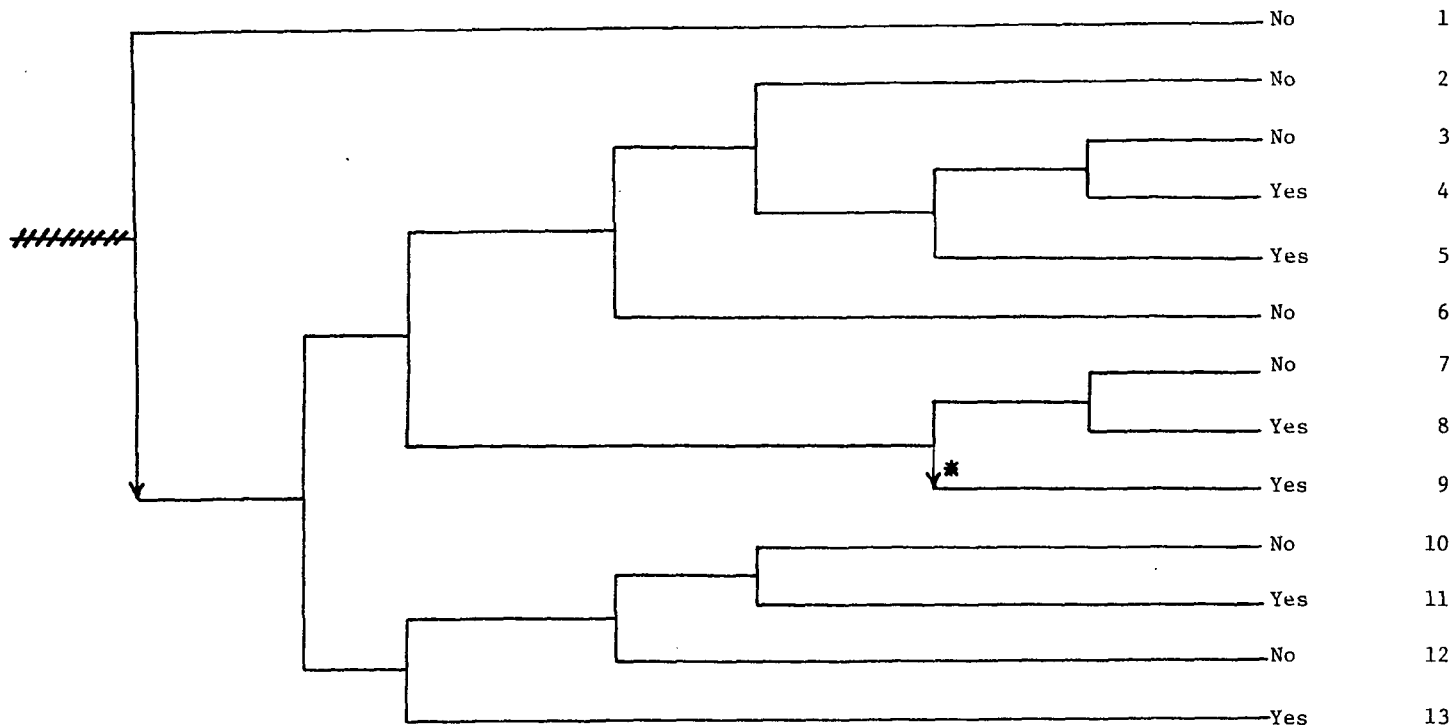
NSIC 65757 — Sequence of Interest for Loss of Offsite Power at Point Beach 1
