PRECURSOR DESCRIPTION AND DATA

NSIC Accession Number: 59484

Title: Failure of Containment Sump Isolation Valves at Point Beach 1

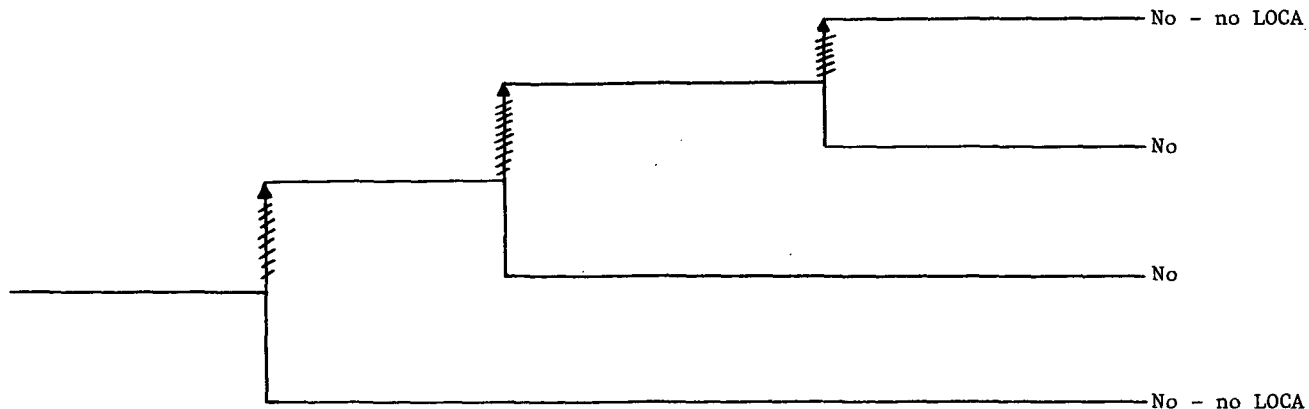
NSIC 59484 — Actual Occurrence for Failure of Sump Isolation Valves at Point Beach 1

1. During a routine check of the containment tendon access gallery with the plant at power, air was observed leaking from the packing of one of the sump isolation valves.
2. When an attempt was made to open the valve it would not open due to a shorted solenoid in the valve hydraulic positioner.
3. The redundant containment sump isolation valve was also found inoperable because of a stuck solenoid in the valve hydraulic positioner.

Reactor at 90% power and containment tendon access gallery check in progress	Containment sump isolation valve packing leak (air) observed	Containment sump isolation valve failed to open for attempted reseating due to failed solenoid	Redundant containment sump isolation valve found failed due to failed solenoid valve	Potential Severe Core Damage
--	--	--	--	------------------------------

1. Both valves were repaired and tested.
2. Both valves were added to the list of valves requiring a monthly check to verify operability.

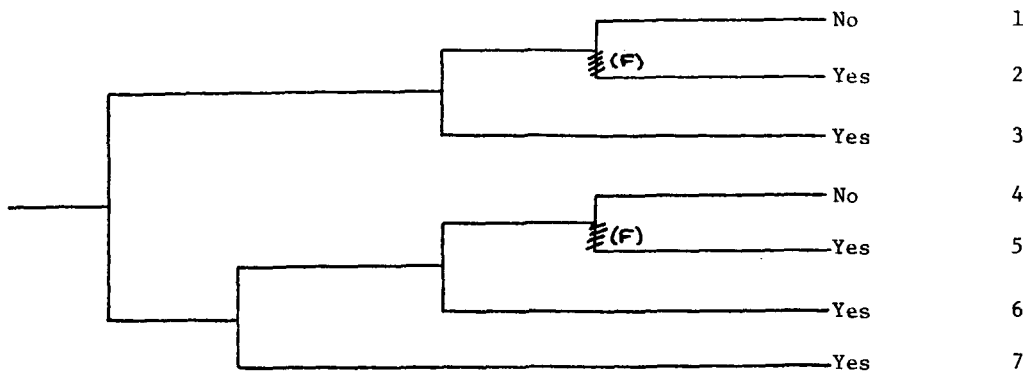
NSIC 59484 - Sequence of Interest for Failure of Sump Isolation Valves at Point Beach 1

Small LOCA	Reactor Trip	Auxiliary Feedwater and Secondary Heat Removal	High Pressure Injection	Low Pressure Recirculation and LPR/HPI Cross-Connect	Potential Severe Core Damage	Sequence No.
---------------	-----------------	---	-------------------------------	---	---------------------------------------	-----------------
