PRECURSOR DESCRIPTION AND DATA

NSIC Accession Number: 65757

Title: Failure of Containment Sump Isolation Valves at Point Beach 1
(Semi-Annual Operations Report for January-June, 1971)

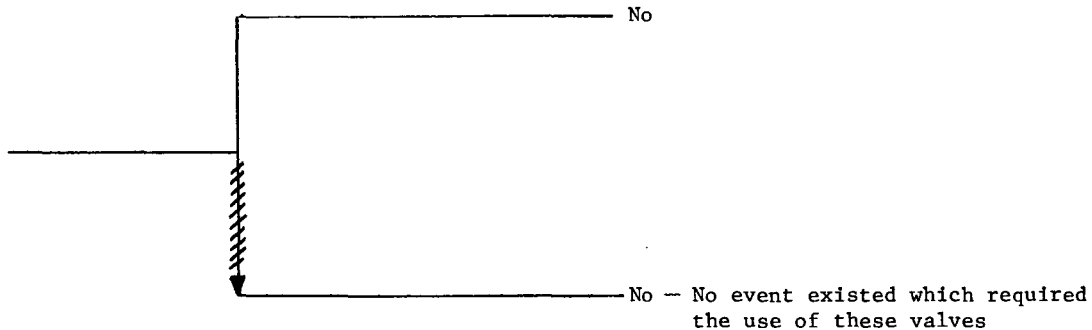
1. During a reactor heatup, the control room operator attempted to open both containment sump isolation valves.
2. Both valves failed to open due to air-binding in their hydraulic operating mechanisms. In addition, both hydraulic units were found to be installed 90° from their upright positions.

NSIC 65757 — Actual Occurrence for Failure of Containment Sump Isolation
Valves at Point Beach 1

CAUSE: Valves failed closed due to air-bound hydraulic operators

The valve hydraulic mechanisms were re-oriented and the suction piping re-routed to take suction from the bottom of the oil sumps.

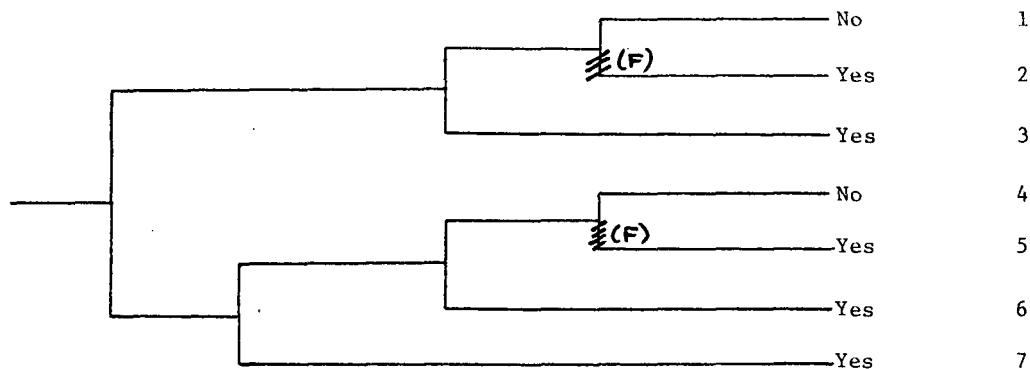
NSIC 65757 — Sequence of Interest for Failure of Containment Sump
Isolation Valves at Point Beach 1
