# PRECURSOR DESCRIPTION AND DATA

NSIC Accession Number: 90421

Title: Auxiliary Feed Pump Suction Strainers Clogged at Point Beach 1

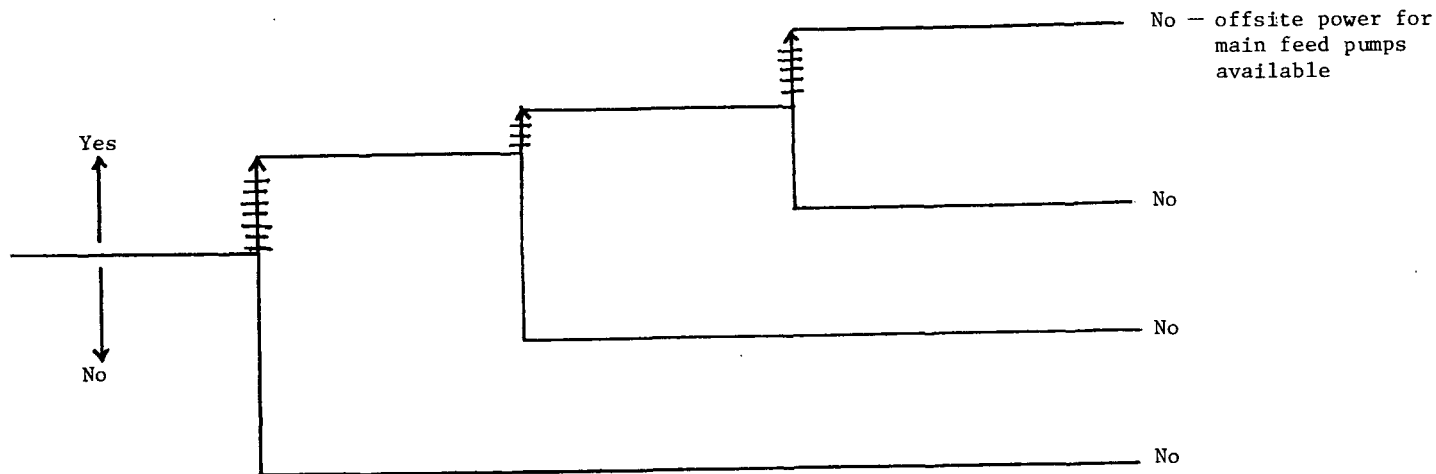
NSIC 90421 - Actual Occurrence for Auxiliary Feed Pump Suction Strainers Clogged at Point Beach 1 & 2

| Unit 1 in cooldown<br>Unit 2 status<br>unknown | Motor-driven AFW<br>pump A fails to<br>deliver adequate<br>flow to Unit 1<br>due to clogged<br>suction strainer | Motor-driven AFW<br>pump B suction<br>strainer clogged | Turbine-driven AFW<br>pump suction<br>strainer partially<br>clogged (applicable<br>to both unit turbine-<br>driven pumps) | Potential<br>Severe<br>Core<br>Damage |

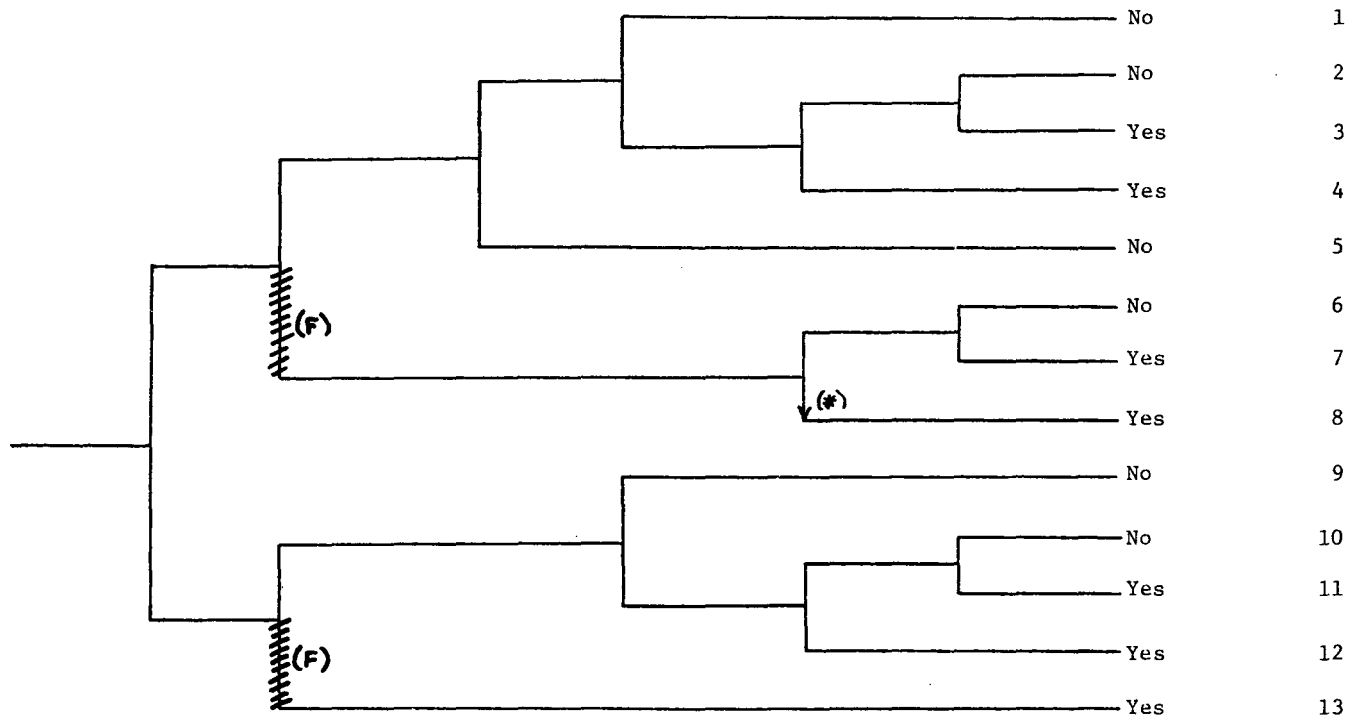
NSIC 90421 - Sequence of Interest for Auxiliary Feed Pump Suction Strainers Clogged at Point Beach 1 & 2

\*Use of HPI following AFW failure not included in mitigation procedures.
