PRECURSOR DESCRIPTION AND DATA

NSIC Accession Number: 152563

Title: Tube Break Occurs in Steam Generator at Prairie Island 1

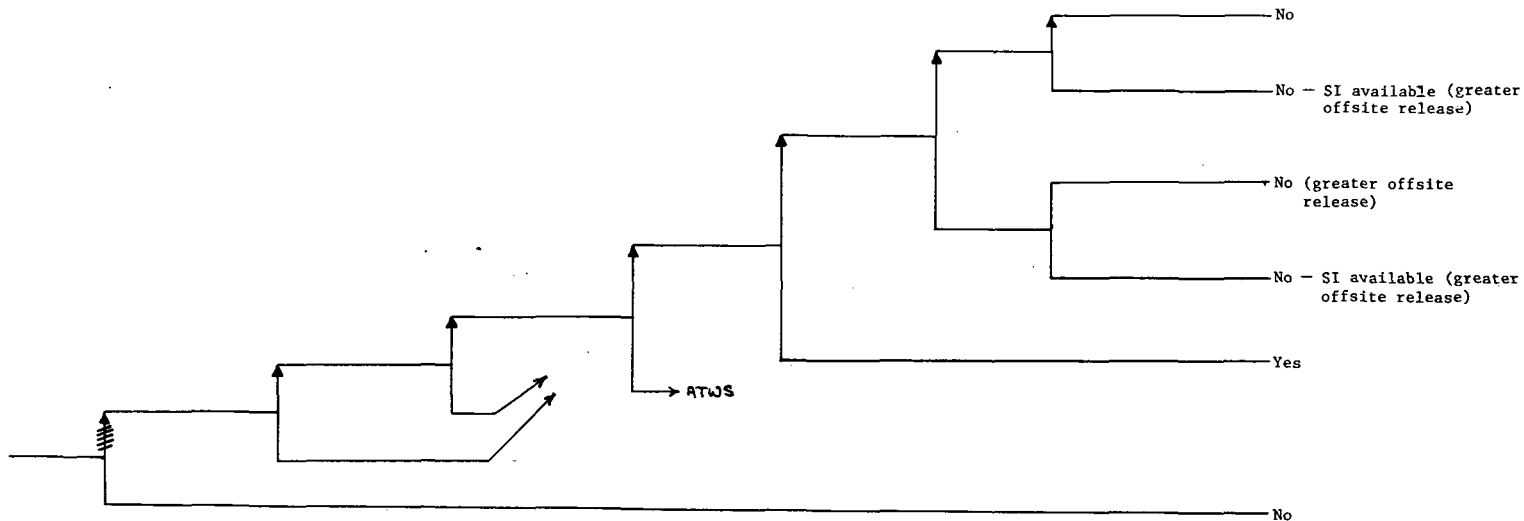
NSIC 152563 - Actual Occurrence for Tube Break Occurs in Steam Generator at Prairie Island 1

Reactor at 100% Power	Steam Generator "A" Tube Rupture and Consequent Air Ejector High Radiation Alarm	Turbine Runback and Load Reduction Due to Decreasing RCS Pressure	Operator Starts Second and Third Charging Pumps Because of Decreasing RCS Pressure	Reactor Trip Due to Low RCS Pressure	Safety Injection Due to Low RCS Pressure, Main Coolant Pumps Stopped by Operator	Loop "A" MSIV Closed by Operator	Pressurizer Filled to High Level Setpoint, SI Pumps Stopped, and RCS Depressurized to Below Steam Generator Relief Valve Set Pressure Using PORV	Potential Severe Core Damage
-----------------------	----------------------------------------------------------------------------------	-------------------------------------------------------------------	------------------------------------------------------------------------------------	--------------------------------------	----------------------------------------------------------------------------------	----------------------------------	--------------------------------------------------------------------------------------------------------------------------------------------------	------------------------------

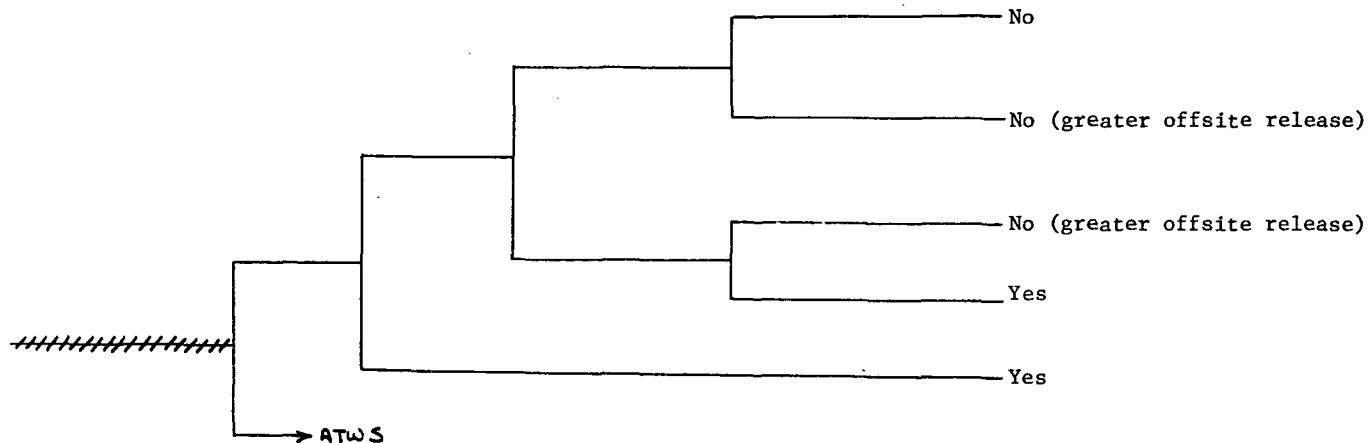
NSIC 152563 — Sequence of Interest for Tube Break Occurs at Prairie Island 1

Steam Generator Tube Rupture	Reactor Trip	Safety Injection	Ruptured Steam Generator Isolated	RCS Depressurized to Below Steam Generator Relief Valve Setpoint	Potential Severe Core Damage
---------------------------------	-----------------	---------------------	-----------------------------------------	---------------------------------------------------------------------------	------------------------------------
