PRECURSOR DESCRIPTION AND DATA

NSIC Accession Number: 80138

Title: Valve Problem Causes Flooding of Turbine-Building Basement at Quad Cities 1

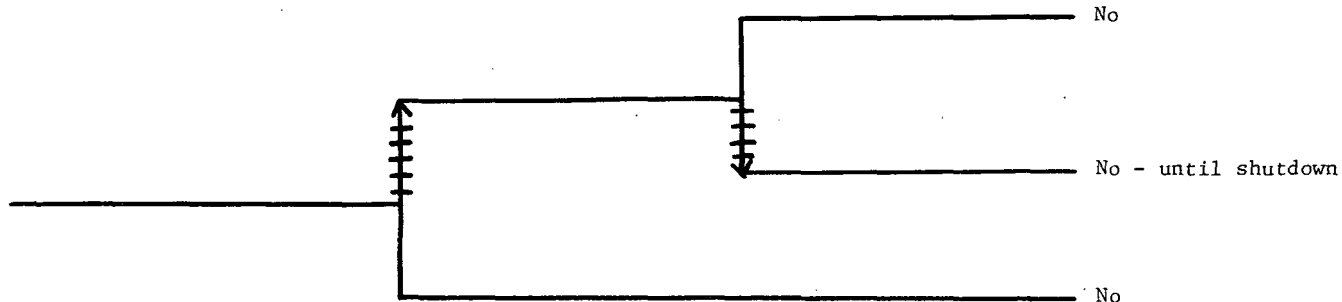
NSIC 80138 — Actual Occurrence of Valve Flooding of the Turbine Building Basement at Quad Cities 1

10' butterfly valve slams shut as operator vents valve actuator. A water hammer results from the valve slamming and the operation of 3 circulating water pumps	The water hammer results in a rupture of 9 snubber expansion joints	Circulating water pumps shutdown in time to prevent loss of safety related equipment	Potential Severe Core Damage
----------------------------------------------------------------------------------------------------------------------------------------------------------------	---------------------------------------------------------------------	--------------------------------------------------------------------------------------	---------------------------------------

1. The water was pumped out of the basement and was continuously monitored for radiation.
 2. The damaged equipment was repaired.
 3. New procedures were adopted for venting the valve hydraulic actuation.
 4. Flood alarms were installed, and a "very high level" trip was installed to shut down the circulating water pump should an expansion joint rupture while the pumps are in operation.
- (see attached sheet)

5. Safety related equipment located in the condenser pump room was enclosed in water tight vaults.

6. The ability to cross tie RHR systems of the two units was also installed.

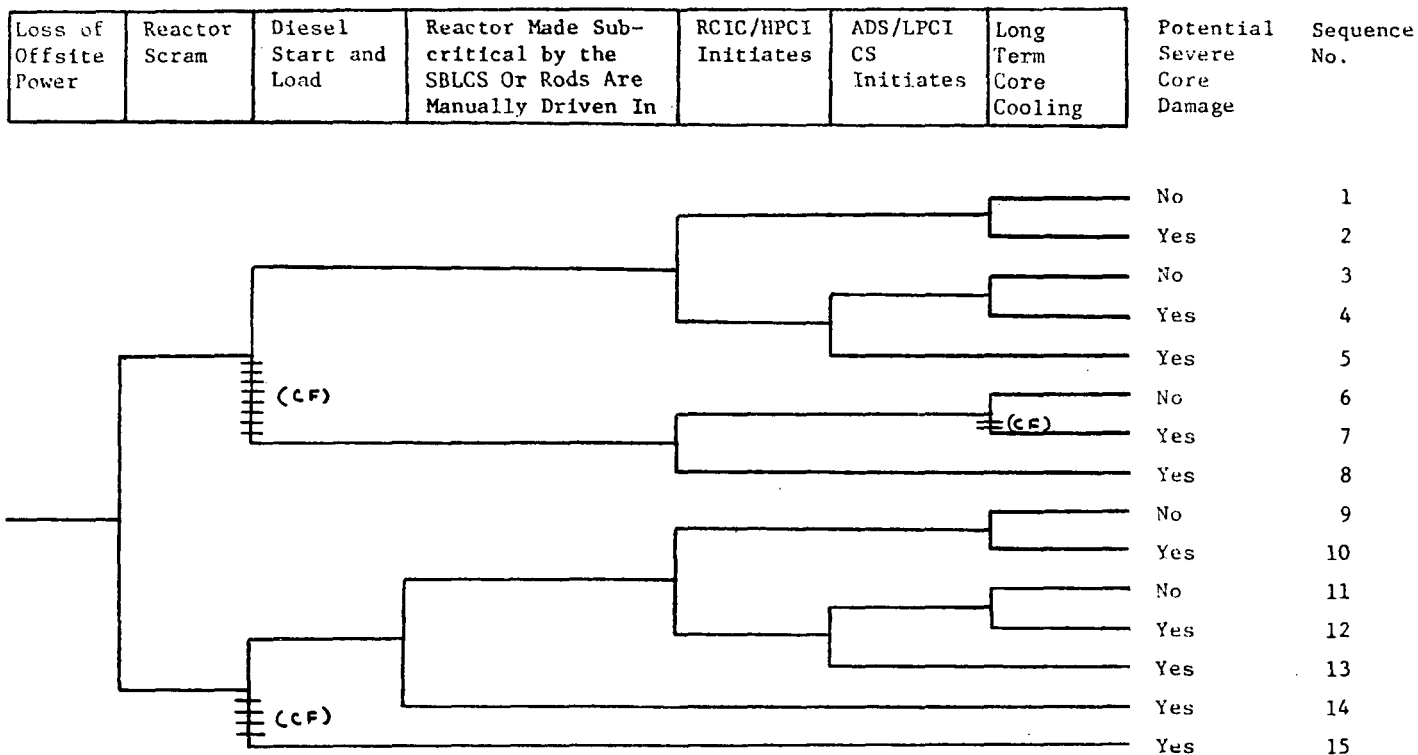
NSIC 80138 — Sequence of Interest for Valve Problem Causes Flooding of Turbine Building Basement at Quad Cities 1

SEQUENCE OF INTEREST: loss of offsite power
