# PRECURSOR DESCRIPTION AND DATA

NSIC Accession Number: 105540

Title: Low Flow Feedwater Line Severed at 6" to 4" Reducer at Quad Cities

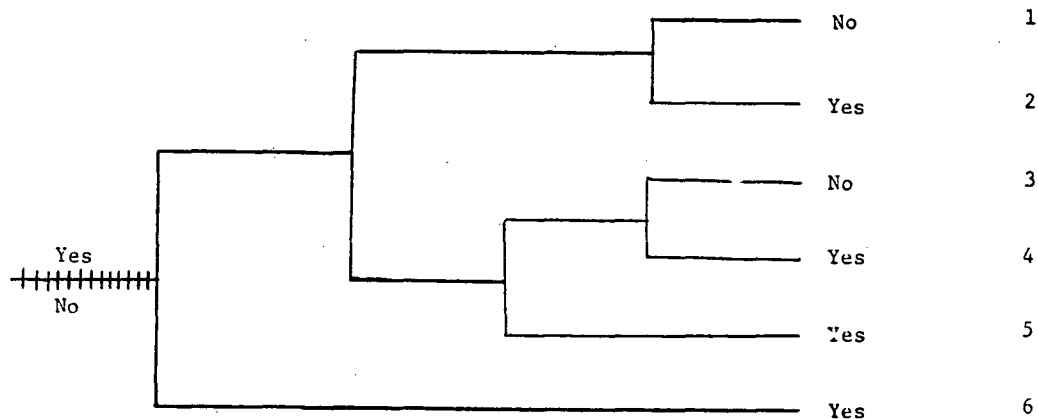
Loss of Coolant Accident	Reactor Maintained Subcritical	HPCI/RCIC Response Adequate	ADS/LPCI CS Response Adequate	Long Term Core Cooling	Potential Severe Core Damage	Sequence No.
--------------------------------	--------------------------------------	-----------------------------------	--	---------------------------------	---------------------------------------	-----------------

NSIC 105540 — Sequence of Interest for Low Flow Feedwater Line Severed at 6x4 Reducer at Quad Cities 2
