PRECURSOR DESCRIPTION AND DATA

NSIC Accession Number: 120995

Title: Suction Valves to Decay Heat Pumps Fail to Open at Rancho Seco

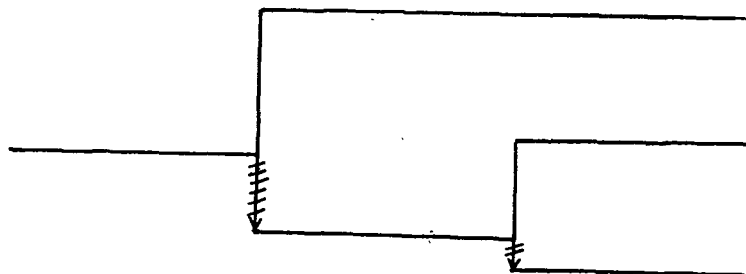
No — No LOCA and unit
in shutdown.

NSIC 120995 — Actual Occurrence for Failure of Both Suction Valves to Decay Heat Pumps
from Emergency Sump at Rancho Seco

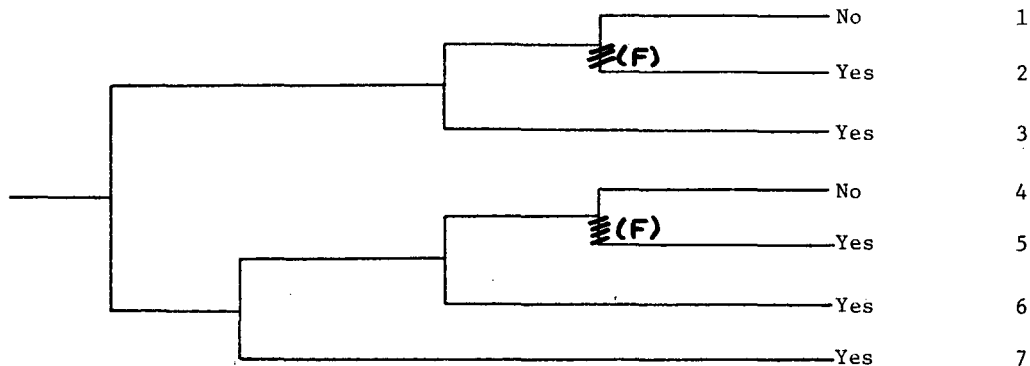
NSIC 120995 — Sequence of Interest for Both Sump Suction Valves to Decay Heat Pumps
Fail to Open at Rancho Seco
