# PRECURSOR DESCRIPTION AND DATA

NSIC Accession Number: 123118

Title: Both AFW Pumps Unavailable at Rancho Seco

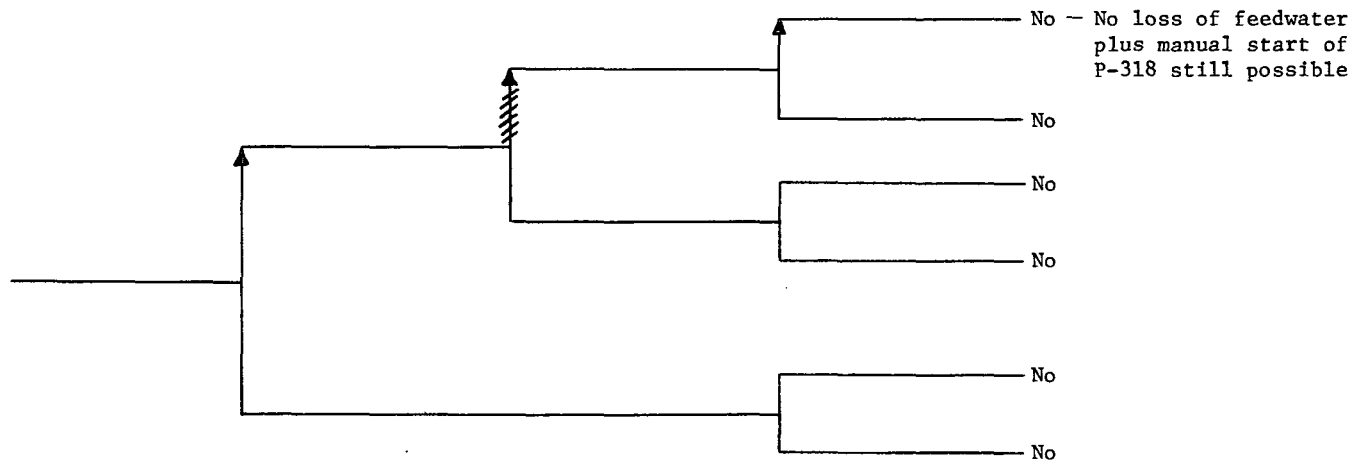
1. With the reactor at 100% power, AFW pump P-318 was tested prior to removing AFW pump P-319 from service for breaker maintenance.
2. When pump P-318 was shut down, the manual/overspeed trip was not properly reset. This resulted in both AFW pumps being unavailable for seven hours.

Reactor at 100% Power	AFW Pump P-318 Tested Prior to Removing AFW Pump P-319 From Service for Maintenance	Pump P-318 Incorrectly Reset Follow- ing Shutdown	Pump P-319 Removed From Service for Maintenance
--------------------------	--	--	--

Potential  
Severe  
Core  
Damage

NSIC 123118 - Actual Occurrence for Both AFW Pumps Unavailable at Rancho Seco

The pump trip was correctly reset, the pump was tested, and returned to service.

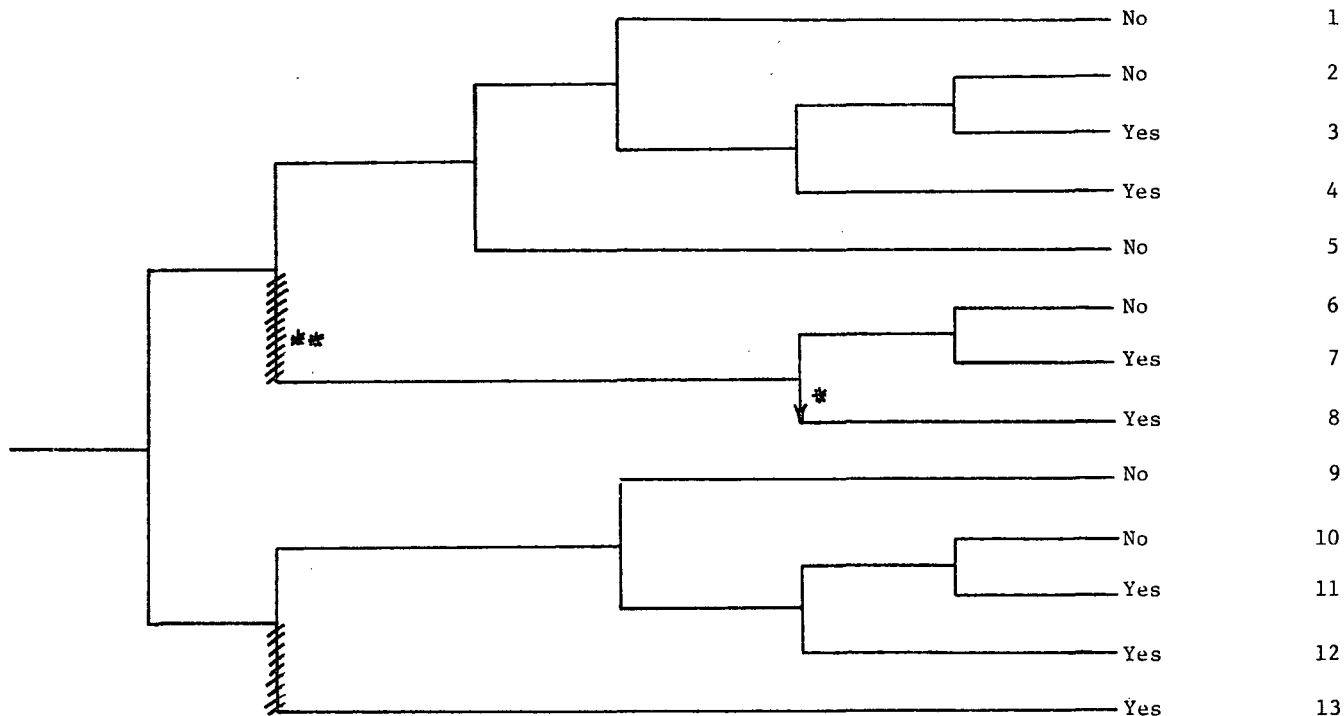
Loss of Main Feedwater	Reactor Trip	Auxiliary Feedwater and Secondary Heat Removal	PORV Demanded	PORV or PORV Isolation Valve Closure	High Pressure Injection	Long Term Core Cooling	Potential Severe Core Damage	Sequence No.
------------------------	--------------	--	---------------	--------------------------------------	-------------------------	------------------------	------------------------------	--------------

NSIC 123118 — Sequence of Interest for Both AFW Pumps Unavailable at Rancho Seco

\*Use of HPI following failure of AFW not included in operating procedures.

\*\*Operator action required for degraded
