PRECURSOR DESCRIPTION AND DATA

NSIC Accession Number: 138830

Title: Reactor Cooldown Rate Exceeds Limit Following Reactor Trip at Rancho Seco

REACTOR NAME: Rancho Seco

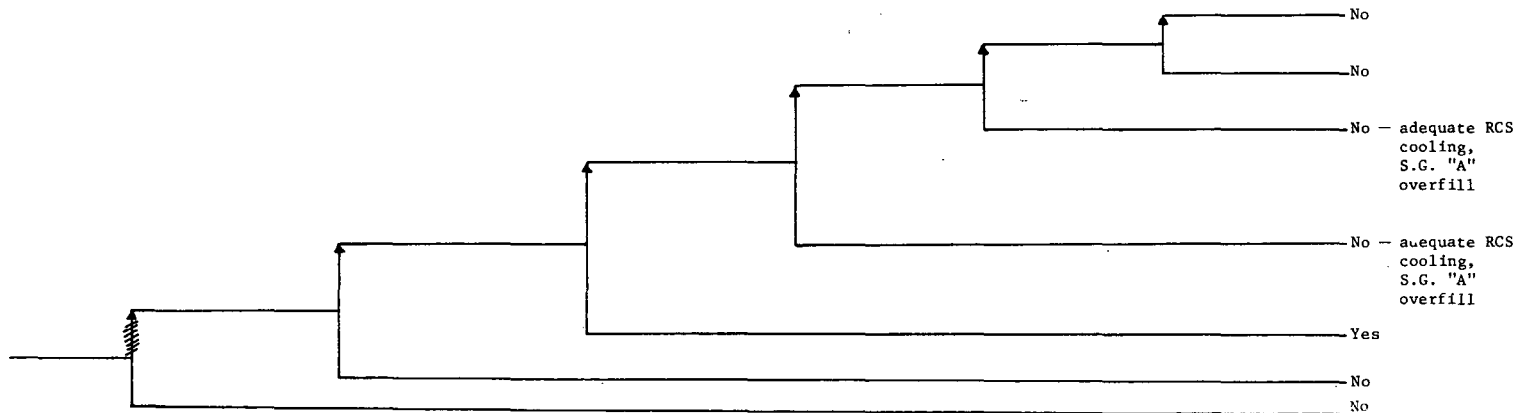
NSIC 138830 - Actual Occurrence for Reactor Cooldown Rate Exceeds Limit Following Reactor Trip at Rancho Seco

Reactor at 70% power	Momentary short circuit results in trip of NNI-Y power supplies - 2/3 of all NNI control and instrumentation signals affected	ICS reduces feedwater flow to zero and starts auxiliary feedwater pump, flow to steam generator inhibited (all due to affected instrumentation), resulting in steam generator boiling dry. (reactor trip on high RCS pressure)	Startup level indication for "A" steam generator eventually drifts below low level setpoint - auxiliary feedwater flow initiated to "A" steam generator	Injection of auxiliary feedwater to "A" steam generator results in RCS cooldown - pressure drop below SFAS low pressure setpoint (1600 psig)	SFAS initiation provides AFW flow to second steam generator, high pressure injection to RCS	Due to lack of instrumentation, operators continue AFW injection until NNI-Y power is returned (70 minutes) and control RCS pressure and level by throttling HPI flow-steam generators filled, water in steam lines, RCS cooldown at 300°F/hr	Potential Severe Core Damage

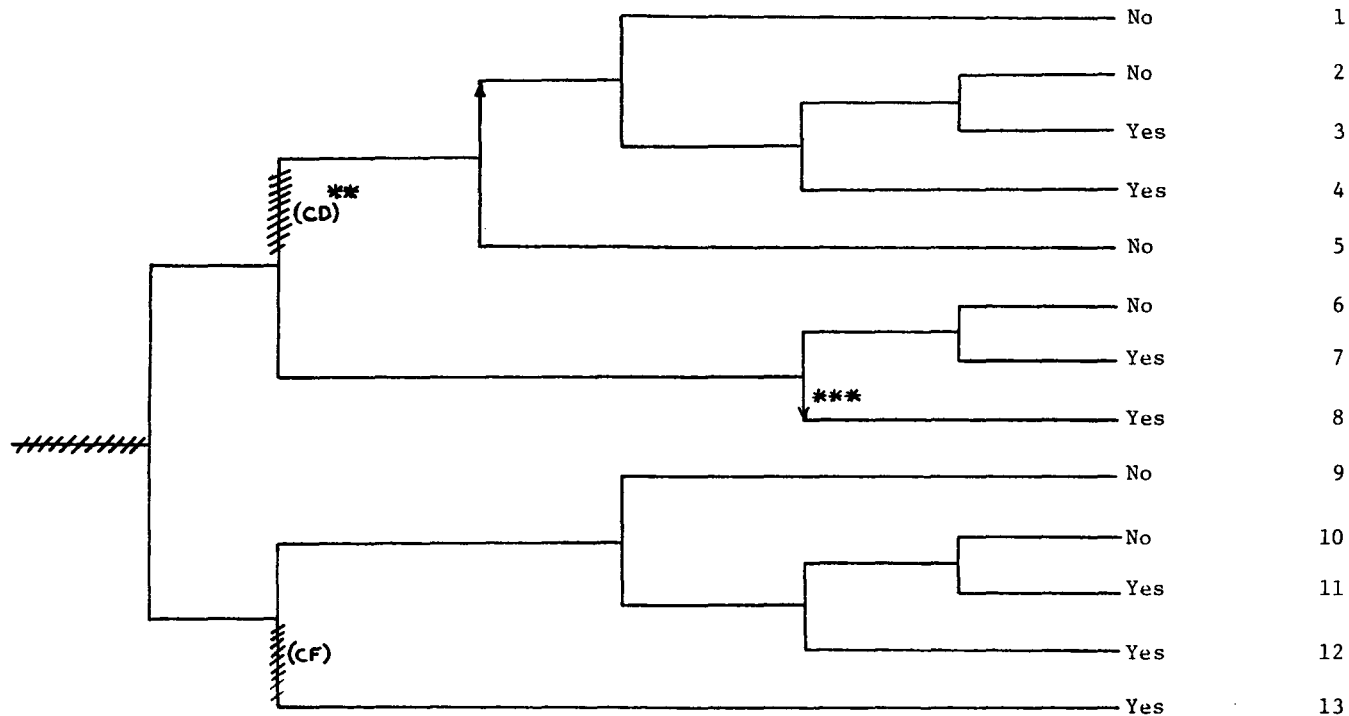
NSIC 138830 - Sequence of Interest for Reactor Cooldown Rate Exceeds Limit Following Reactor Trip at Rancho Seco

\* due to NNI-Y power supply trip

\*\* success requires instrument drift in correct direction or operator decision to open AFW control valves when instrumentation indicates steam generators contain water

\*\*\* not part of mitigation procedure (pre-TMI-2)
