# PRECURSOR DESCRIPTION AND DATA

NSIC Accession Number: 141455

Title: Both Diesel Generators Inoperable Simultaneously at Rancho Seco

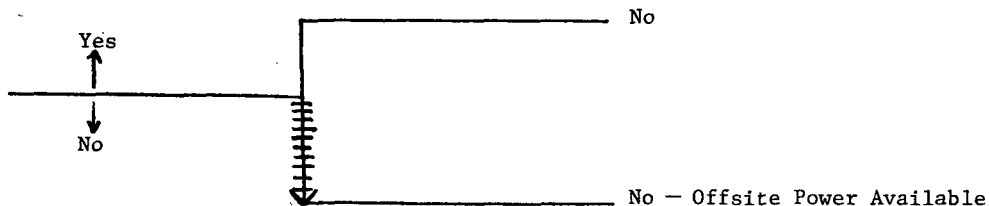
NSIC 141455 - Actual Sequence for Both Diesel Generators  
Inoperable Simultaneously at Rancho Seco

1. While one diesel generator was out of service for maintenance, the second diesel generator was started and paralleled with the nuclear service bus, as required.
2. While the diesel was running, fuel oil began to spray from a loose packing, which could not be tightened while the diesel was in operation.
3. The second diesel was shut down for repair.

Diesel generator B out of service with reactor at power, diesel generator A running	Diesel generator A remains operable
---	--

Potential  
severe core  
damage

1. The running diesel was shut down to repair the packing gland. The reactor was shut down as required. The packing gland was repaired, the diesel generator restarted, and the plant returned to power.

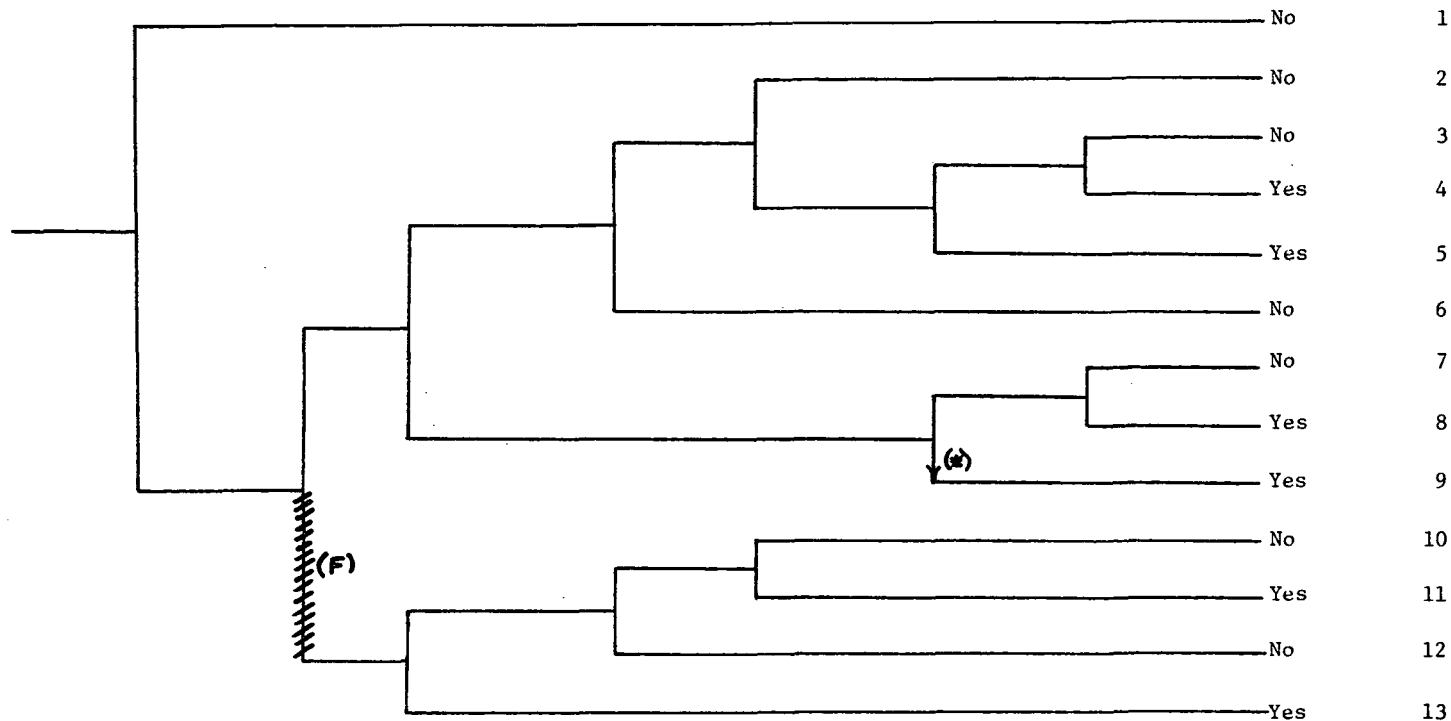
NSIC 141455 - Sequence of Interest for Both Diesel Generators Inoperable Simultaneously at Rancho Seco

\* Not included in mitigation procedures.
