# PRECURSOR DESCRIPTION AND DATA

NSIC Accession Number: 63144

Title: Both Diesels Fail to Start at Robinson 2

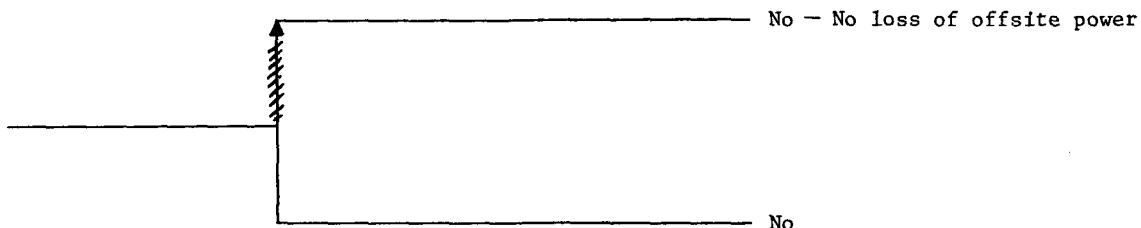
NSIC 63144 - Actual Occurrence for Both Diesel Generator  
Fail to Start at Robinson 2

Reactor at Power and Diesel Generator Testing in Progress	Both Diesel Generators Fail to Start Due to Improperly Sized and Vented Hydraulic Lines Between the Diesel Lube Oil System and Low Lube Oil Pressure Switches
--	---

Potential  
Severe  
Core  
Damage
