PRECURSOR DESCRIPTION AND DATA

NSIC Accession Number: 135079

Title: All Safety Injection Pumps Inoperable During Heatup at Robinson 2

NSIC 135079 — Sequence of Interest for Inoperable Safety Injection Pumps at Robinson 2

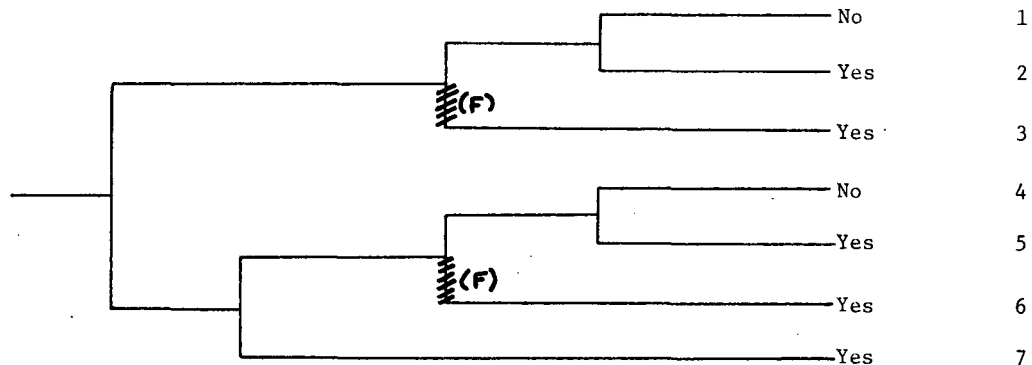
The failure sequence was:

1. While the reactor was shut down, the SI pumps were tested and determined to be **operable**. The pump breakers were then racked out as required for over-pressure protection during cold shutdown.
2. During heatup (~4 hrs later) the pump breakers were not racked in, as required before going above 200°F due to a misunderstanding of the procedures.
3. This fact was discovered while completing a minimum equipment list and the breakers were racked in (five hours after they were required to be racked in).

1. The breakers were racked in.
2. Operating procedures were revised as necessary to require the pumps to be in service before exceeding 200°F.
