PRECURSOR DESCRIPTION AND DATA

NSIC Accession Number: 142462

Title: Loss of a Vital Instrument Bus Initiates a Reactor Trip at Salem 1

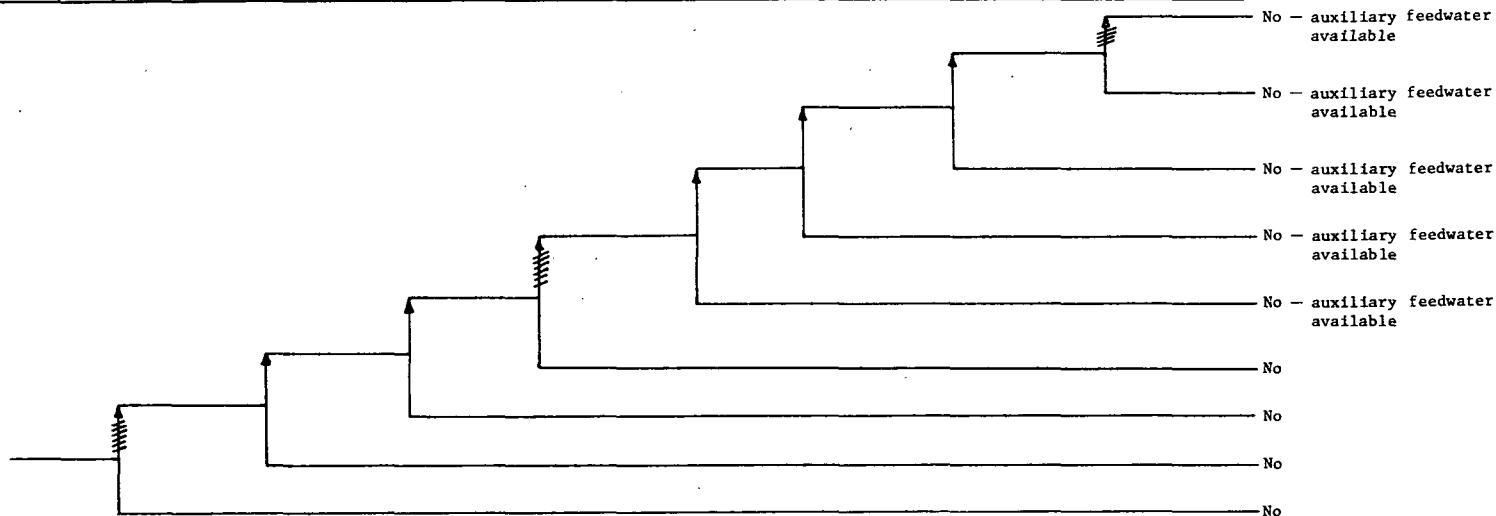
Reactor at 100% power	Loss of vital bus 1B due to output transformer and regulating resistor failures	Reactor trip due to false low RCS loop flow signals resulting from vital bus failure	AFW Pump 12 failure to start due to bus failure	AFW Pump 13 failure to start due to misadjustment of overspeed trip mechanism	Operator manually starts AFW Pump 12	Decreasing Tavg plus safety injection inputs due to loss of vital bus result in inadvertant safety injection	Failure of 1B diesel generator, #11 charging pump, and #12 RHR pump to start due to loss of vital bus	Failure of #11 RHR pump to start after being initially secured due to pump breaker failure	Potential Severe Core Damage
-----------------------	---	--	---	---	--------------------------------------	--	---	--	------------------------------

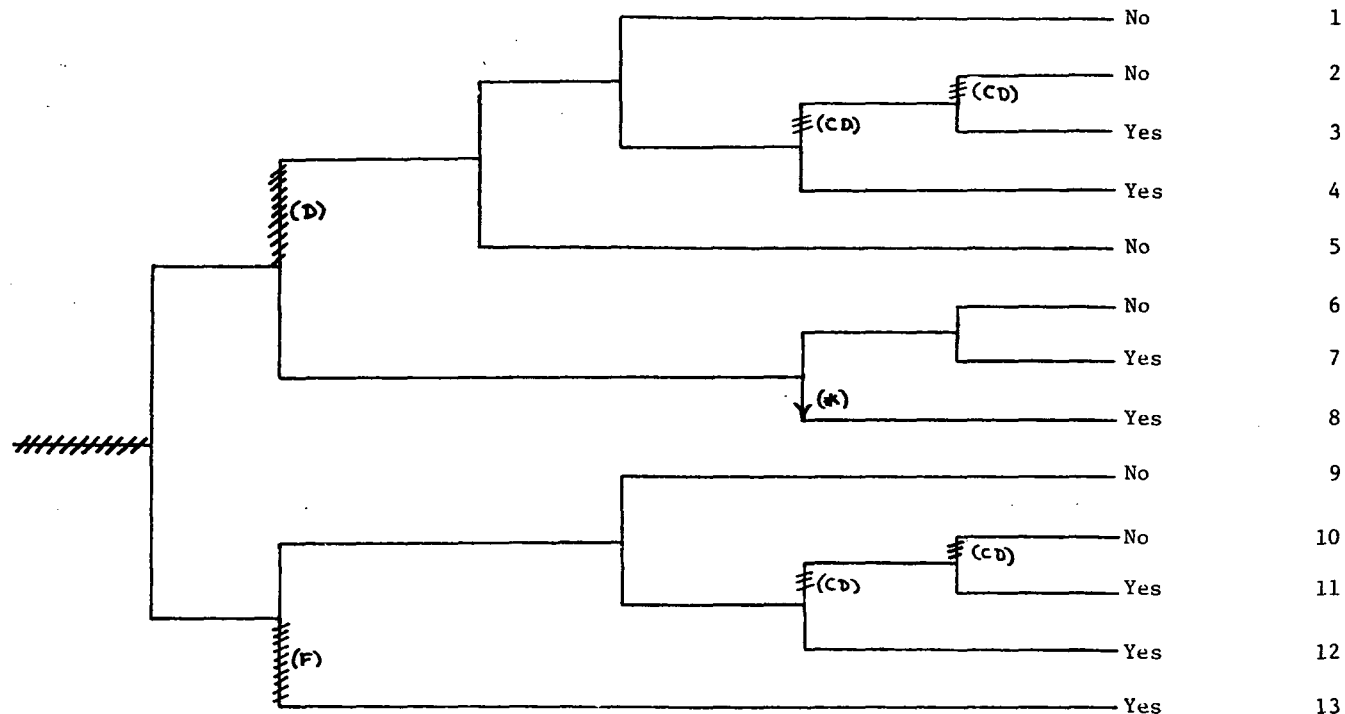
NSIC 142462 — Sequence of Interest for Loss of a Vital Instrument Bus Initiates a Reactor Trip at Salem 1

Loss of Vital Bus 1B	Reactor Trip	Auxiliary Feedwater and Secondary Heat Removal	PORV Demanded	PORV or PORV Isola- tion Valve Closure	High Pressure Injection	Long Term Core Cooling	Potential Severe Core Damage	Sequence No.
----------------------------	-----------------	---	------------------	---	-------------------------------	------------------------------	---------------------------------------	-----------------
