PRECURSOR DESCRIPTION AND DATA

NSIC Accession Number: 125563

Title: Offsite Power Lost at St. Lucie 1

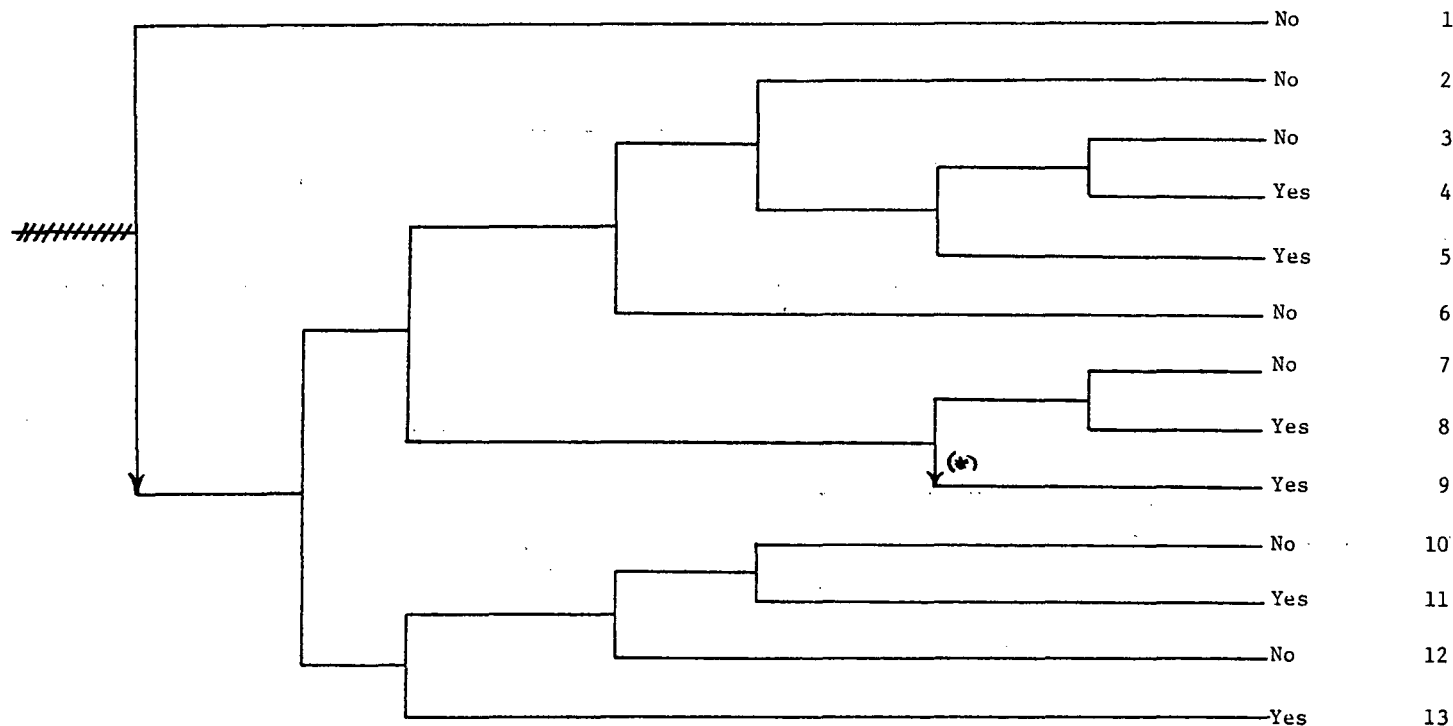
NSIC 125563 — Sequence of Interest for Off-Site Power Lost at St. Lucie 1

1. Fifteen minutes after a manual reactor trip due to grid disturbances, a system undervoltage condition occurred which caused the reactor coolant pumps to trip.
2. Both diesel-generators started and loaded.
3. The reactor was cooled down using natural circulation until off-site power was restored (approximately 20 minutes).
4. One hour later, off-site power was again lost and natural circulation cool-down was used until off-site power was restored (one to one-and-a-half hours later).

SEQUENCE OF INTEREST: loss of offsite power

ACTUAL OCCURRENCE: reactor trip with loss of offsite power
