# PRECURSOR DESCRIPTION AND DATA

NSIC Accession Number: 139565

Title: Off-site Power Lost at St. Lucie 1

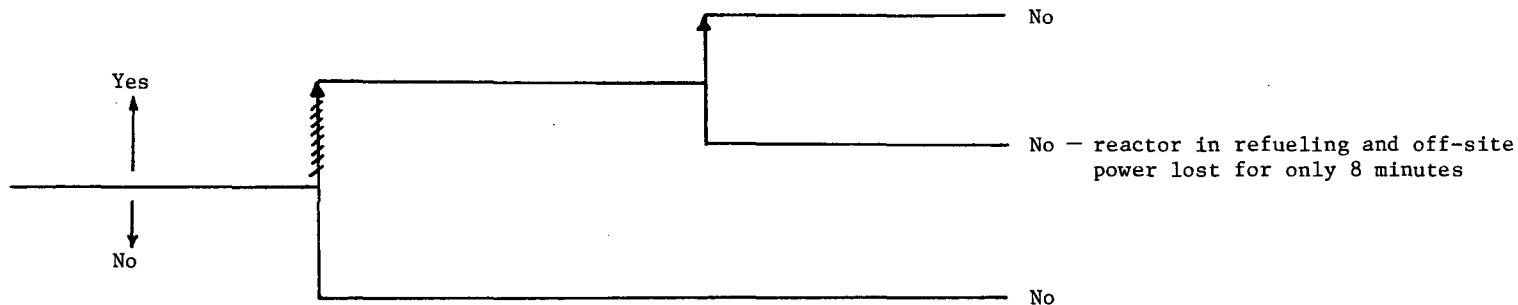
NSIC 139565 - Actual Occurrence for Offsite Power Lost at St. Lucie 1

Reactor shut down for refueling and one diesel-generator down for maintenance	Switching errors at one substation and improper connection of both 240 KV/138 KV autotransformer polarizing current transformer circuits at another substation result in a total loss of offsite power	Operable diesel-generator starts and safety-related loads
---	--	---

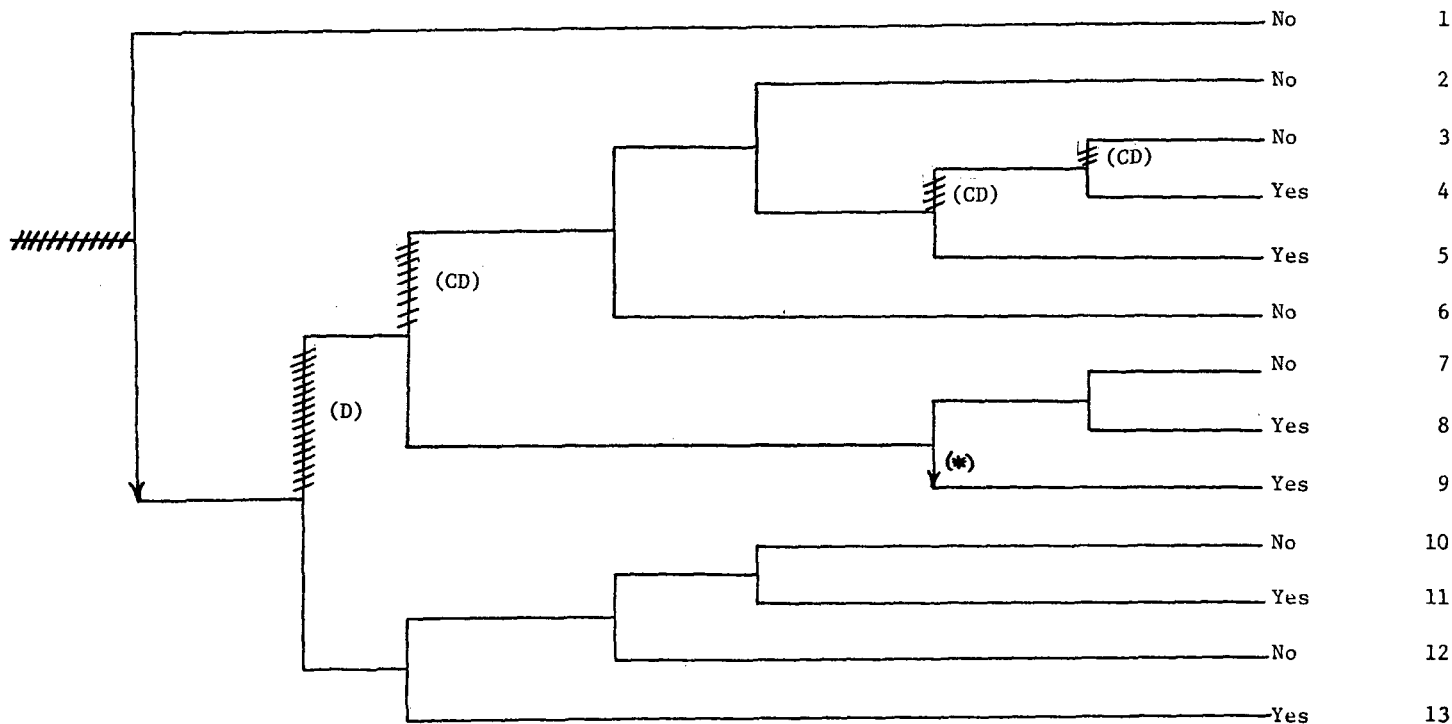
NSIC 139565 - Sequence of Interest for Offsite Power Lost at St. Lucie 1

Loss of Offsite Power	Turbine Generator Runs Back and Assumes House Loads	Emergency Power	Auxiliary Feedwater and Secondary Heat Removal	PORV Demanded	PORV or PORV Isolation Valve Closure	High Pressure Injection	Long Term Core Cooling	Potential Severe Core Damage	Sequence No.
-----------------------	---	-----------------	--	---------------	--------------------------------------	-------------------------	------------------------	------------------------------	--------------
