PRECURSOR DESCRIPTION AND DATA

NSIC Accession Number: 152187

Title: Startup Transformer Fails and Diesel Generator Fails to Start at St. Lucie 1

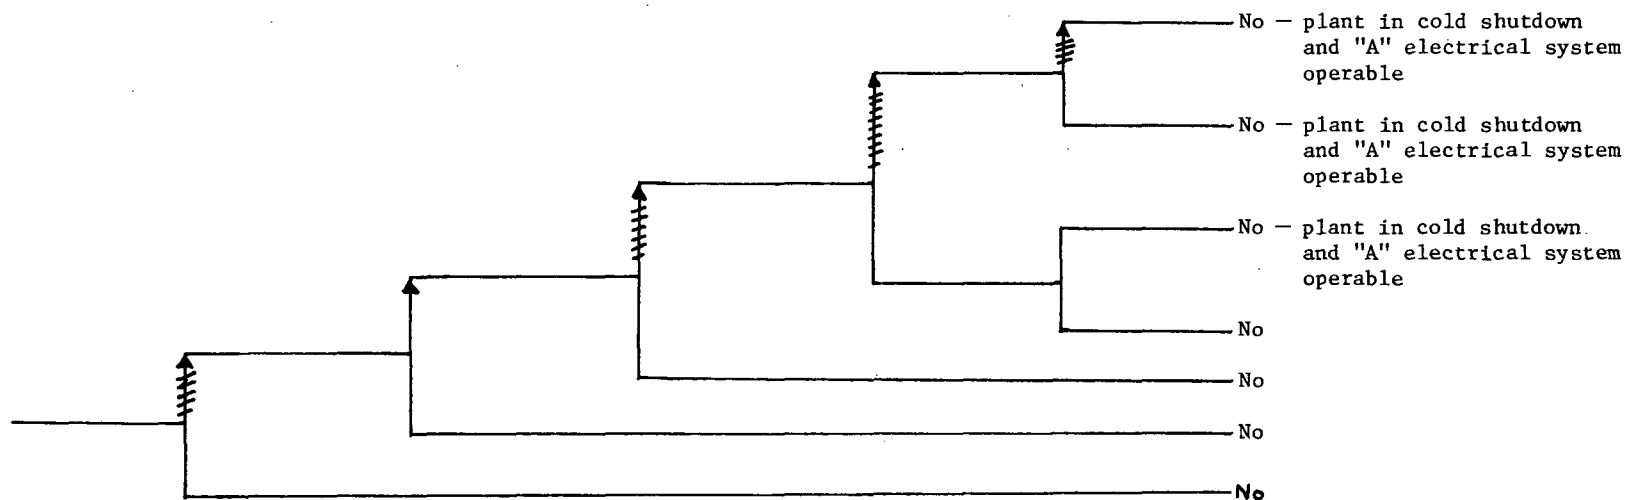
NSIC 152187 - Actual Occurrence for Startup Transformer Fails and Diesel-Generator Fails to Start at St. Lucie 1

1. With the reactor in cold shutdown during the passage of hurricane David, a support cable for a crane used in the Unit 2 construction fell across the lines to the "B" startup transformer.
2. The East switchyard bus locked-out and the "B" startup transformer de-energized, resulting in de-energization of the "B" and "AB" (because of the alignment at the time) electrical systems.
3. The "B" diesel-generator failed to start due to a binding relay in its auto-start circuitry, the "B" inverter failed due to a blown fuse, and the "AB" 125VDC bus tripped due to a current transient during the event, resulting in the loss of numerous instrumentation.

| Reactor in Cold Shut-down During Passage of Hurricane David | Support Cable for Crane (Unit 2 Construction Falls Across Lines to "B" Startup Trans. | East Switch-yard Bus Lockout and De-energization of "B" Startup Trans. ("B" and "AB" Electrical Systems De-energized) | "B" Diesel-Generator Fails to Start Due to Binding Relay in Auto-Start Circuitry | "B" Inverter Fails Due to a Blown Fuse | "AB" D.C. Bus De-energized Due to a Current Transient | Potential Severe Core Damage |

1. The binding relay was replaced.
2. The auto-start and loading capability of the "B" diesel generator was verified.

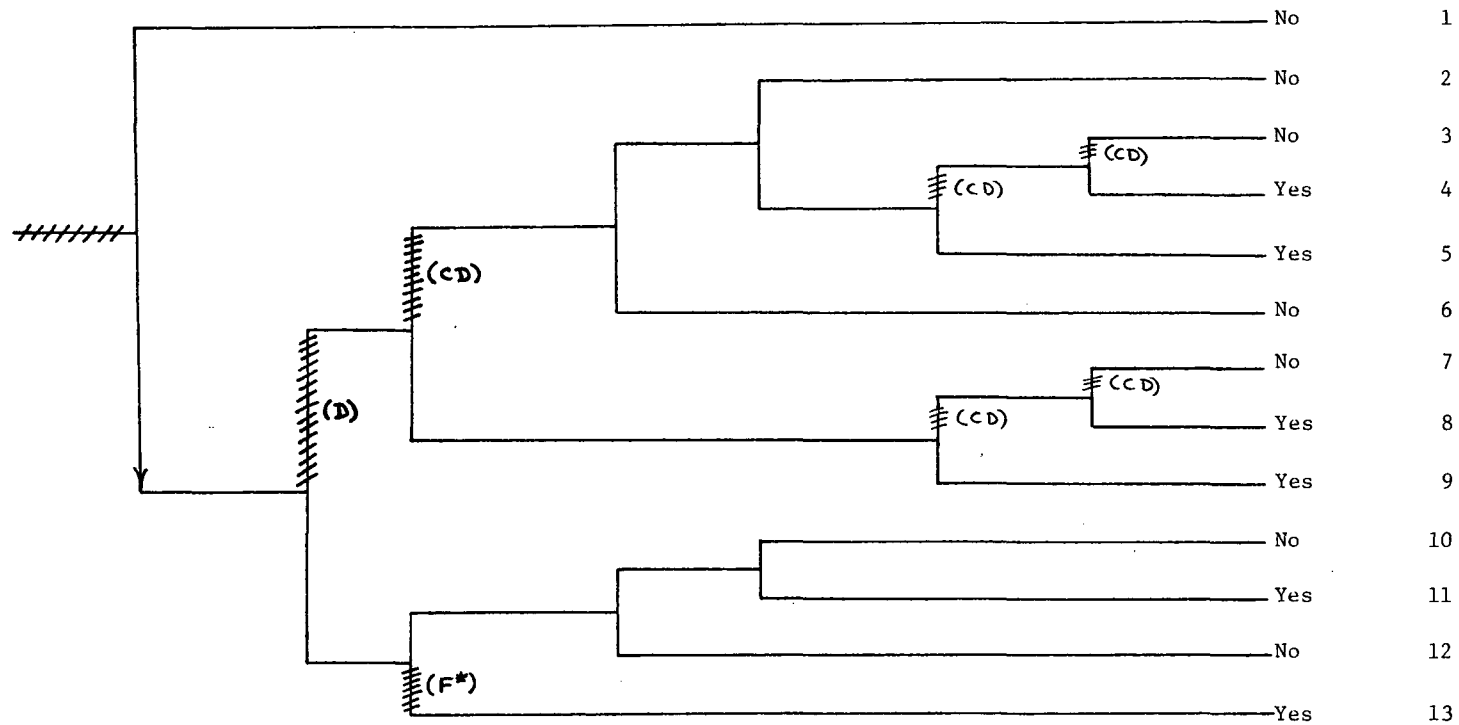
NSIC 152187 - Sequence of Interest for Startup Transformer Fails and Diesel-Generator Fails to Start at St. Lucie 1

*Manual action may be successful in initiating the turbine-driven AFW pump.
