NSIC Accession Number: 82198

Title: Failure to Transfer Auxiliary Power to Startup Transformer at Turkey Point 3

REACTOR NAME: Turkey Point 3

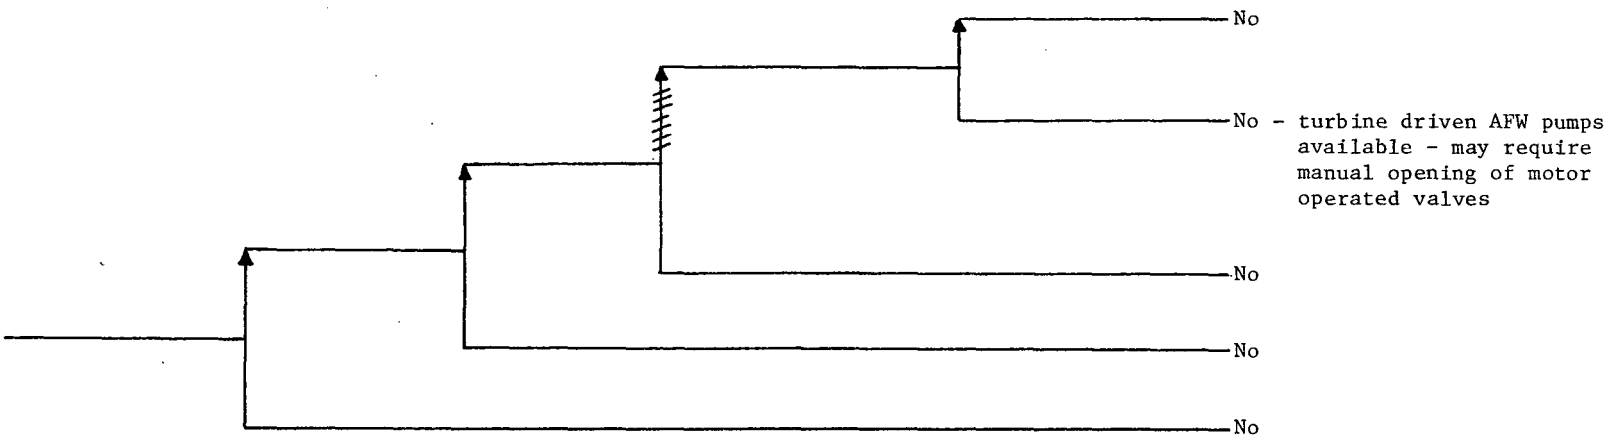
Reactor at 87% power and calibration of steam line pressure transmitters in progress	Inadvertent safeguards initiation during testing	Reactor trip, turbine trip	Failure to transfer safety-related loads from auxiliary transformer to startup transformer	Diesel generators start and assume safety-related loads	Potential Severe Core Damage
--	--	----------------------------	--	---	------------------------------

NSIC 82198 - Actual Occurrence for Failure to Transfer Auxiliary Power to Startup Transformers at Turkey Point 3

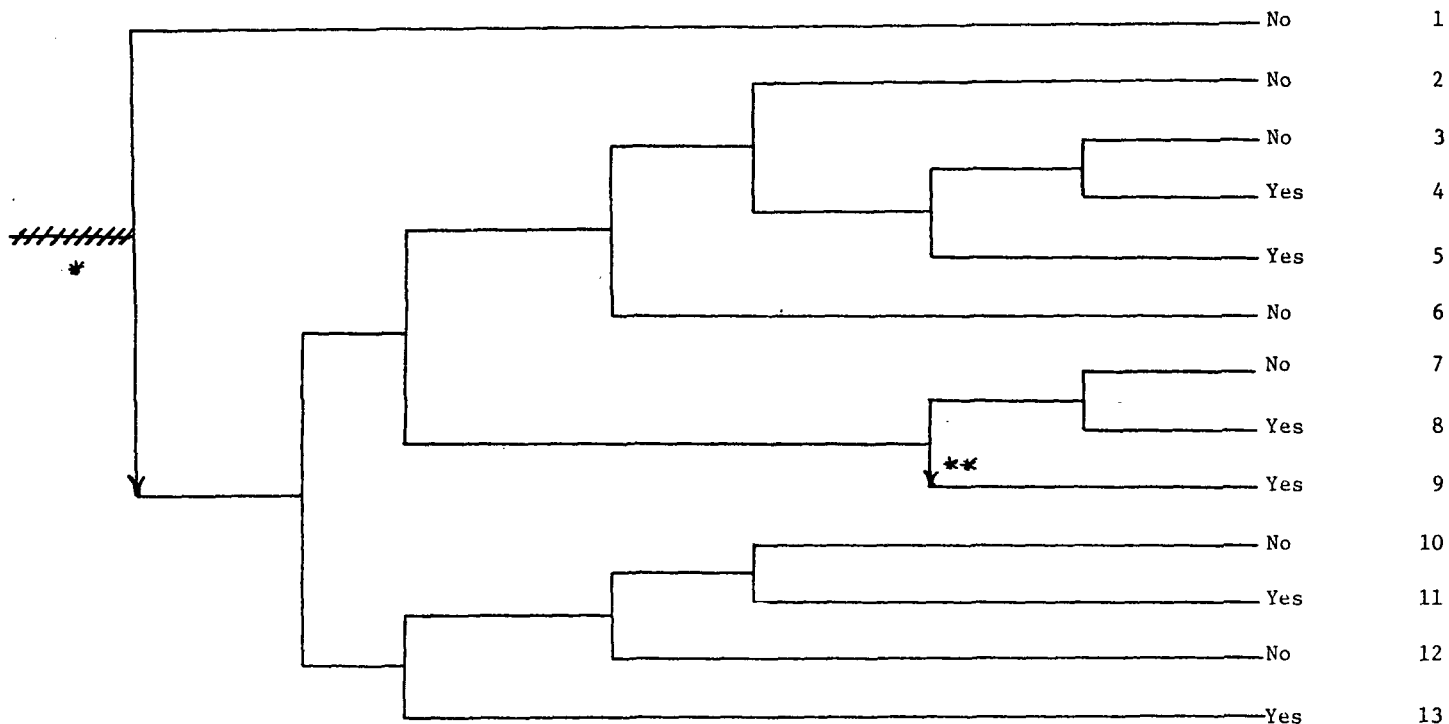
NSIC 82198 - Sequence of Interest for Failure to Transfer Auxiliary Power to Startup Transformers at Turkey Point 3 (effective loss of offsite power)

*Success requires manual transfer to the startup transformer.

**Not included in mitigation procedures.
