# PRECURSOR DESCRIPTION AND DATA

NSIC Accession Number: 91676

Title: Malfunction of Auxiliary Feedwater Pumps at Turkey Point 3

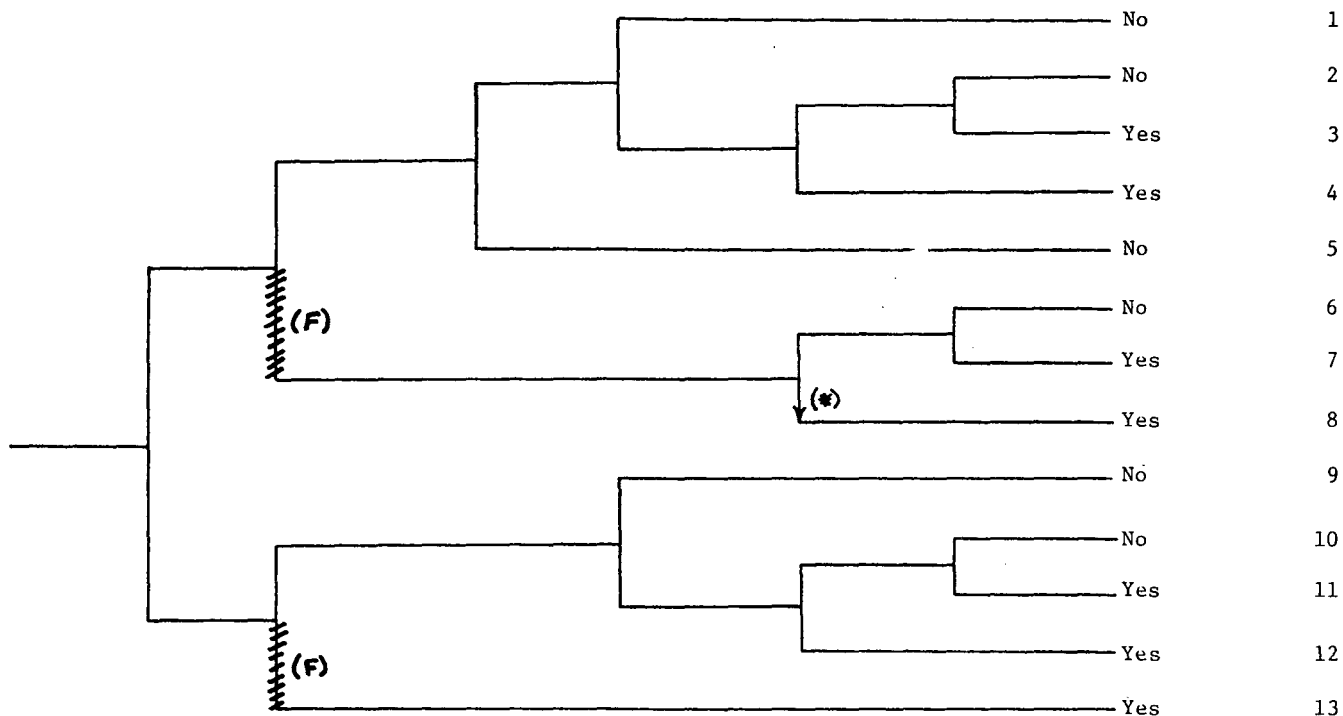
NSIC 91676 - Sequence of Interest for Malfunction of Auxiliary Feedwater Pumps at Turkey Point 3  
 \*Use of HPI following AFW failure not included in mitigation procedures.
