# PRECURSOR DESCRIPTION AND DATA

NSIC Accession Number: 81523

Title: Failure of AFW Pumps to Auto-Start at Turkey Point 4

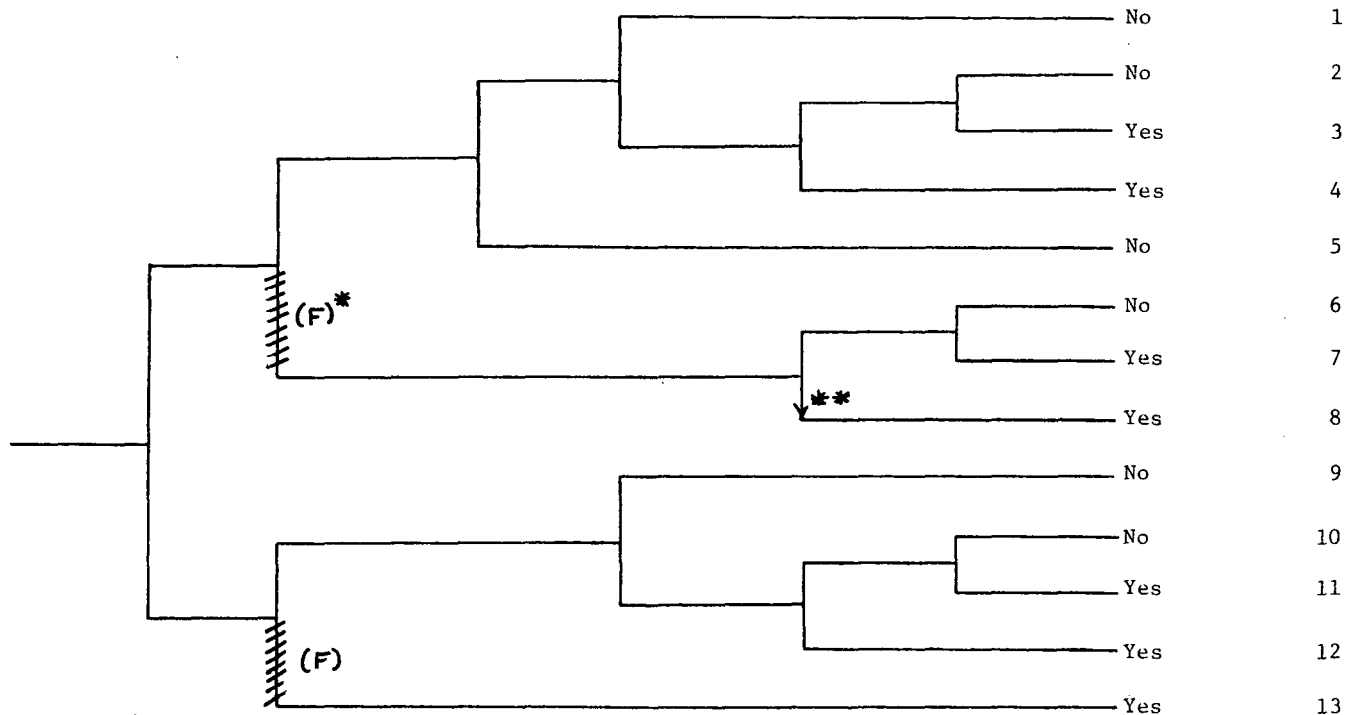
NSIC 81523 - Sequence of Interest for Failure of AFW Pumps to Auto-Start at Turkey Point 4

\*Success requires manual start

\*\*Not included in operating procedures
