PRECURSOR DESCRIPTION AND DATA

NSIC Accession Number: 103207

Title: Diesel Generator Breaker and Bus Stripping Relay Malfunction at Turkey Point 4

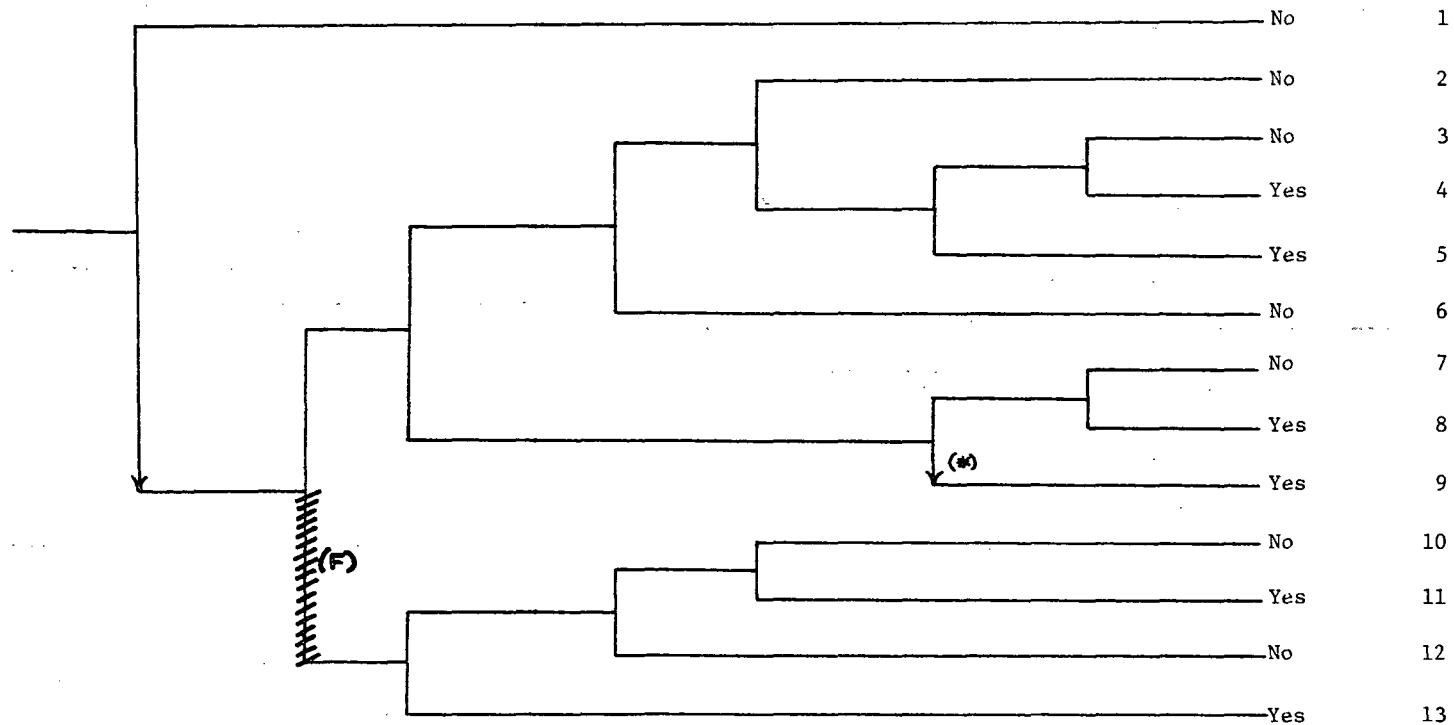
NSIC 103207 — Sequence of Interest for Diesel Generator Breaker and Bus Stripping Relay Malfunction at Turkey Point 4

* use of HPI following AFW failure not included in mitigation procedures.
