PRECURSOR DESCRIPTION AND DATA

NSIC Accession Number: 89252

Title: Three Related Abnormal Occurrences with Diesel Generator at Zion 2

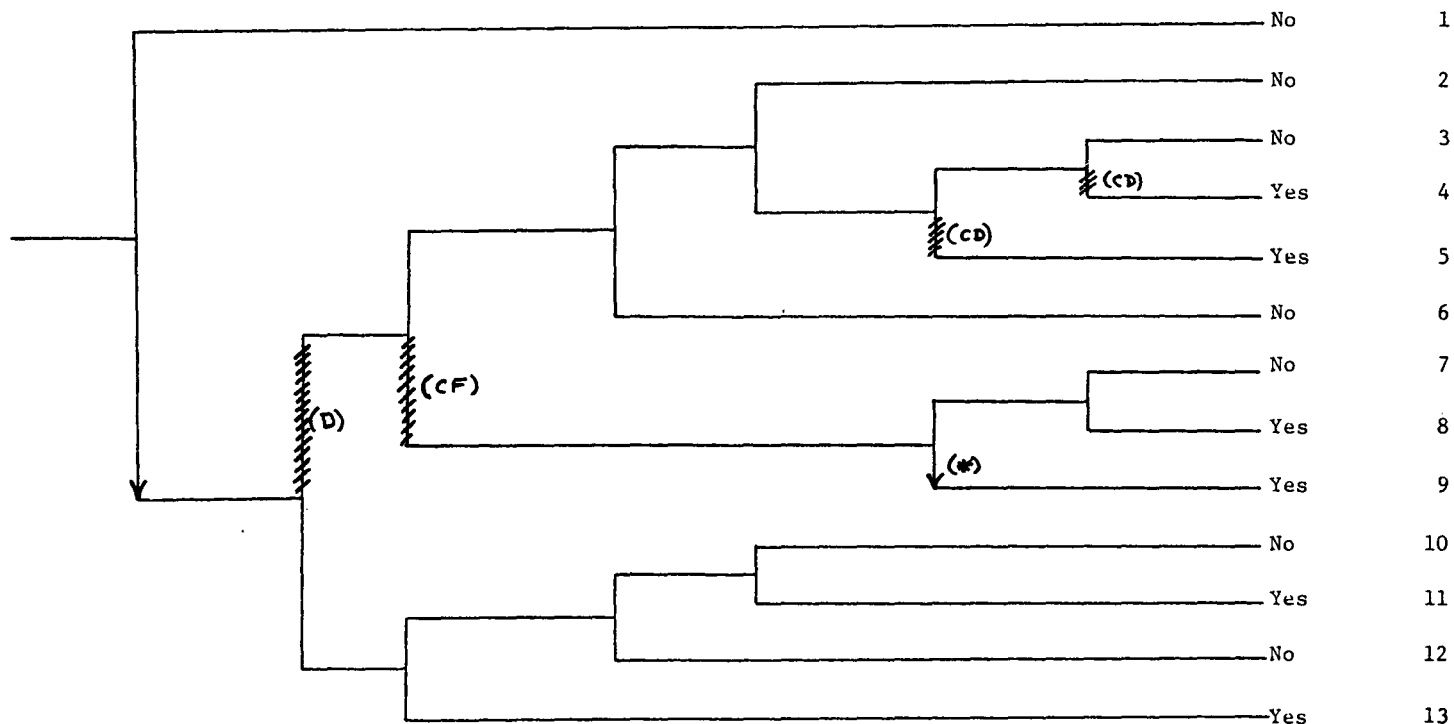
1. Two auxiliary feed pumps were out of service.
2. During testing of the diesel generator associated with the operable auxiliary feed pump, the diesel generator tripped on overspeed while starting.
3. Once the diesel was started, its output breaker would not close on the associated safety-related bus because of a relay failure.

NSIC 89252 -- Sequence of Interest for Failure of Diesel Generator to Start and Load When Two AFW Pumps Were Out of Service at Zion 2

*Use of HPI following AFW failure not included in mitigating procedures.

CAUSE: The diesel generator failed to start due to incorrect synchro-speed setting, an output breaker relay failed to close because of a foreign object lodged in

1. The synchro-speed setter was readjusted to its correct setting, which permitted the diesel to start without tripping out on overspeed.
2. A foreign object (screw and two washers) was removed from the failed relay and the relay was returned to service.
