PRECURSOR DESCRIPTION AND DATA

NSIC Accession Number: 97107

Title: BIT Auto-Injection Failure at Zion 2

REACTOR NAME: Zion 2

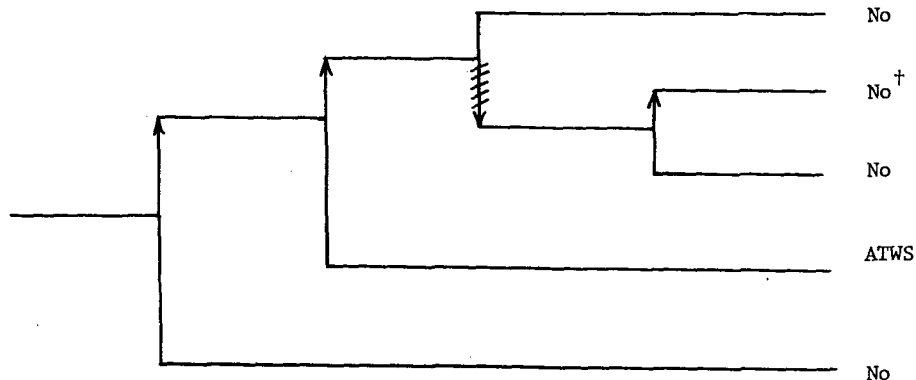
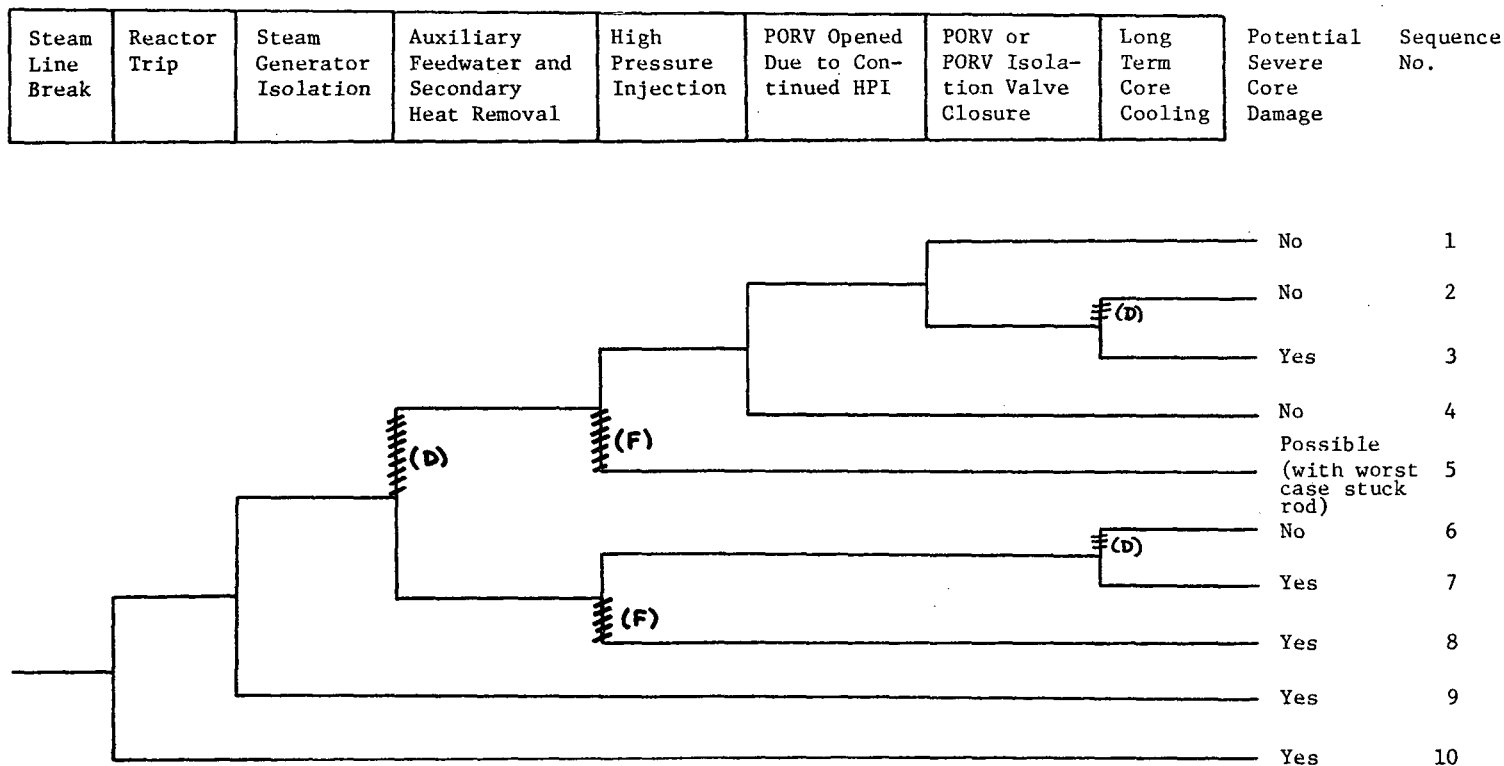
1. An instrument mechanic inadvertently tripped a RCS pump.
2. The resulting flow transient caused a reactor trip and SI signal.
3. Train A safeguards failed due to a loss of power.
4. The train B inlet valve to BIT failed to open.

NSIC 97107 — Actual Occurrence for Boron Injection Tank Inlet Valve Failures at Zion 2 (BIT is primarily for main steam pipe break — FSAR says no core melt for any pump trips. [†]To return to criticality would require the most reactive RCCA to be stuck fully withdrawn and end of core life negative coolant temperature coefficient.)

CAUSE: Power failure to one safeguards train and stuck valve on other train, (human error)

Valve stem was cleaned, packing was changed, and torque limits were increased.
