SUBJECT: INTERNATIONAL ISOTOPES, INC. - NRC INSPECTION
REPORT 030-35486/2020-001

NRC INSPECTION REPORT 030-35486/2020-001 - DATED June 22, 2020

NRC Inspection Report 030-35486/2020-001

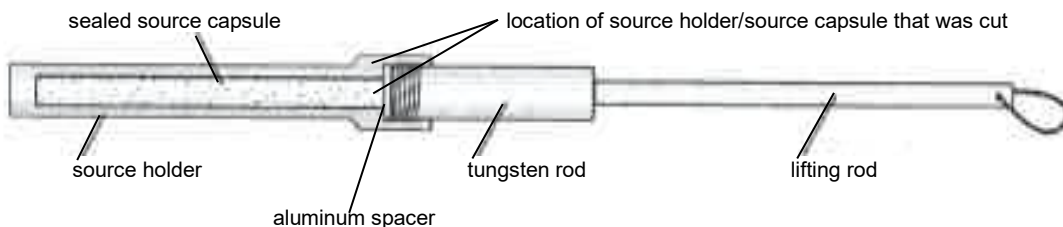
On May 2, 2019, INIS personnel began operations on-site at the University to remove the sealed source capsule from the source holder by using a high-speed cut-off saw, with attached grinding wheel, while the source holder was within the mobile hot cell. The original plan was to grind down the ends of a roll pin (a small rod inserted perpendicular through the source holder and the tungsten rod in the area of their threaded interface) sufficiently to allow the tungsten rod to be unthreaded from the source holder, thereby allowing the source holder to be opened and sealed source capsule removed. International Isotopes, Inc., considered it necessary to remove the sealed source capsule from the source holder because the source holder was too long to fit into the NPI transportation cask which they had previously used for shorter source holders, and the external dose rates were too high to use the 10-160B transportation cask.

International Isotopes, Inc., personnel proceeded to make several circumferential cuts into the source holder in an area that they believed to contain the threaded portion of the tungsten rod/source holder interface (INIS was apparently unsure of the critical dimensions of the source holder/source capsule, and where the active portion of the source capsule was located). Some of the circumferential cuts into the source holder penetrated the source capsule at various lengths and depths, which resulted in the release of cesium-137. Since this work was performed within the mobile hot cell, it would be assumed that a radioactive release would have been contained; however, this mobile hot cell was not designed to contain unsealed radioactive material, so the contamination subsequently spread outside of the mobile hot cell and into the room in which the work was ongoing, contaminated the workers within the room, and eventually spread throughout the University's Harborview Medical Center.
