ATTACHMENT 1
Description and Assessment

Subject: Application for Revision to TS 5.5.9, "Steam Generator (SG) Program," for a One-Time Deferral of Steam Generator Tube Inspections

In accordance with 10 CFR 50.90, "Application for amendment of license, construction permit, or early site permit," Exelon Generation Company, LLC (EGC) requests amendments to the Technical Specifications (TS) for Renewed Facility License Nos. NPF-37 and NPF-66 for Byron Station, Units 1 and 2 (Byron).

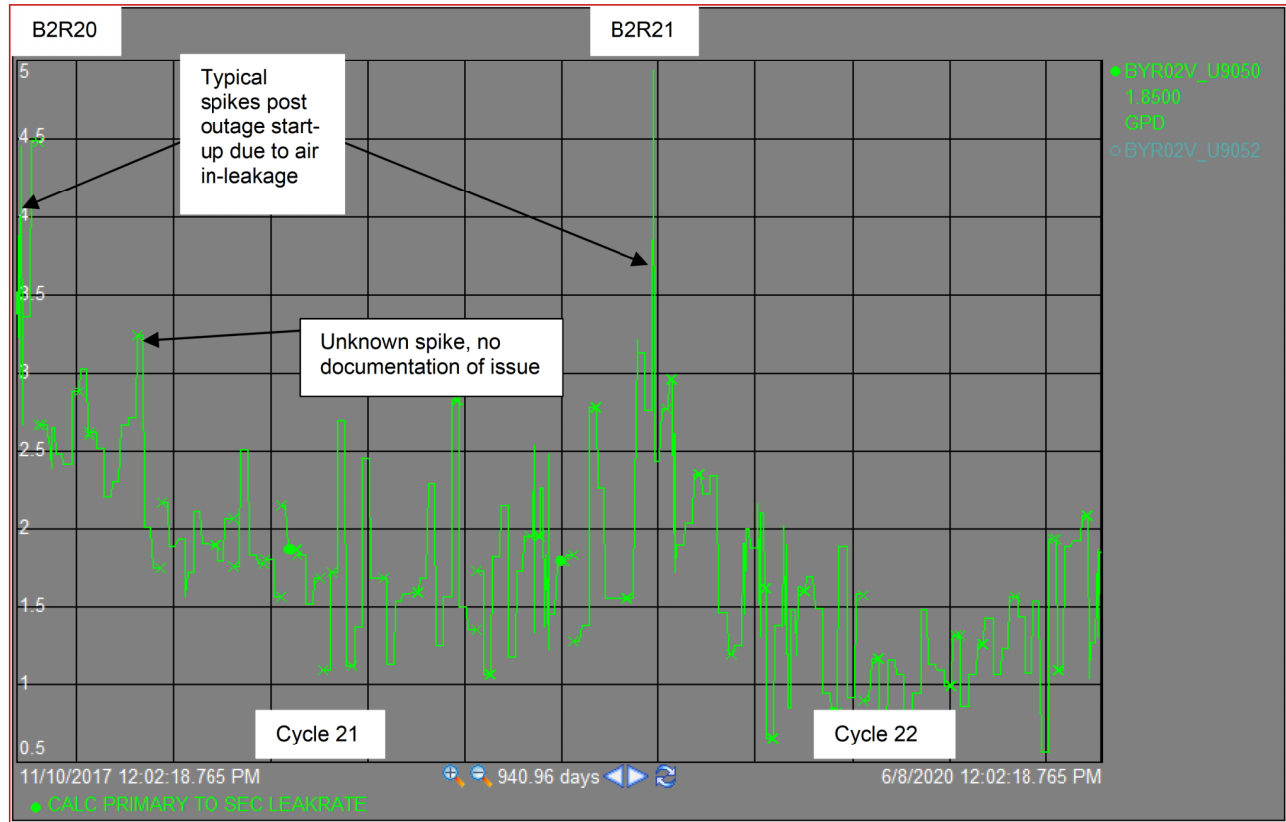
Figure 1: Primary to Secondary Leak Rate for Operating Cycles 21 and 22

No primary to secondary side leakage has been noted for operating Cycles 21 and 22. As seen in Figure 1, all trends are below 3 gallons per day (gpd), except for a spike occurring around February 23, 2018, possible due to computer point error since no issue was documented. Other typical spikes which occurred post refueling outages were due to air in-leakage issues and not related to primary to secondary leakage. The primary to secondary leak rate determination utilizes the Condenser Offgas method, which uses steam jet air ejector (SJAЕ) flow. During unit start-ups, these flows are normally higher due to systems being returned to service. The high SJAЕ flow causes a higher apparent primary to secondary leak rate during start-up and post outage which are not related to actual primary to secondary leakage.
