# Loss of an Iridium-192 Source and Therapy Misadministration at Indiana Regional Cancer Center Indiana, Pennsylvania, on November 16, 1992

**U.S. Nuclear Regulatory Commission**

Manuscript Completed: February 1993  
Date Published: February 1993

On December 1, 1992, the Indiana Regional Cancer Center reported to the U.S. Nuclear Regulatory Commission's (NRC) Region I that they believed a  $1.37 \text{ E}+11$  becquerel (3.7-curie) iridium-192 source from their Omnitron 2000 high dose rate remote brachytherapy afterloader had been found at a biohazard waste transfer station in Carnegie, Pennsylvania. After notifying the NRC, this cancer center, one of several operated by the licensee, Oncology Services Corporation, retrieved the source, and Region I dispatched an inspector and a supervisor to investigate the event. The source was first detected when it triggered radiation alarms at a waste incinerator facility in Warren, Ohio. The licensee informed the NRC that the source wire had apparently broken during treatment of a patient on November 16, 1992, leaving the source in the patient. On the basis of the seriousness of the incident, the NRC elevated its response to an Incident In

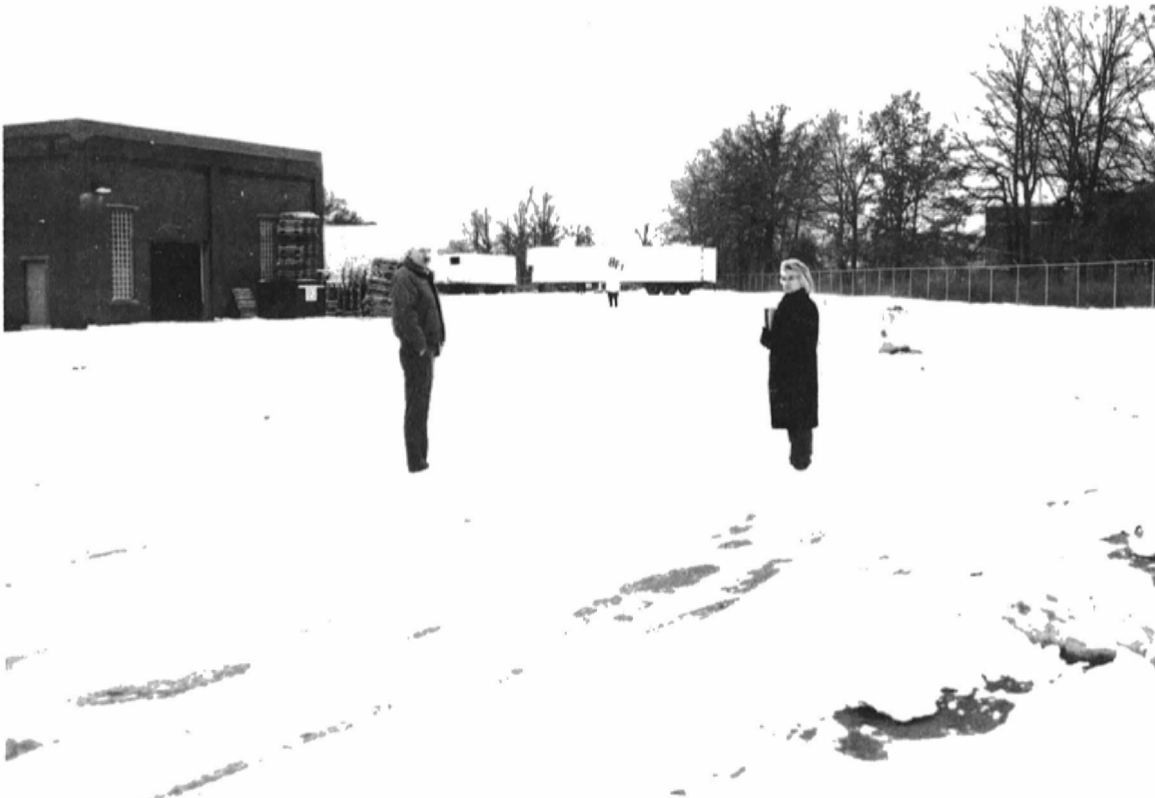
After identifying the possible cause of the radiation alarms, both the Plant Manager and the Supervisor began to look for the source with their portable survey meters (Figure 2.16) outside of the parked trailers (Figure 2.17). When they came within approximately 121.9 meters (400 feet) of the trailer, both portable survey meters immediately alarmed and registered at their highest levels over 5  $\mu\text{Sv}$  (500  $\mu\text{rem}$ ) per hour.

Figure 2.17 Location of Where Manager and Supervisor Detected Radiation (~ 400')  
from BFI Trailer 808

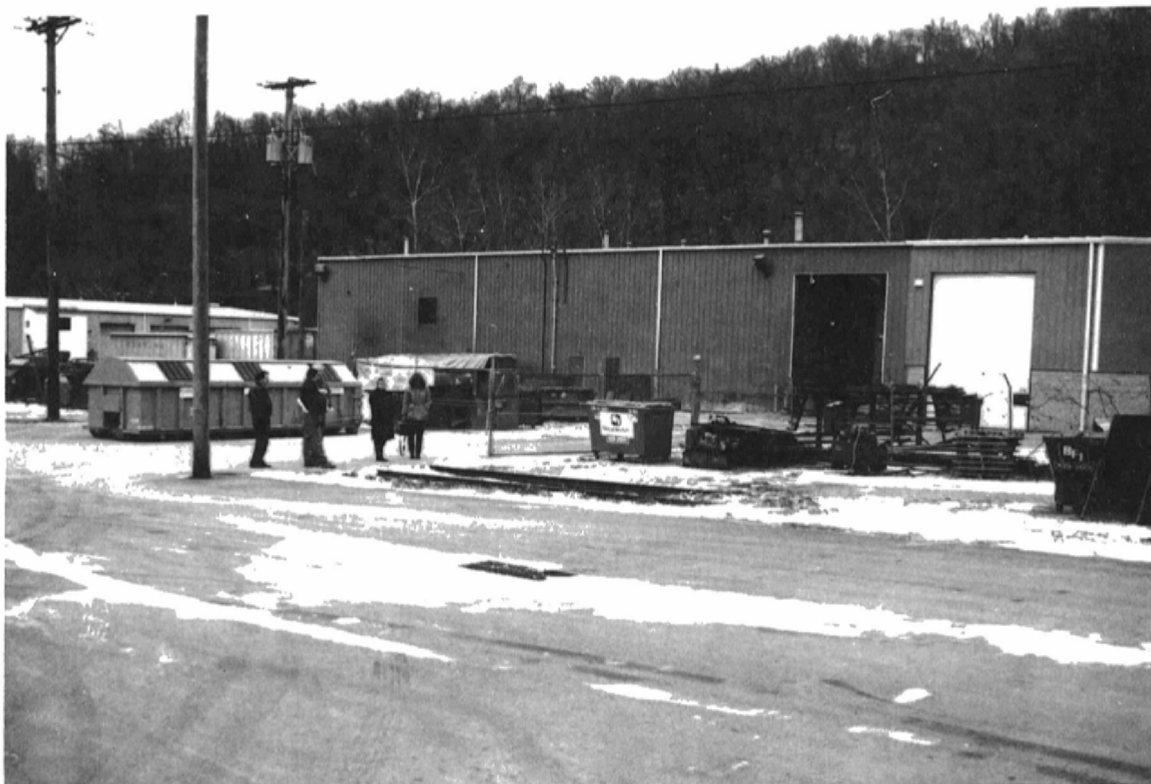
Upon approaching the green recycle container (Figure 2.22), Safety Technician A unlocked it and stood approximately 2 meters (6.6 feet) away with a portable survey meter turned on. Medical Physicist A also had a portable survey meter and noted that the radiation reading at about 1.5 to 1.8 meters (5 to 6 feet) away from the container was above 7.8 mSv (780 mrem) per hour.

Figure 2.22 Location of Radioactive Source Recycle Container at BFI – Carnegie

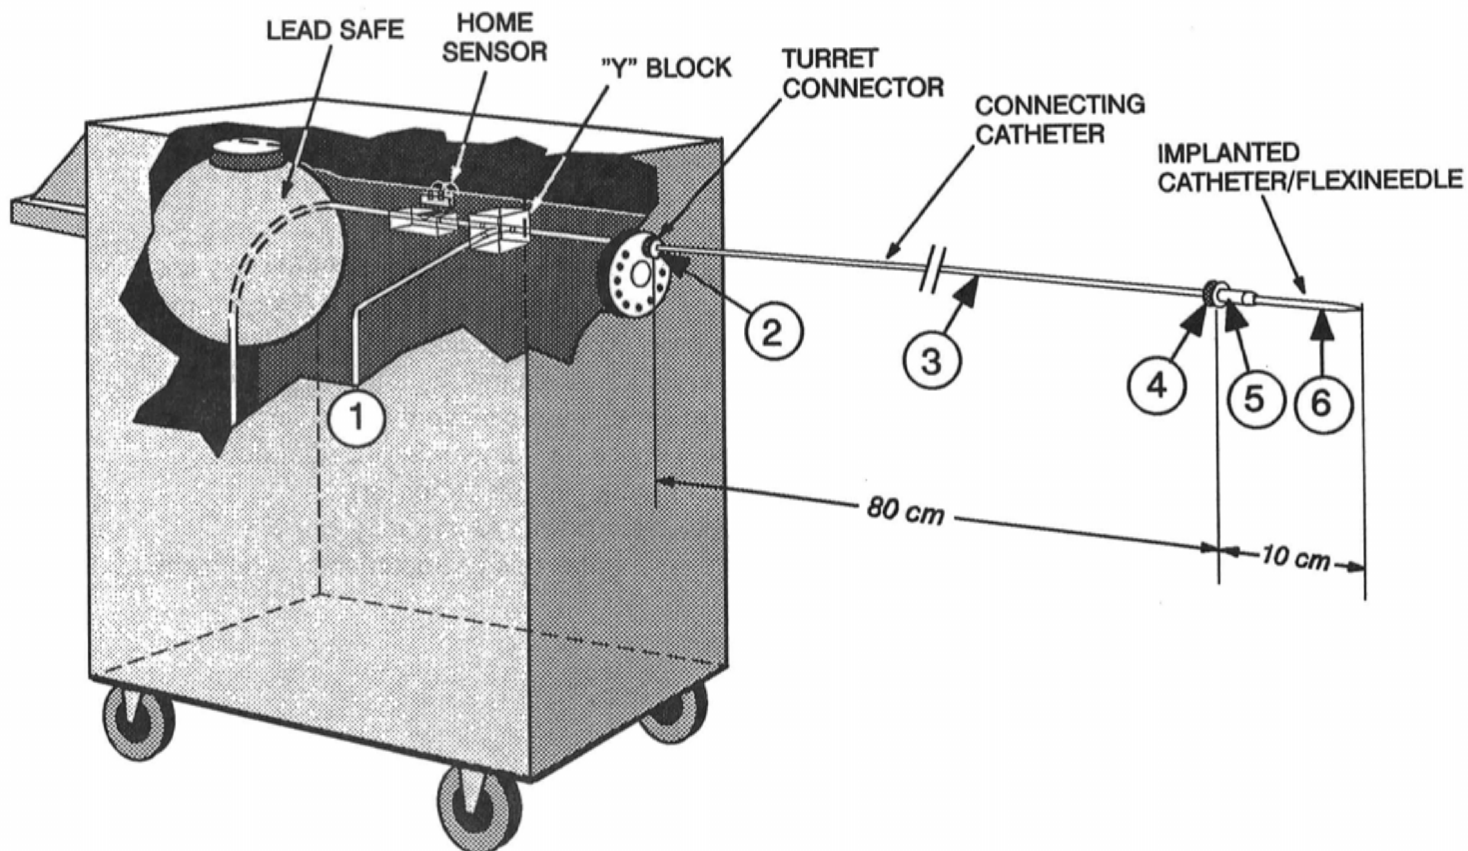
Figure 4.1 Source Wire – Possible Failure Areas

| ① Inside HDR Afterloader | ④ Connecting catheter connector |
| ③ Connecting catheter (teflon tube) | ⑥ Flexineedle catheter |

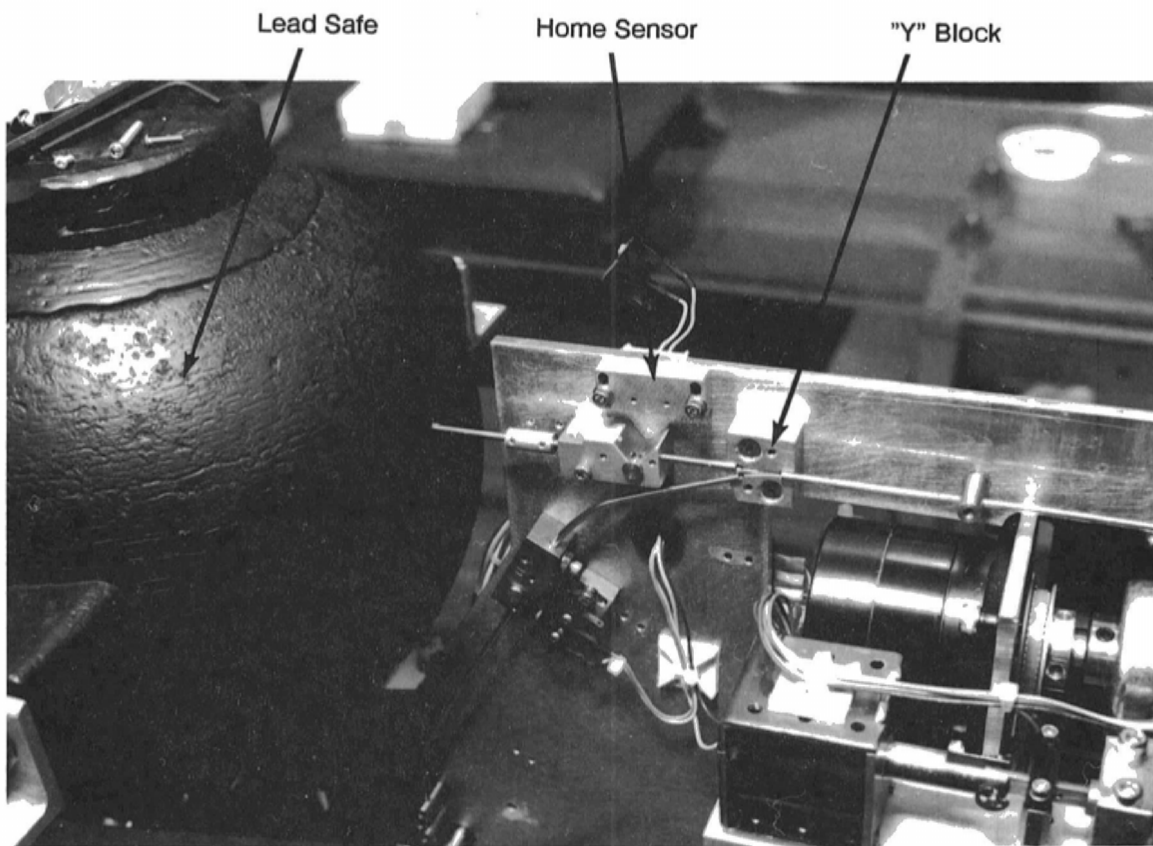
Figure 4.2 Track Where Source Tip May Have Contacted Parts of the Afterloader

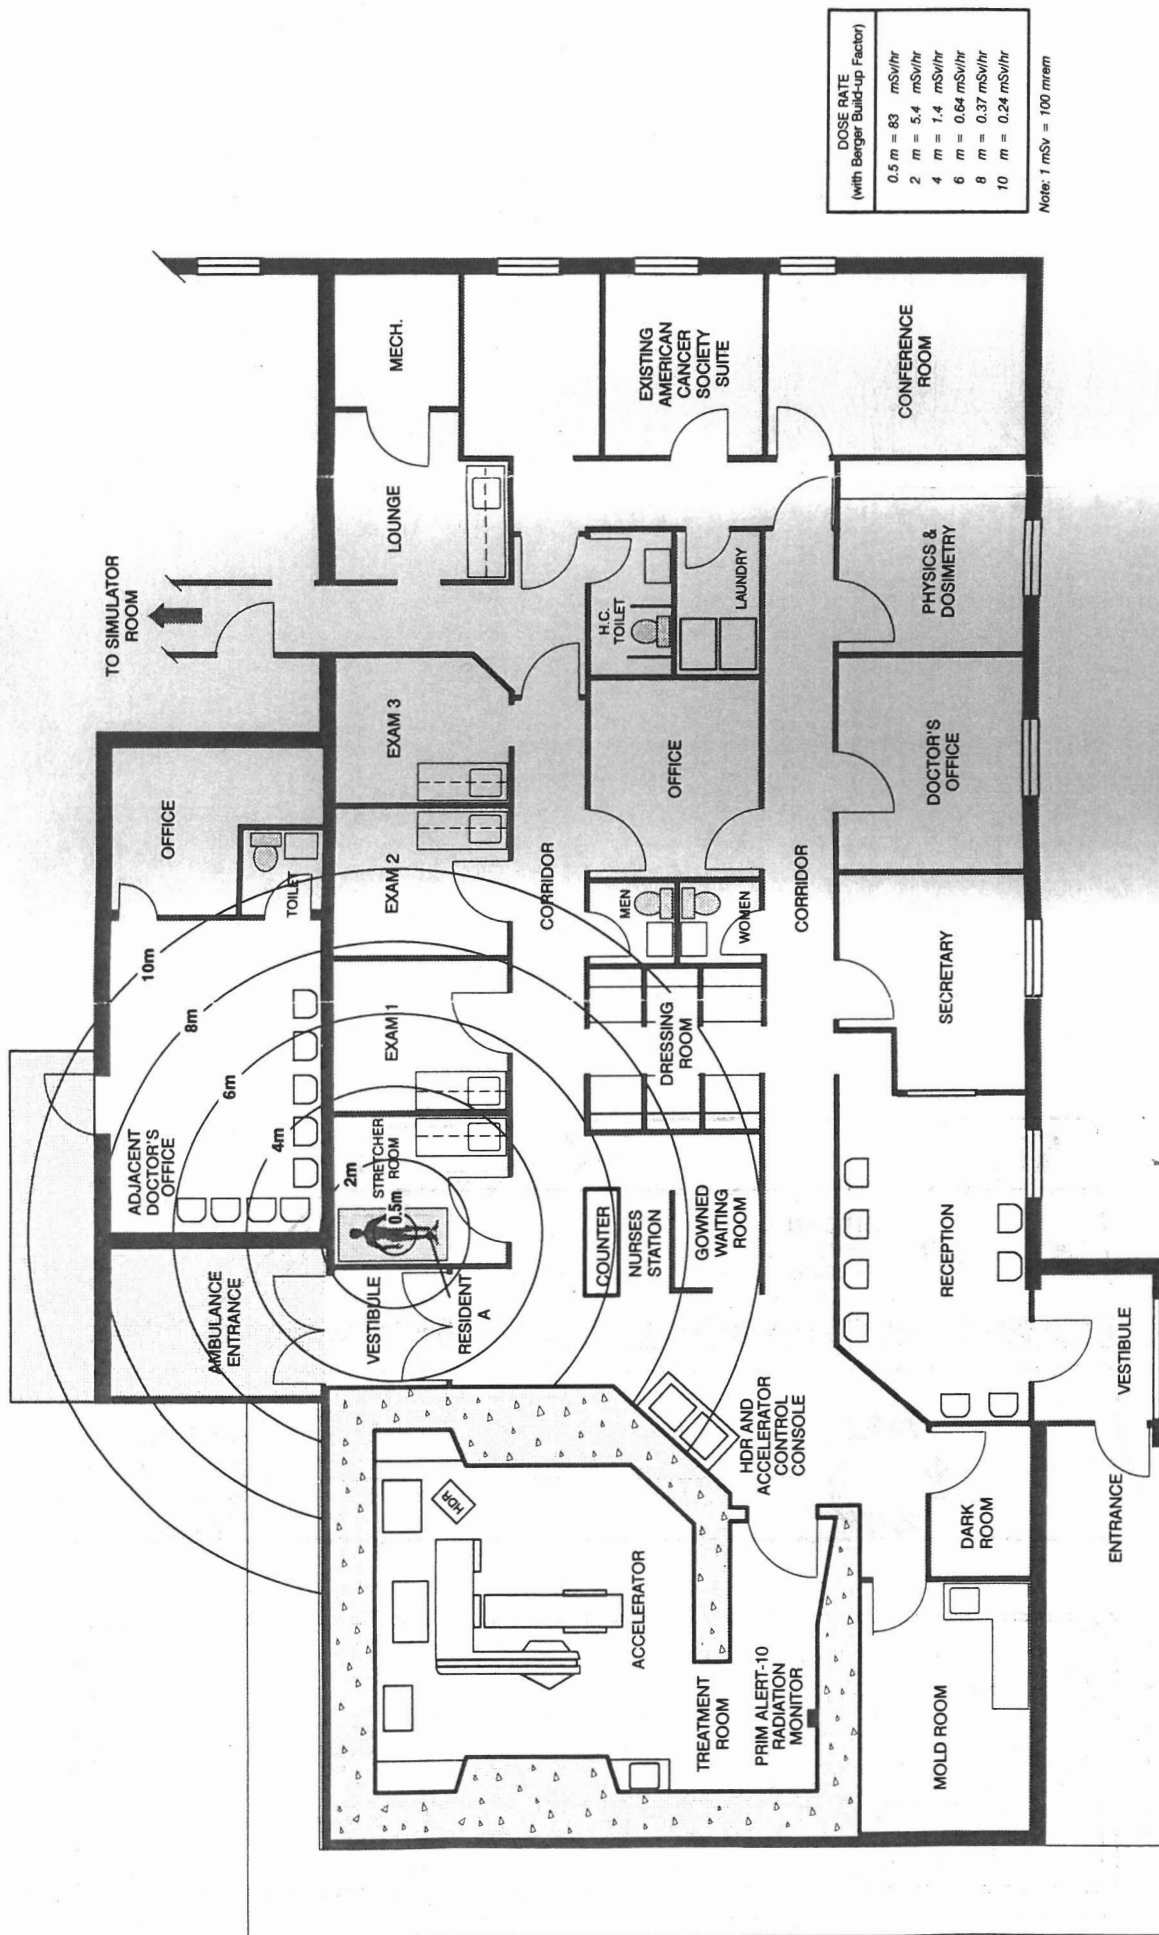
Figure 6.1 Diagram of the Indiana Regional Cancer Center Showing Isodose Curves from the Iridium-192 Source on November 16, 1992.

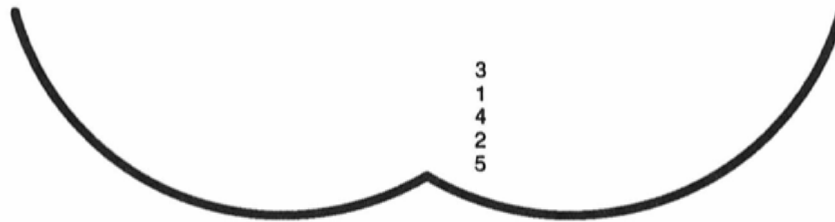
Numbers represent placement of implanted catheters within the patient and correspond to the treatment channel number indicated on the turret head.

Figure 7.1 Treatment Plan Catheter Location

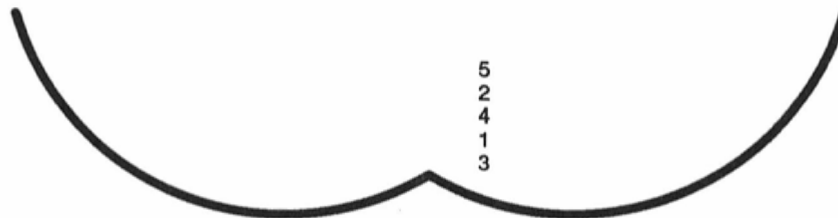
Numbers represent placement of implanted catheters within the patient and correspond to the treatment channel number indicated on the turret head.

Figure 7.2 Actual Catheter Location
