Watts Bar Nuclear Plant (WBN)  
Pre-submittal Meeting for Inservice Testing (IST) Program  
Request for Relief from Increased Frequency Testing of  
Residual Heat Removal (RHR) Pump 1B-B

July 28, 2020

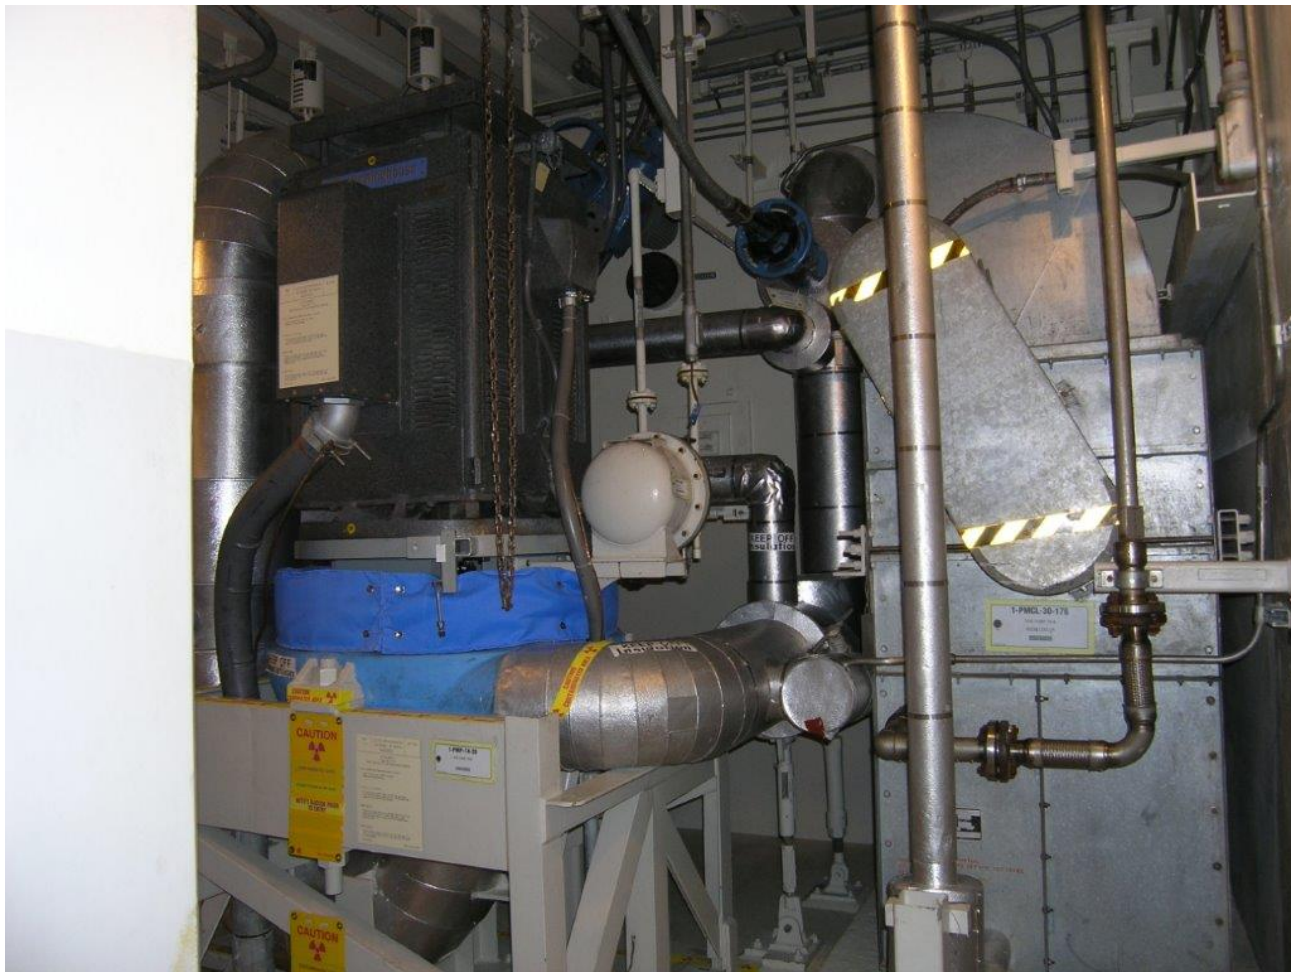
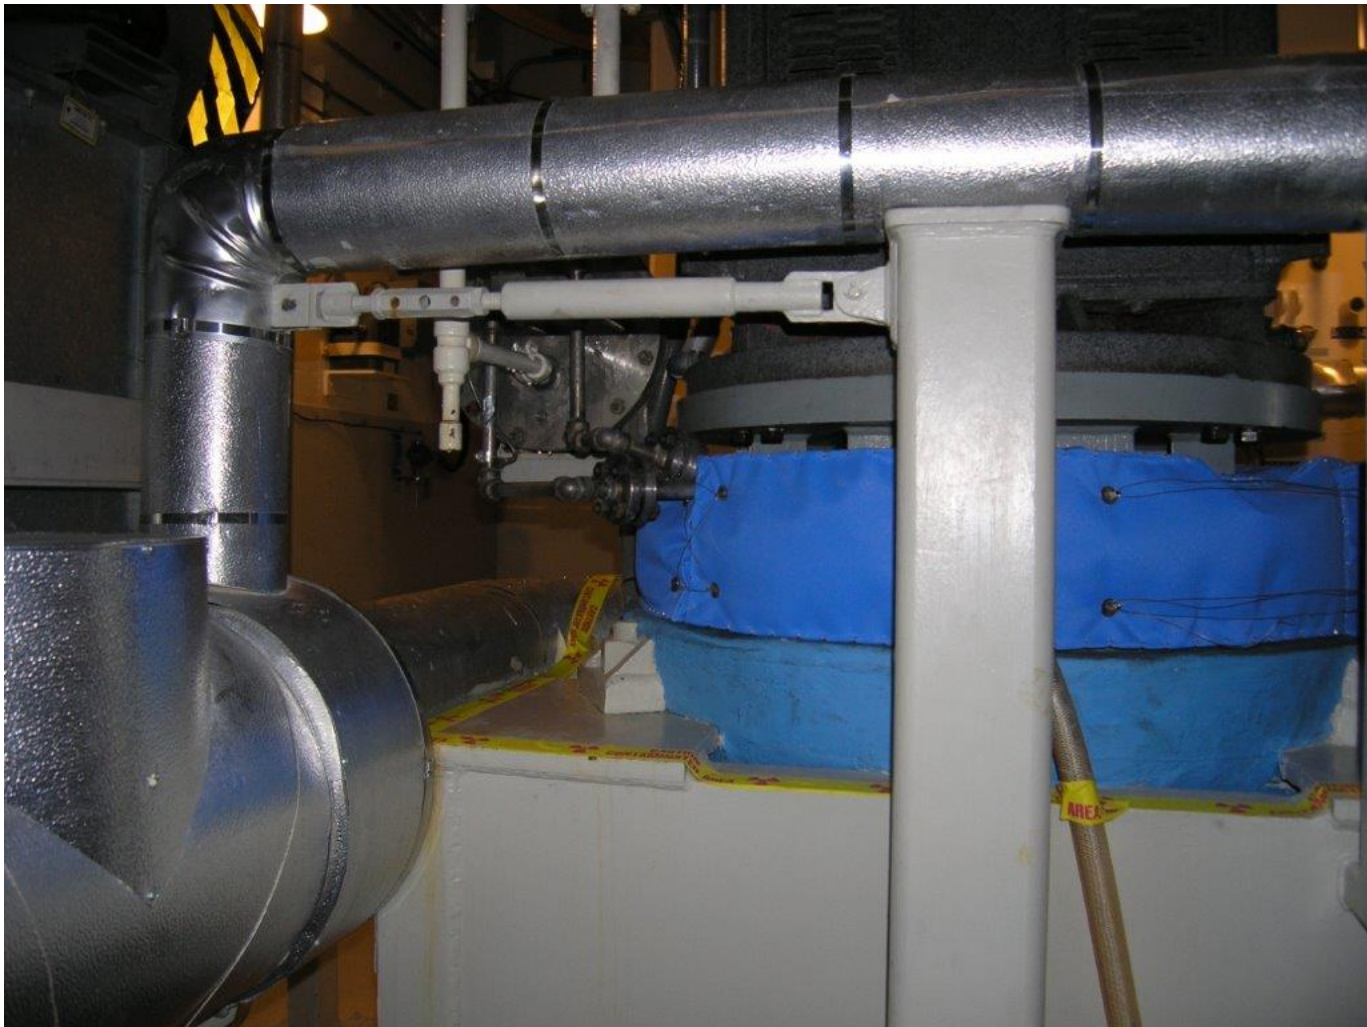
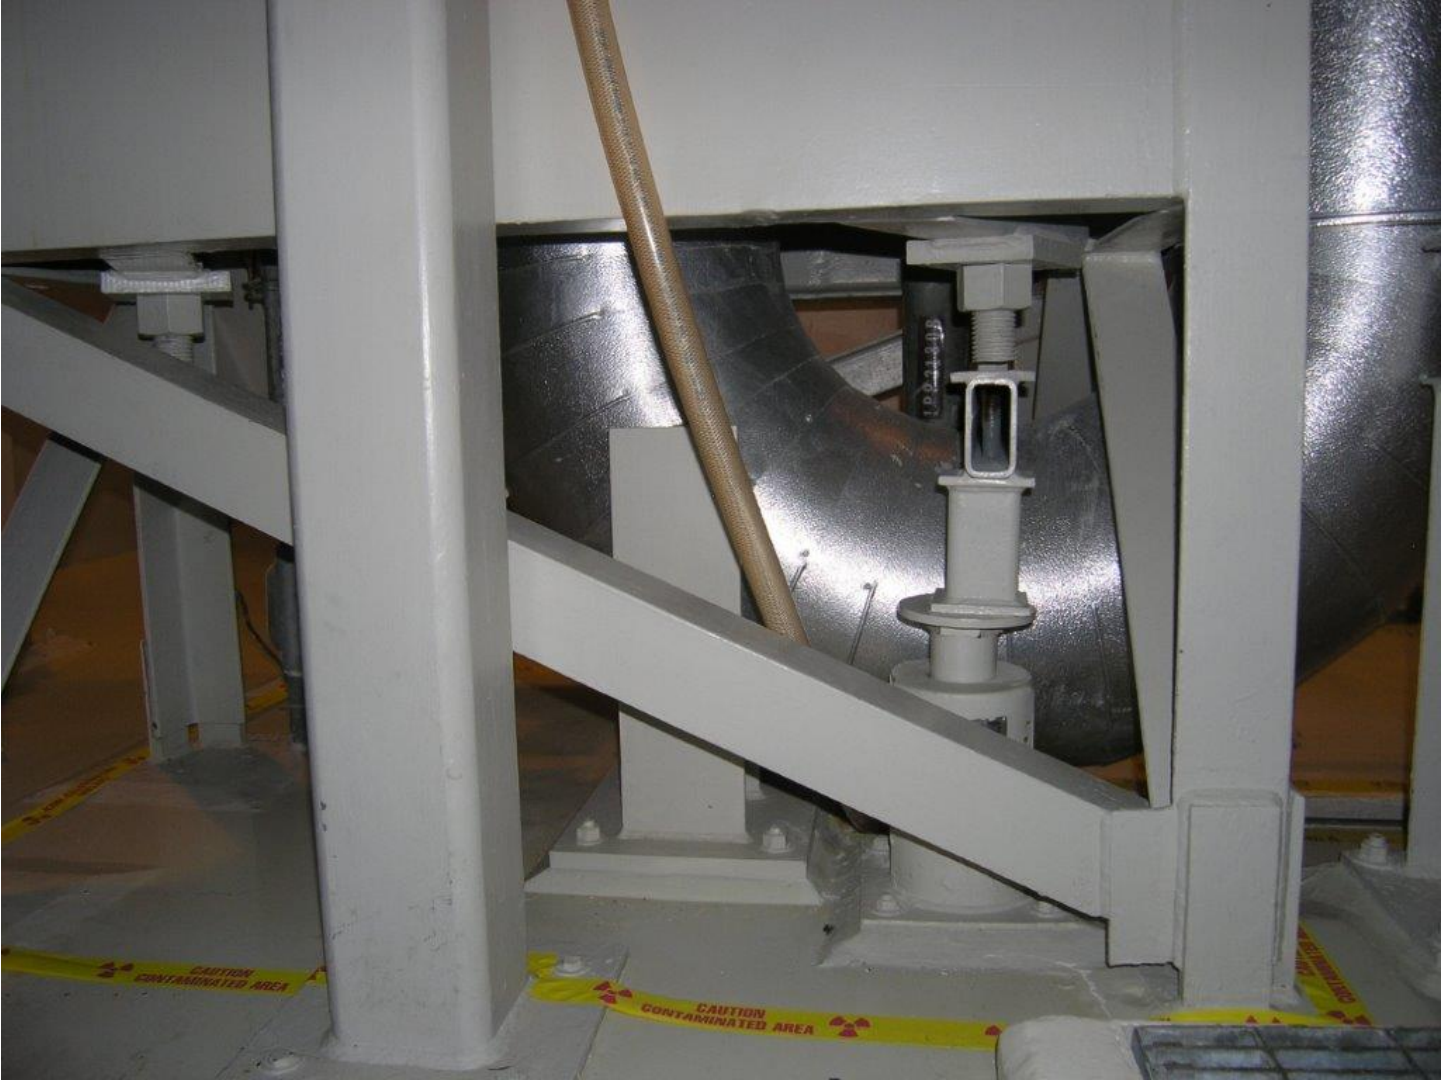
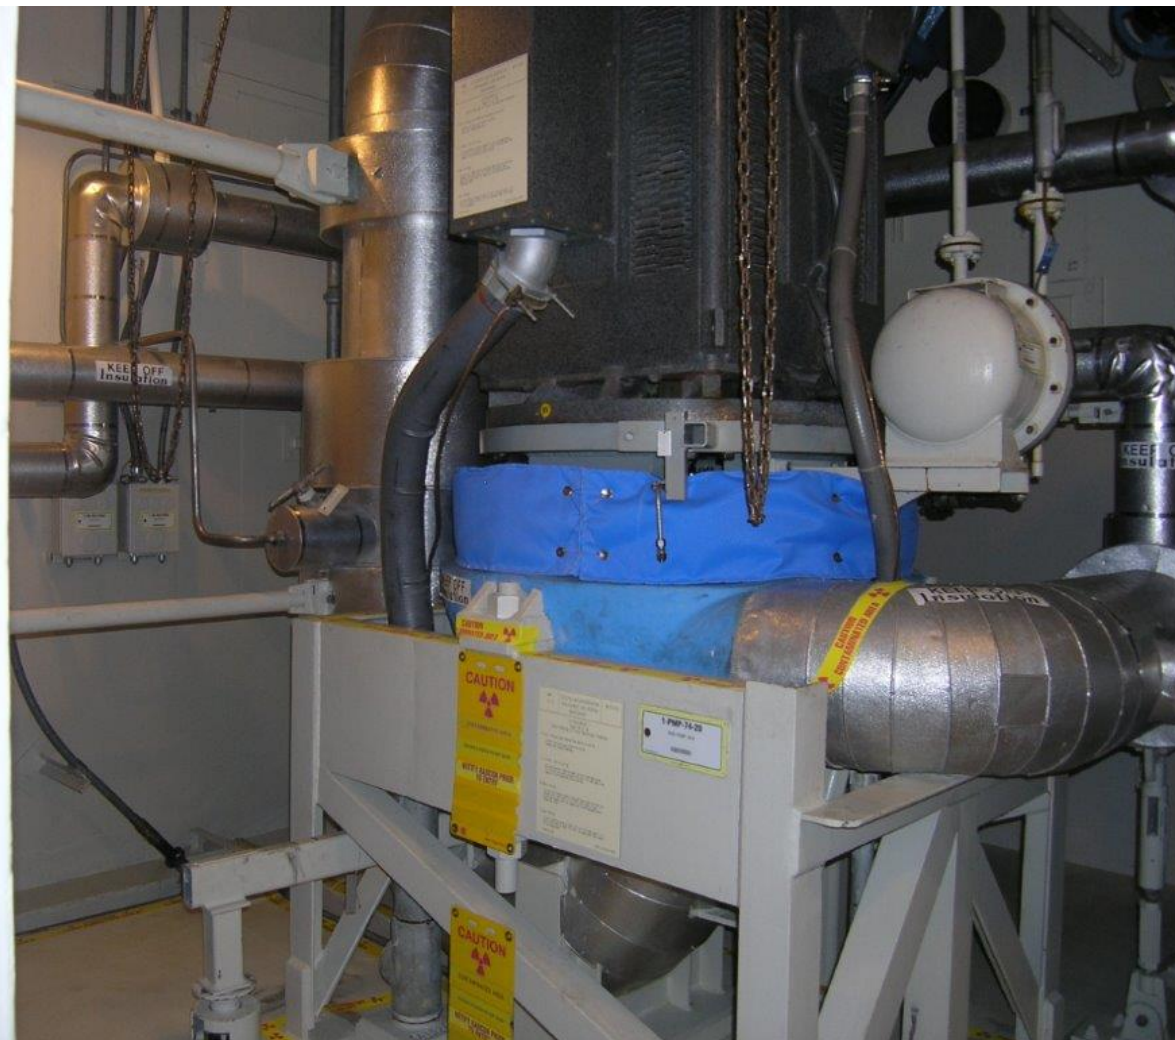
- RHR Pump 1B-B is a vertically mounted centrifugal pump with the pump impeller attached to the motor shaft.
- There are no bearings in the pump bowl area (only in the motor).
- The pump motor does not have its own support foundation or structure. The pump bowl is attached to a support table structure in three locations as shown in the following photos.

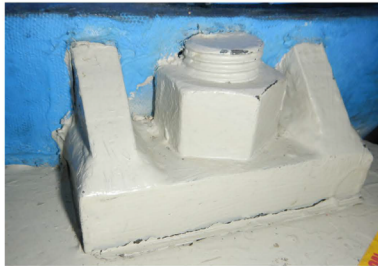
**SOUTH EAST FOOT**

Cross Channel Phase Between Foot and Base : -8 deg(SAT)  
Foot(Vertical) : 0.044 in/sec  
Base(Vertical): 0.044 in/sec

- The East Foot appeared to have no movement between the foot and Structural Base. The vibration difference between the two points is negligible.
- The South East Foot appeared to have no movement between the foot and Structural Base. The vibration difference between the two points is negligible.
- The North East Foot appeared to have some movement between the foot and Structural Base due to the phases being 158 degrees different. The vibration difference between the two points, in comparison, is much different than the East and South East feet. This foot appears to be less secure than the other two feet.

- Another Group A test was performed on June 24, 2020, and the following actions were taken:
  - While the pump was running at the Group A test flow rate.
  - Vibration levels were monitored, and
  - Bolting of the support structure was re-torqued in the area that had shown evidence looseness / slippage.
- There was no appreciable change in vibration level after re-torquing of the support structure.
- Three of the five monitored bearing locations/directions (A-H, A-A, and B-H) exhibited an increase from the June 8, 2020, Group A test.
