## **MRP** Materials Reliability Program \_\_\_\_\_ MRP 2020-015

SUBJECT: 2020 Biennial Report of Recent MRP-227-A Reactor Internals Inspection Results

MRP-227 Related Inspections Performed in USA through mid-2020

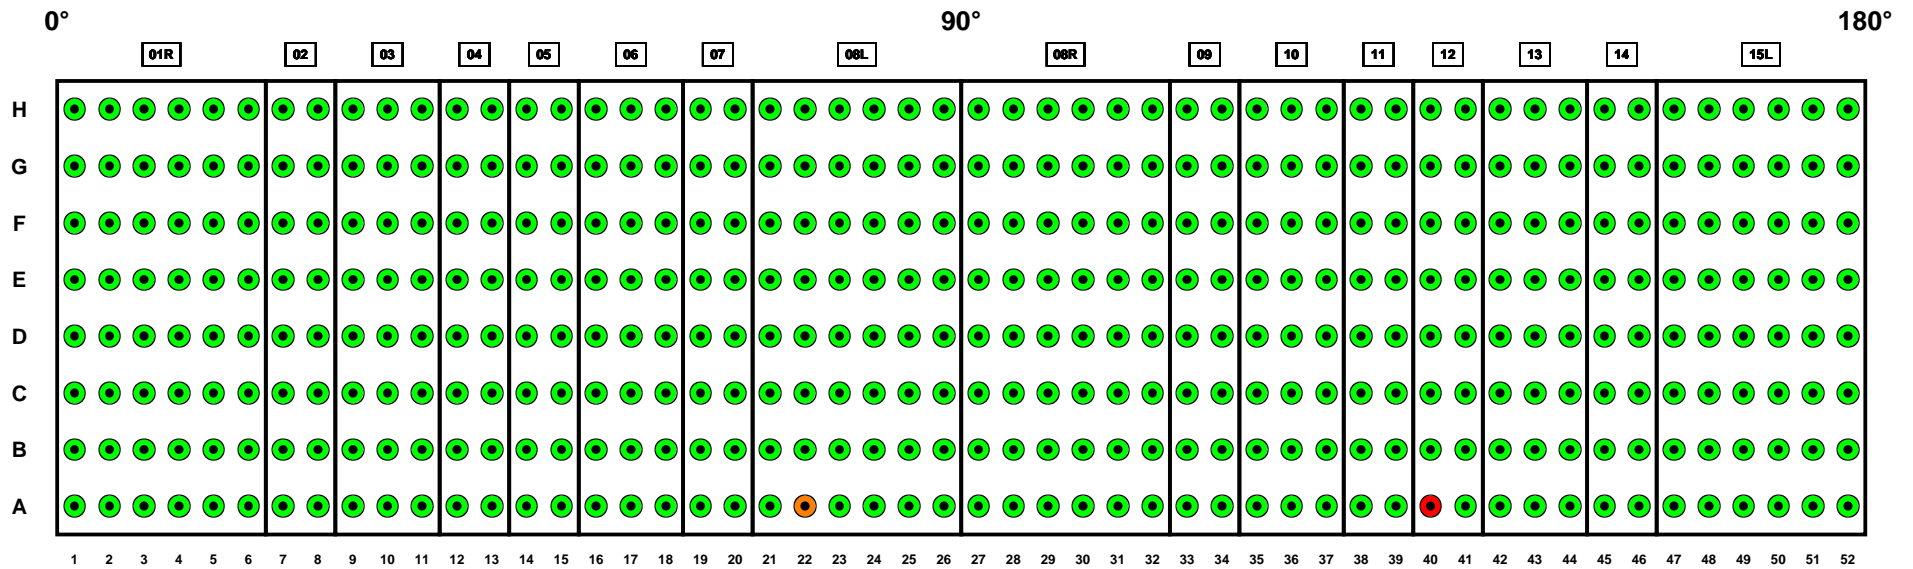
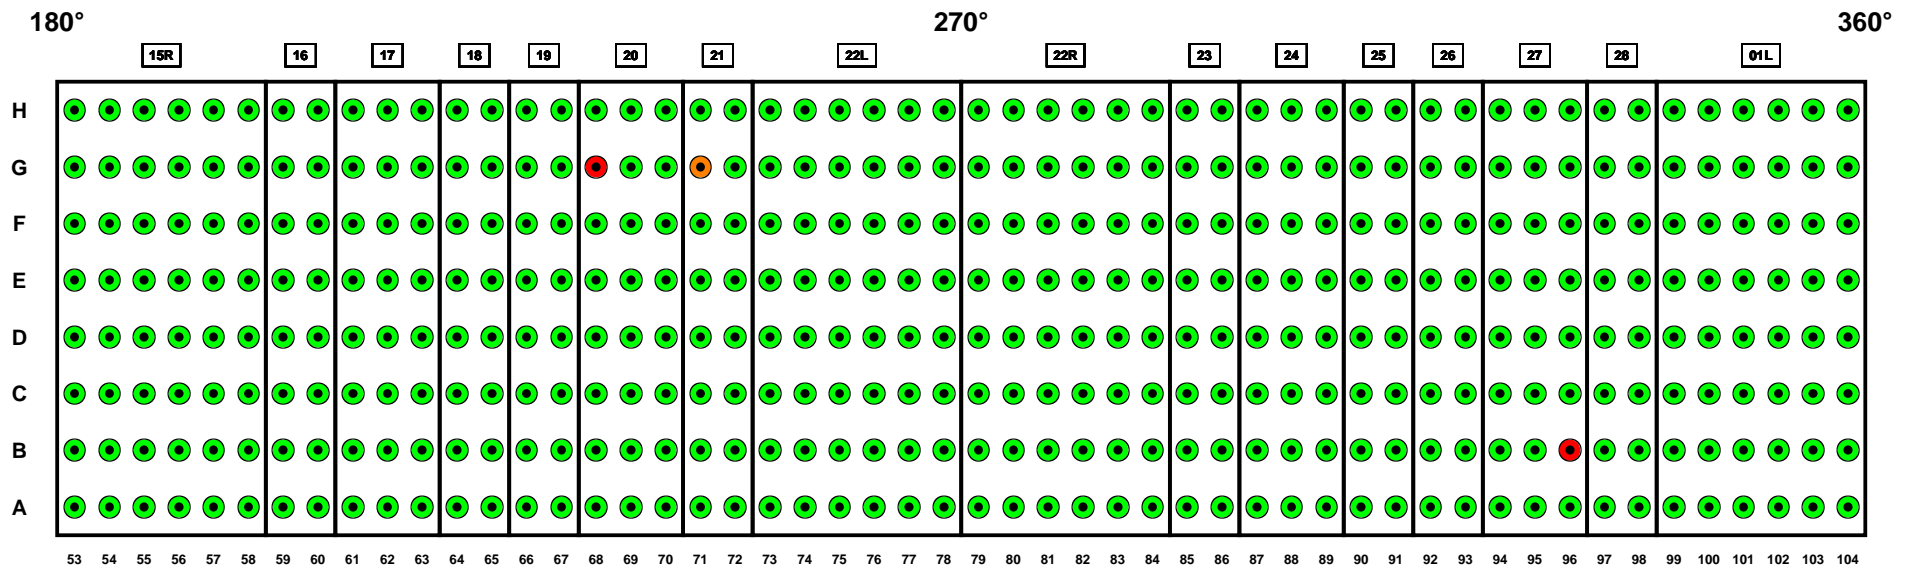
Next Inspection: (~2028)				
<b>Comments:</b>  UT Inspection performed due to OE at NSAL 16-1 Tier 1 units and interim guidance in MRP 2016-014. Acceptable per WCAP-17096-NP-A. SQN2 is a Tier 1b PWR unit per NSAL 16-1.  <i>(Please reference or include the inspection report, if possible)</i>
