NP-33-98-006

LER 1998-006  
Davis-Besse Nuclear Power Station, Unit No. 1  
Date of Occurrence - June 24, 1998

Tornado Damage to Switchyard Causing Loss of Offsite Power

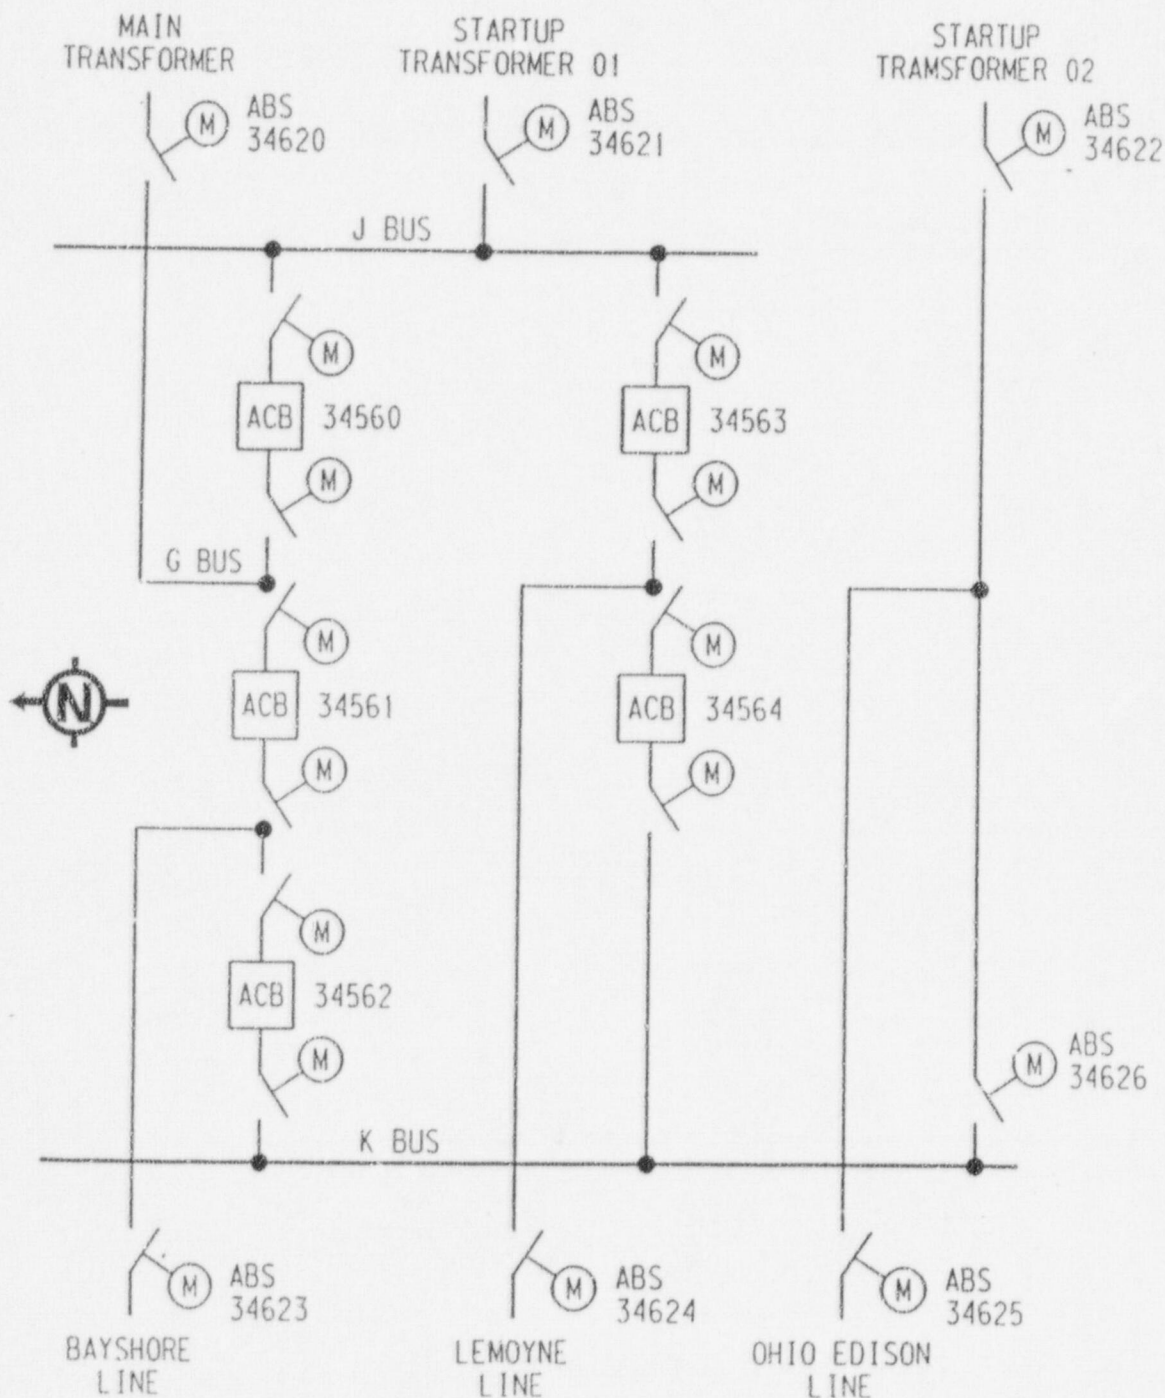
ATTACHMENT 2  
345 KV SWITCHYARD ONE LINE

At 2230 hours, the initial switchyard [FK] damage report indicated that there was substantial damage, which included the following (Reference Attachment 2): ABS 34620 had one broken connector [EA-CON], ABS 34621 had two broken connectors, ABS 34622 had one broken connector and ABS 34623, 34624 and 34625 were also damaged. This damage resulted in the loss of all three offsite power sources: Bayshore, Lemoyne and Ohio Edison lines. At 2238 hours, the plant entered Technical Specification (TS) 3.8.1.1 Action d, to restore at least one of the inoperable offsite sources within 24 hours. At this time, the unit was in HOT STANDBY and both EDGs were supplying their essential loads.

The switchyard equipment and transformers were inspected for extent of visible damage, and protective relaying target indications were reviewed for possible indication of further damage. No damage was indicated and the transformers were electrically tested satisfactorily. The damaged Motor Operated Disconnects (MODs) [MOD] were disassembled, reworked and reassembled.
