Subject: **COLUMBIA GENERATING STATION, DOCKET NO. 50-397
RESPONSE TO REQUEST FOR ADDITIONAL INFORMATION
RELATED TO EXIGENT LICENSE AMENDMENT REQUEST FOR
CHANGE TO TECHNICAL SPECIFICATION 3.8.7 DISTRIBUTION
SYSTEMS – OPERATING**

RESPONSE TO REQUEST FOR ADDITIONAL INFORMATION

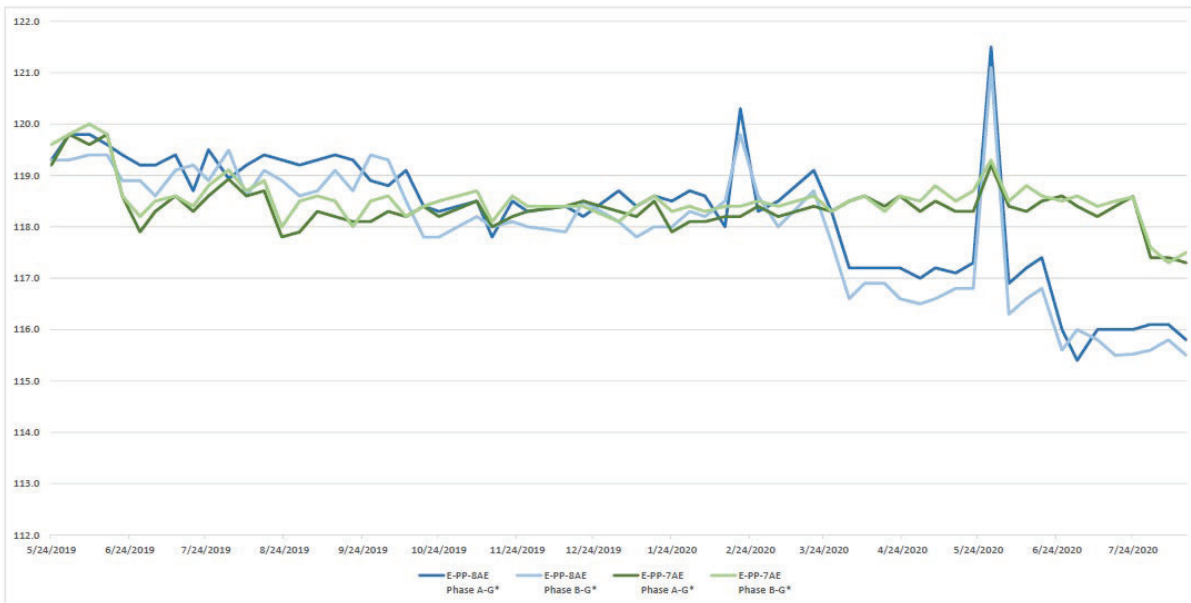
TS Bases 3.8.7 AC Distribution Systems Operating notes that OPERABLE AC electrical power distribution subsystems require the associated buses to be energized to their proper voltages. The figure below plots data obtained from weekly voltage surveillances under TS Surveillance Requirement 3.8.7.1 on E-PP-8AE and the Division 1 redundant power panel E-PP-7AE for the current operating cycle. While E-PP-8AE has shown gradual declining performance, the redundant subsystem E-PP-7AE has remained well above its administrative limit of 115 voltage alternating current (VAC). E-PP-7AE has experienced a recent step change in July 2020 however, the power panel output is stable above 117 VAC which is considered to be acceptable margin to the administrative limit of 115 VAC at this time.

E-PP-8AE is supplied by E-PP-8A via E-TR-8A/1. Other branch circuits sharing common power source E-PP-8A are operating at nominal voltages within expected voltage output of 120 VAC \pm 3% further indicating satisfactory health of the source available at E-PP-8A and eliminating a common cause concern that could impact additional Division 2 electrical distribution subsystems.
