**Supplement to Request for Relief Related to American Society of Mechanical Engineers (ASME)
Code Case N-729-6 Supplemental Examination Requirements, ISIR-5-04**

Enclosure to AEP-NRC-2020-71

Final Photographs of the CNP Unit 1 Reactor Vessel Closure Head (RVCH)

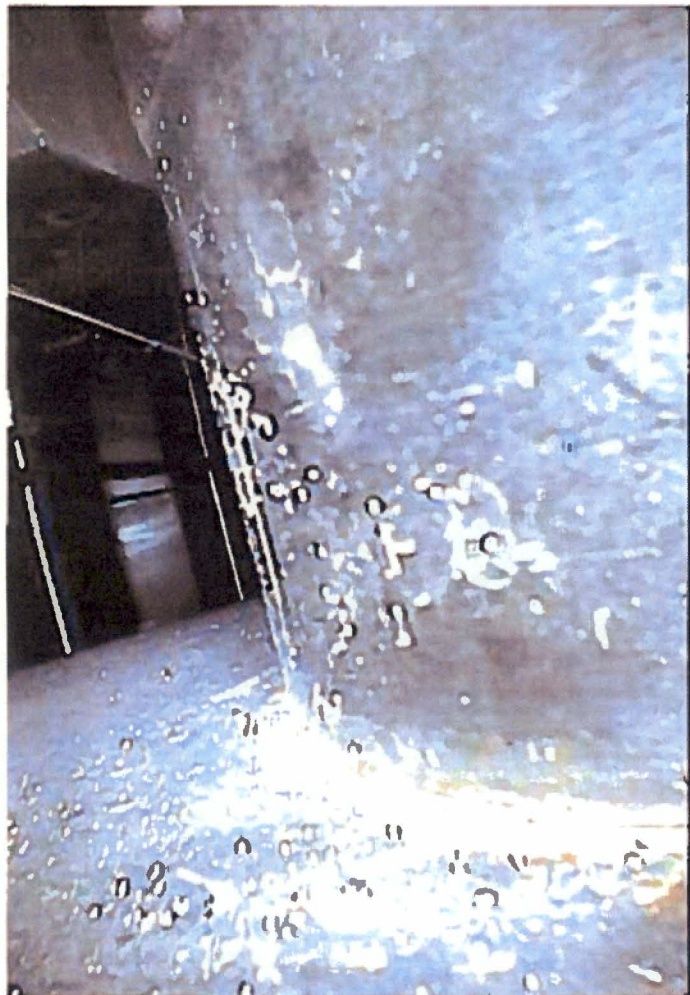
U1C30 RVCH Inspection Photos Penetration Number 1

As Found Photo

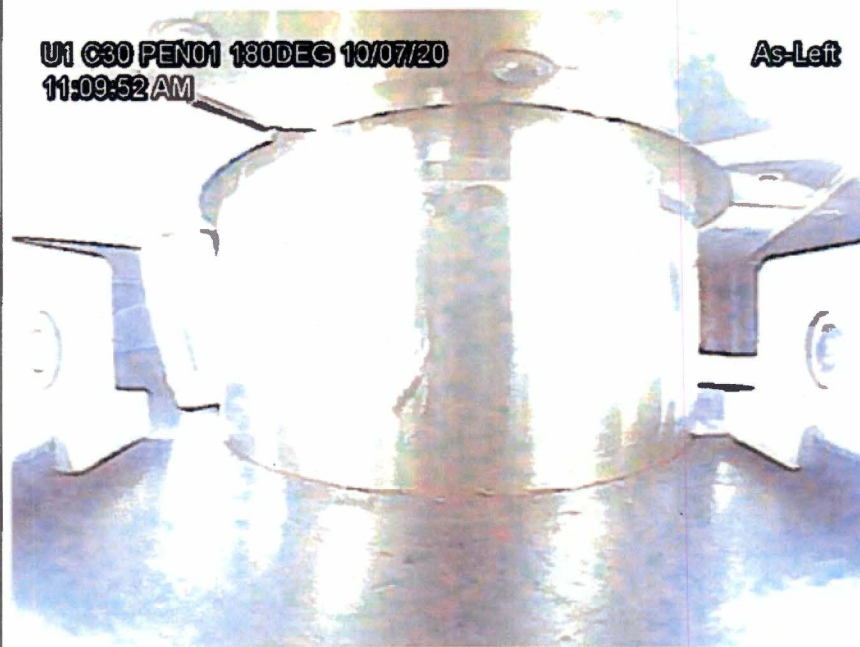
As Left Photo

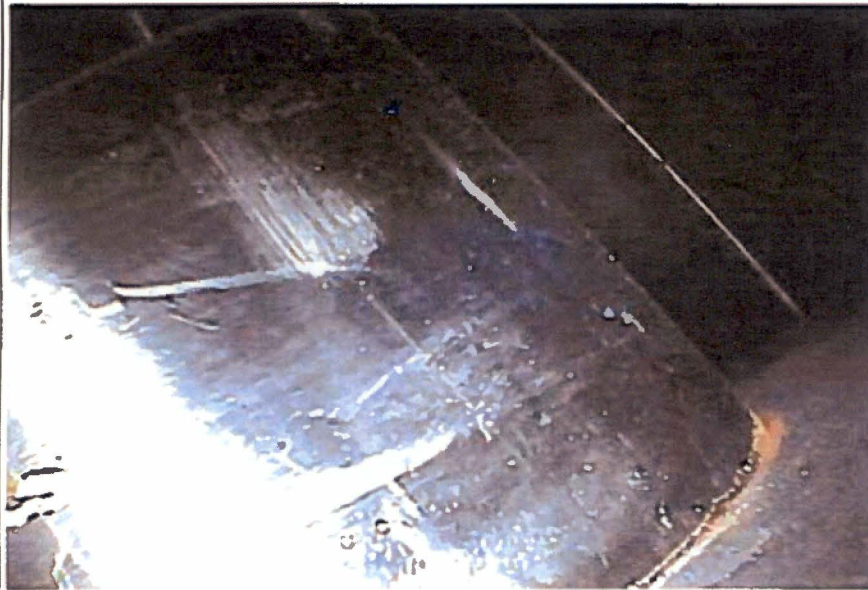
U1C30 RVCH Inspection Photos Penetration Number 7

As Found Photo

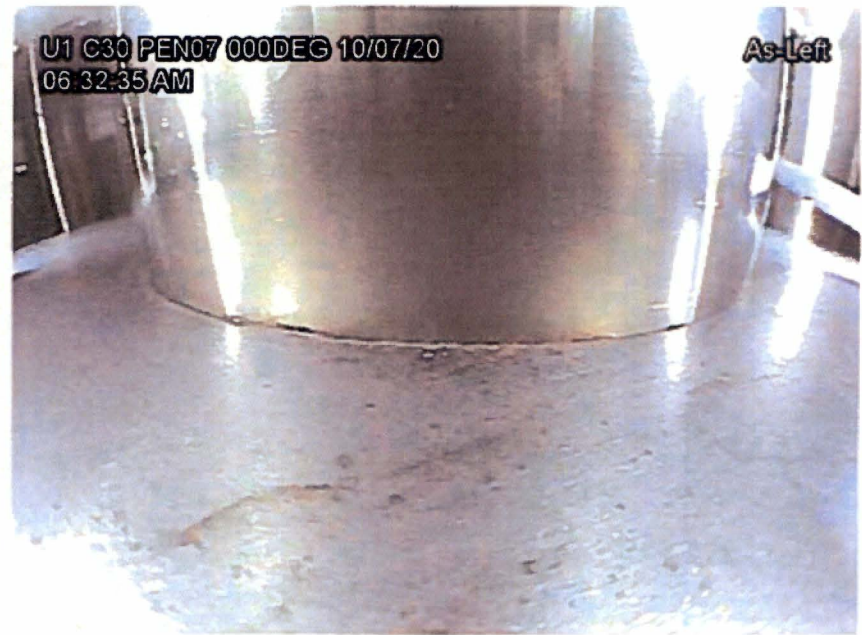
As Left Photo

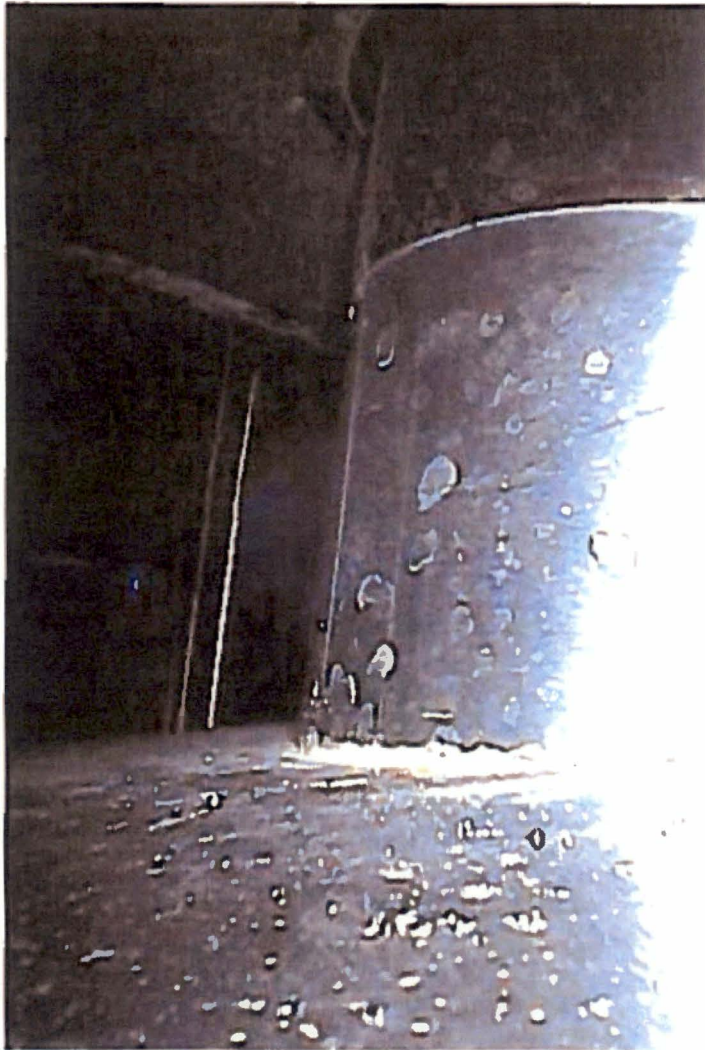
U1C30 RVCH Inspection Photos Penetration Number 8

As Found Photo

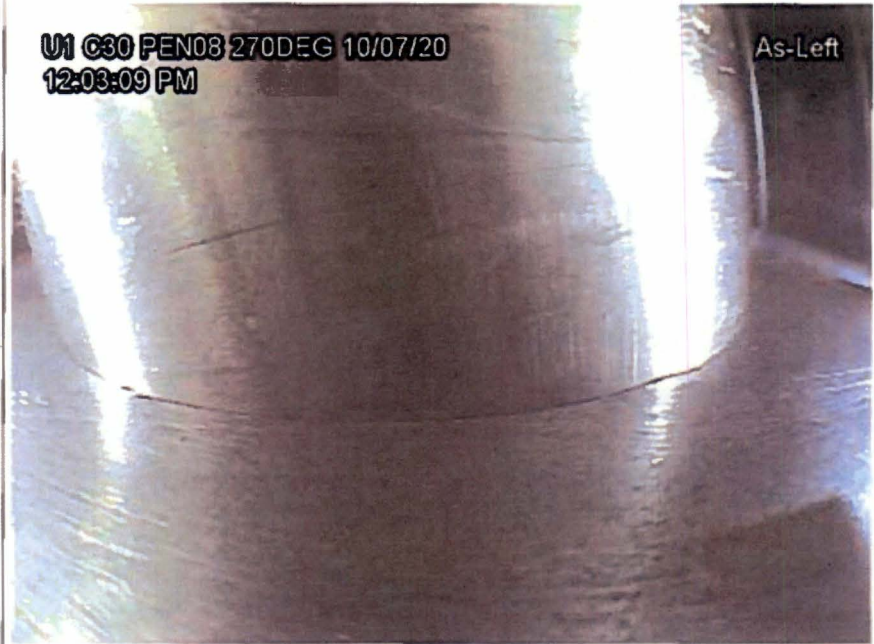
As Left Photo

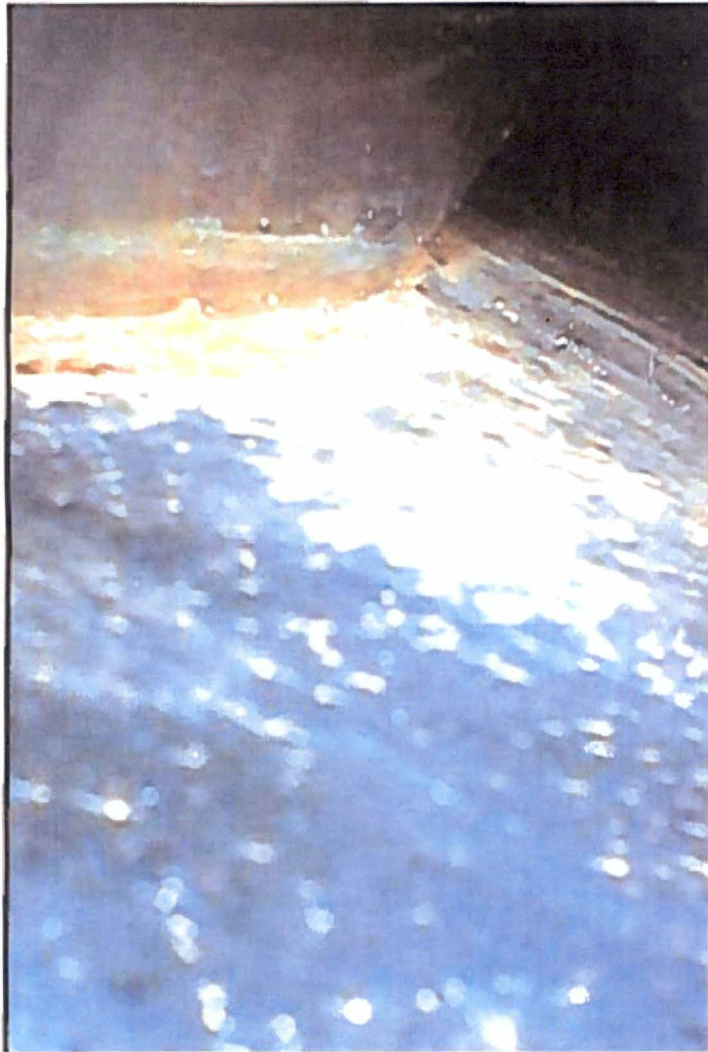
U1C30 RVCH Inspection Photos
Penetration Number 10

As Found Photo

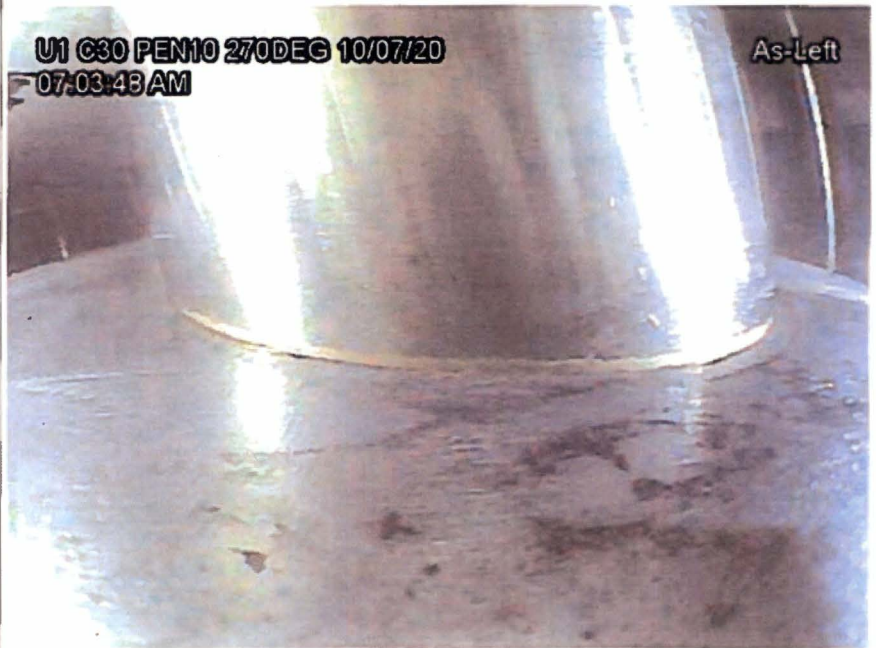
As Left Photo

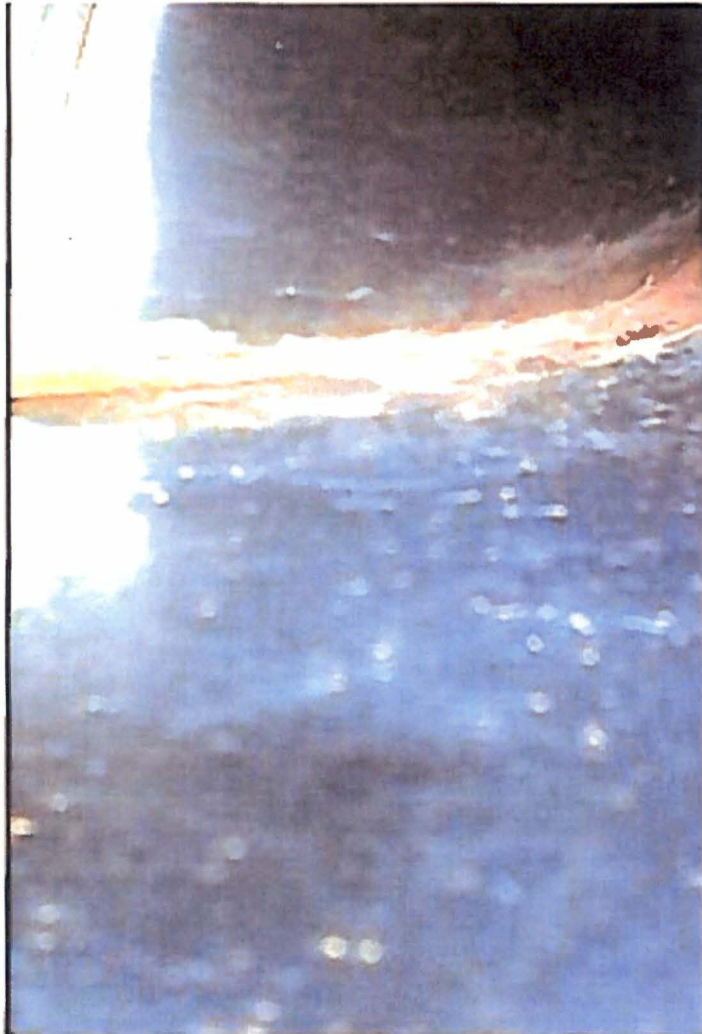
U1C30 RVCH Inspection Photos
Penetration Number 22

As Found Photo

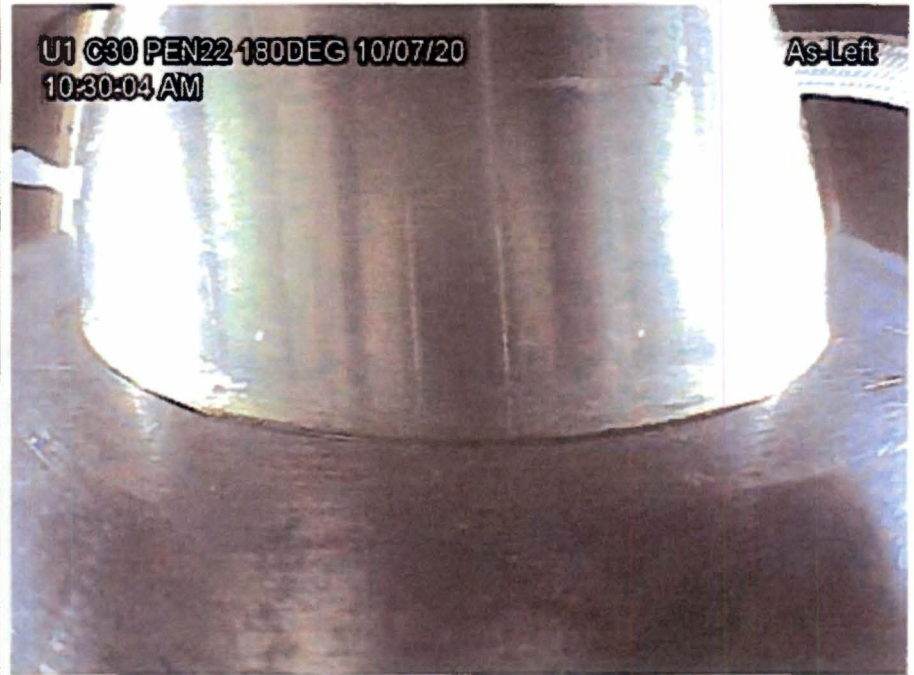
As Left Photo

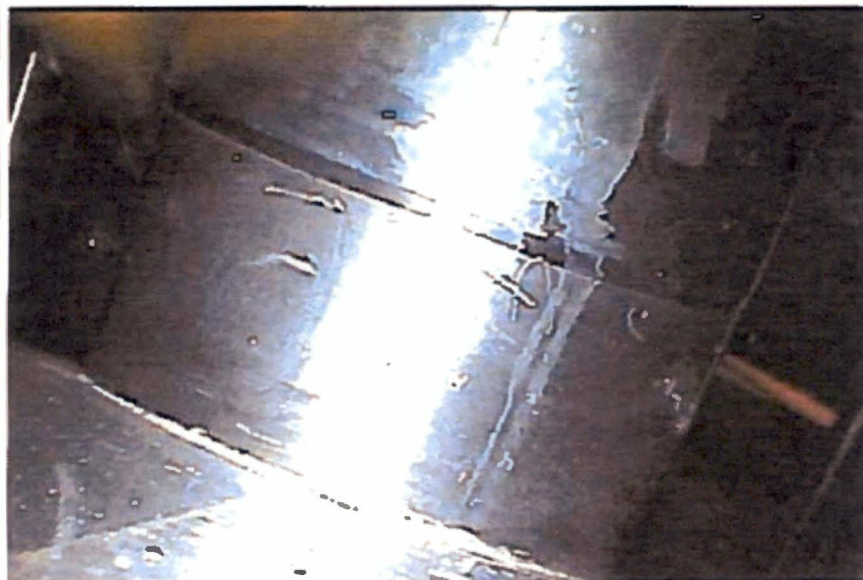
U1C30 RVCH Inspection Photos Penetration Number 23

As Found Photo

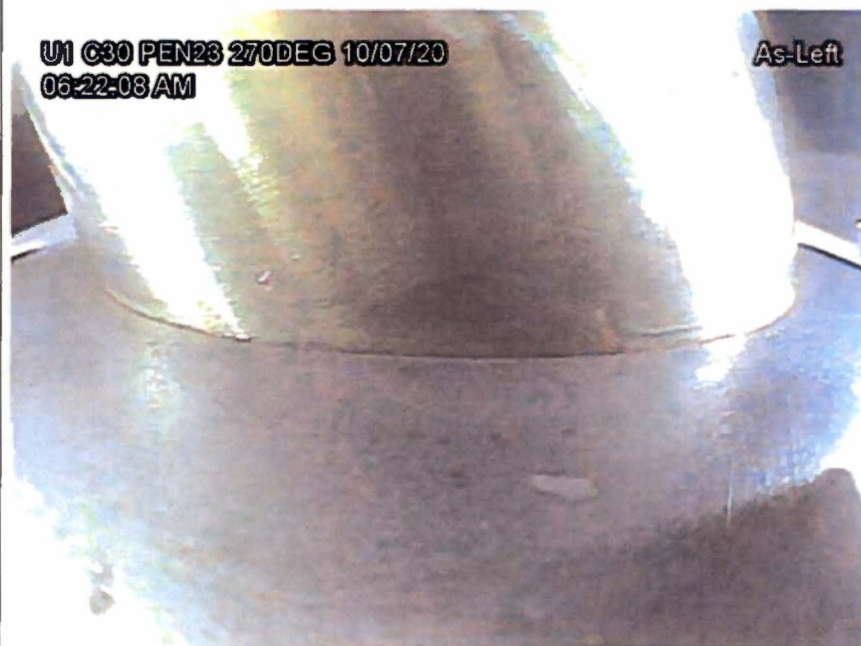
As Left Photo

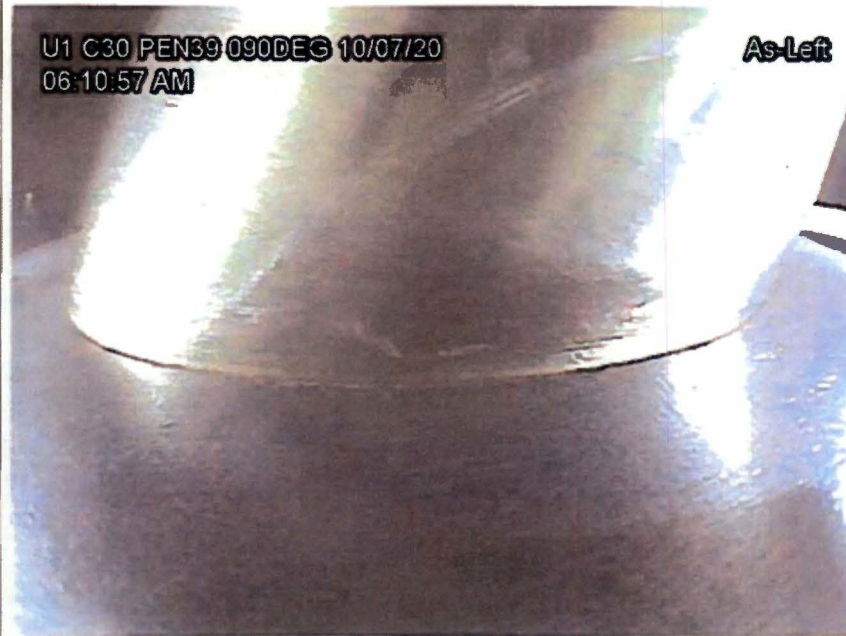
As Left Photo

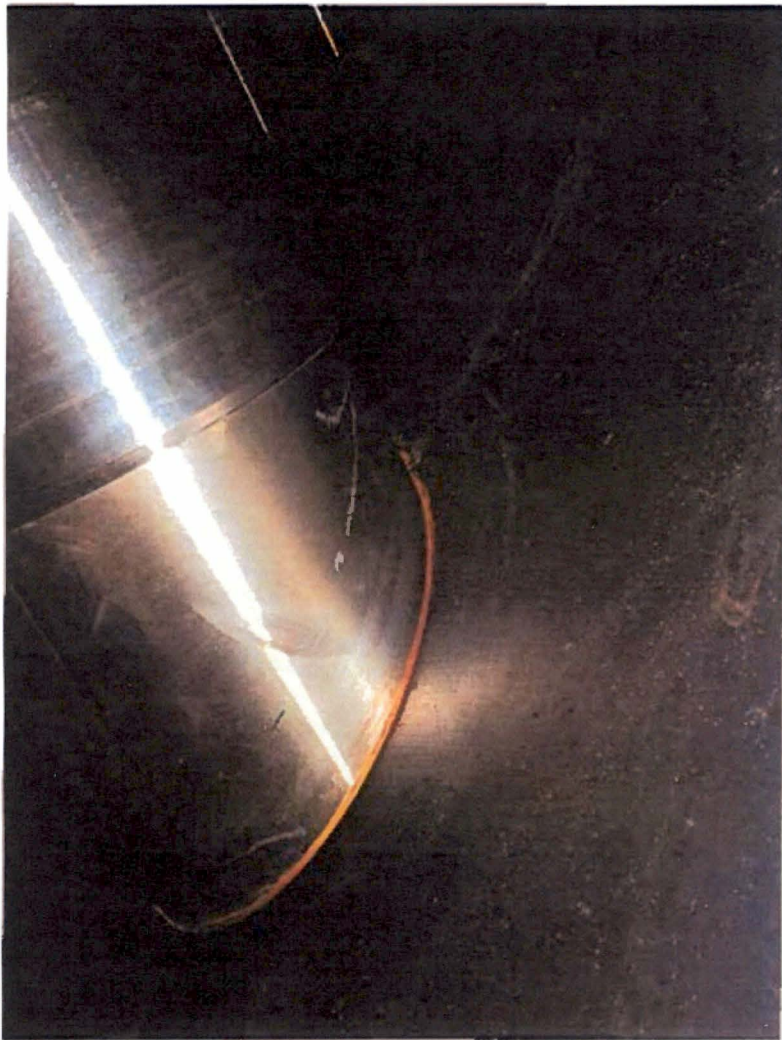
U1C30 RVCH Inspection Photos Penetration Number 46

As Found Photo

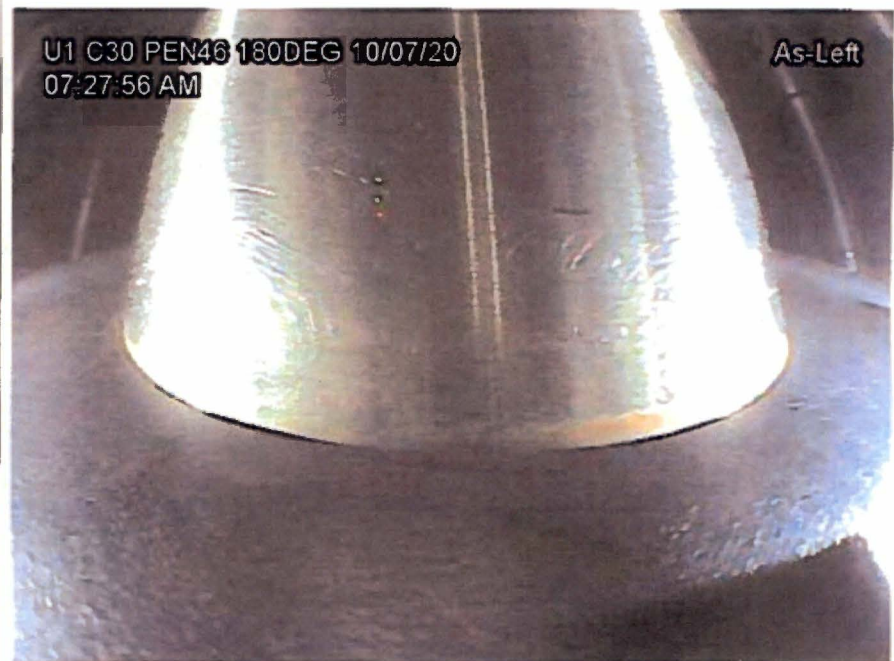
As Left Photo

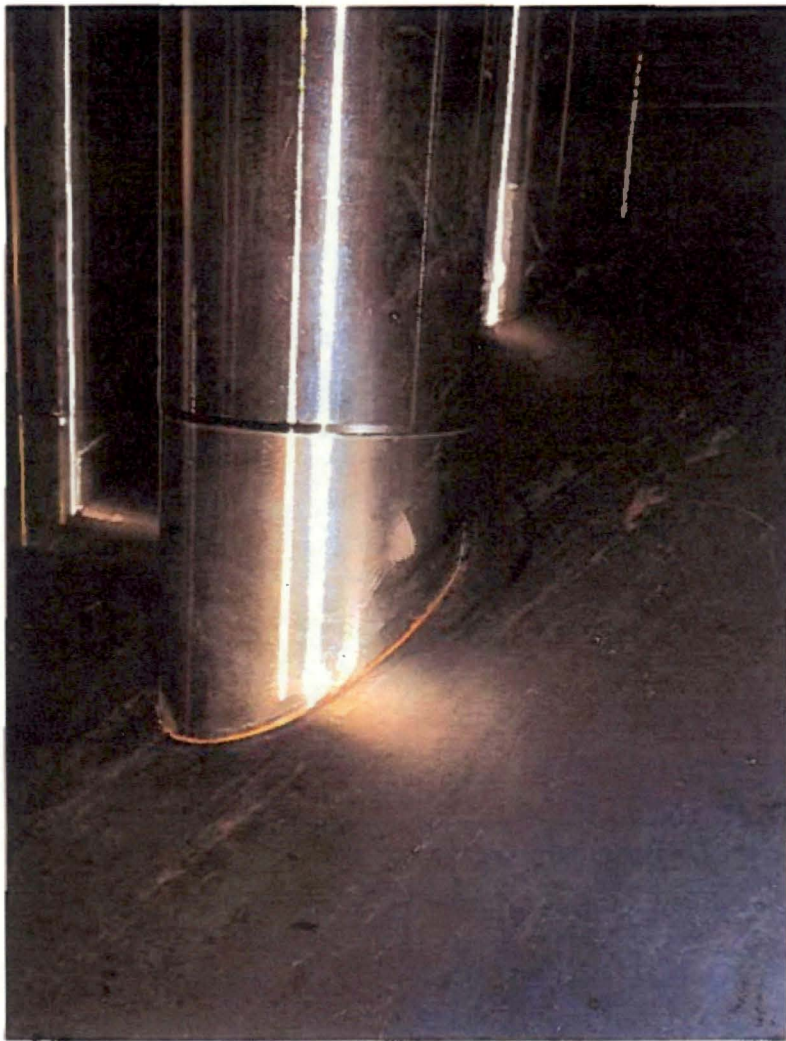
U1C30 RVCH Inspection Photos Penetration Number 59

As Found Photo

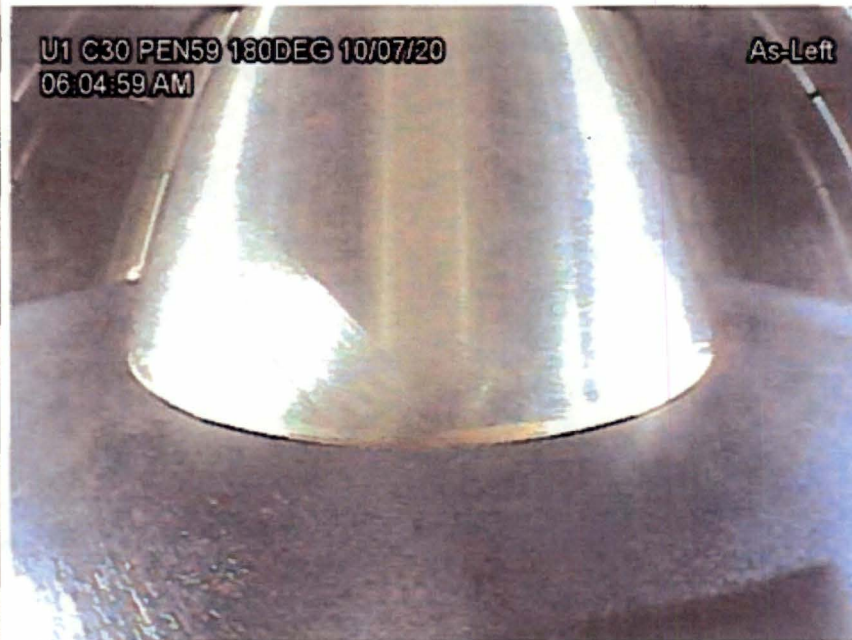
As Left Photo

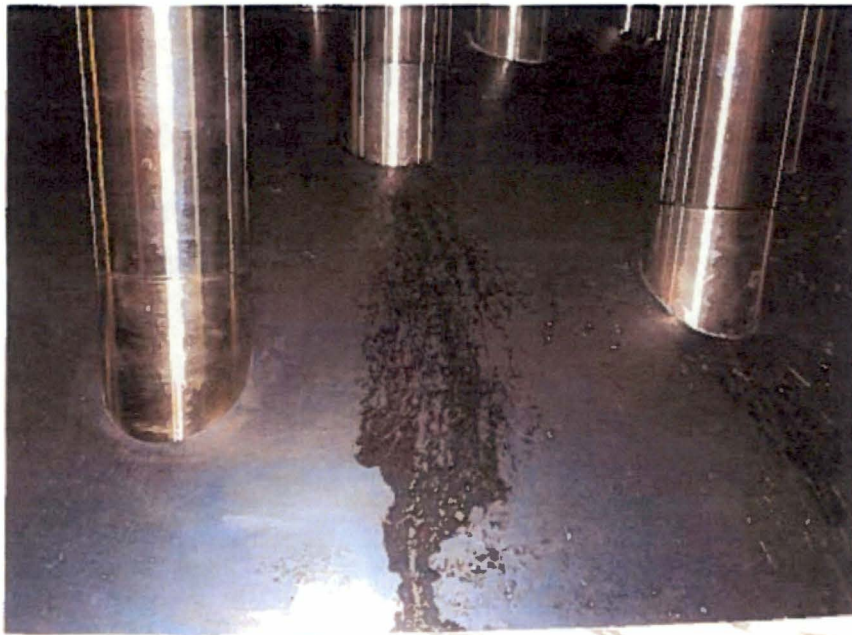
U1C30 RVCH Inspection Photos Penetration Number 62

As Found Photo

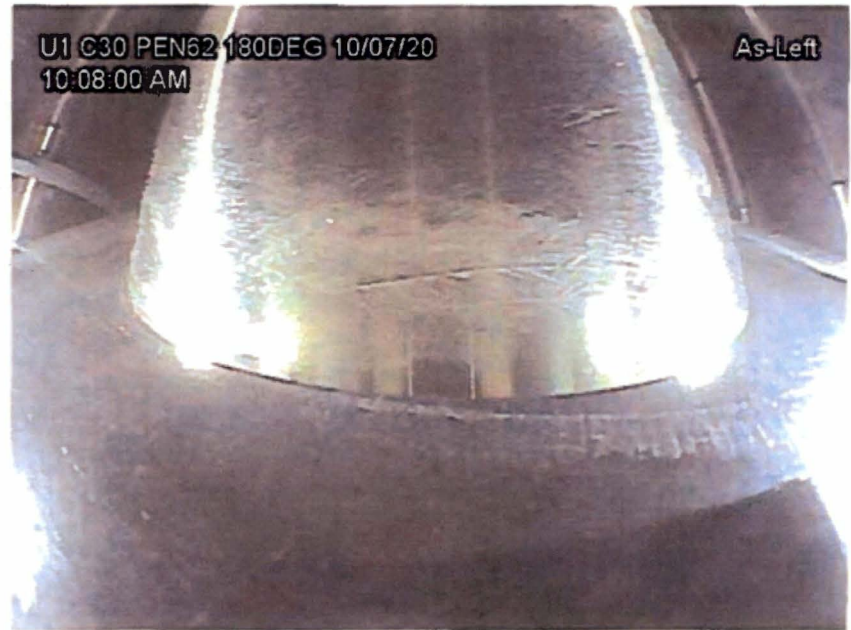
As Left Photo

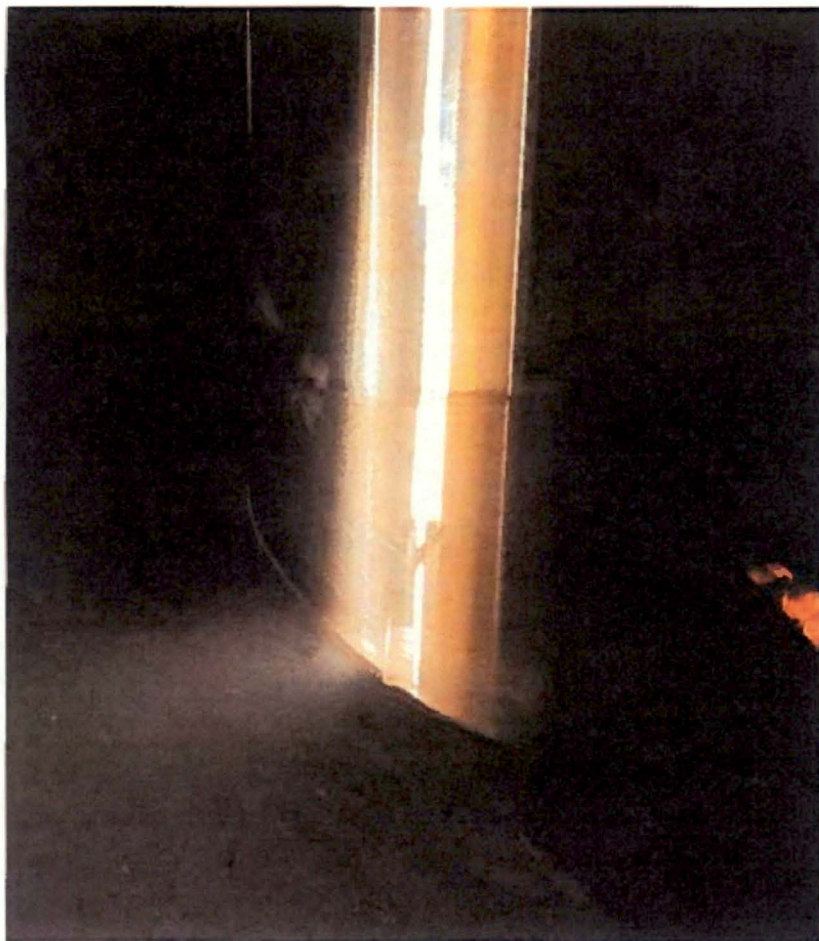
U1C30 RVCH Inspection Photos Penetration Number 64

As Found Photo

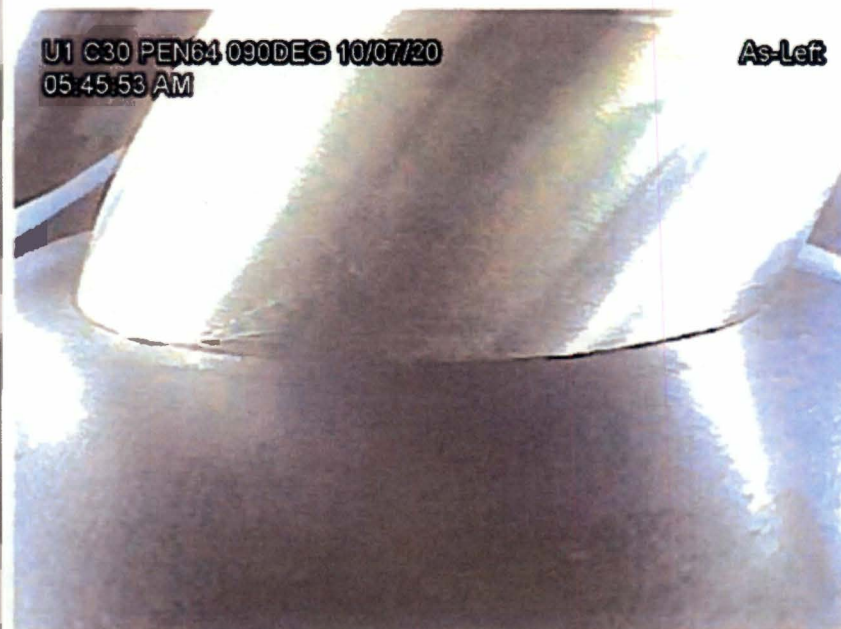
As Left Photo

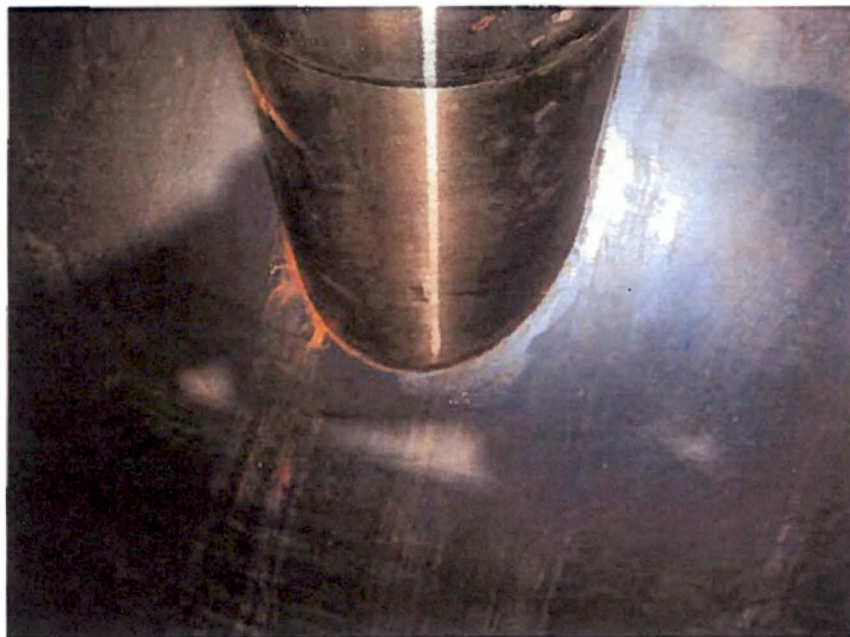
U1C30 RVCH Inspection Photos Penetration Number 70

As Found Photo

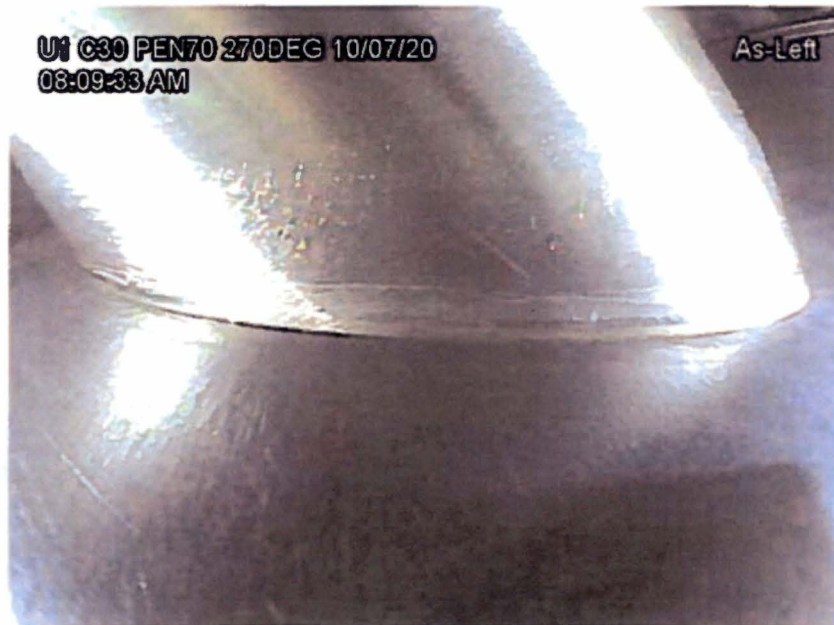
As Left Photo

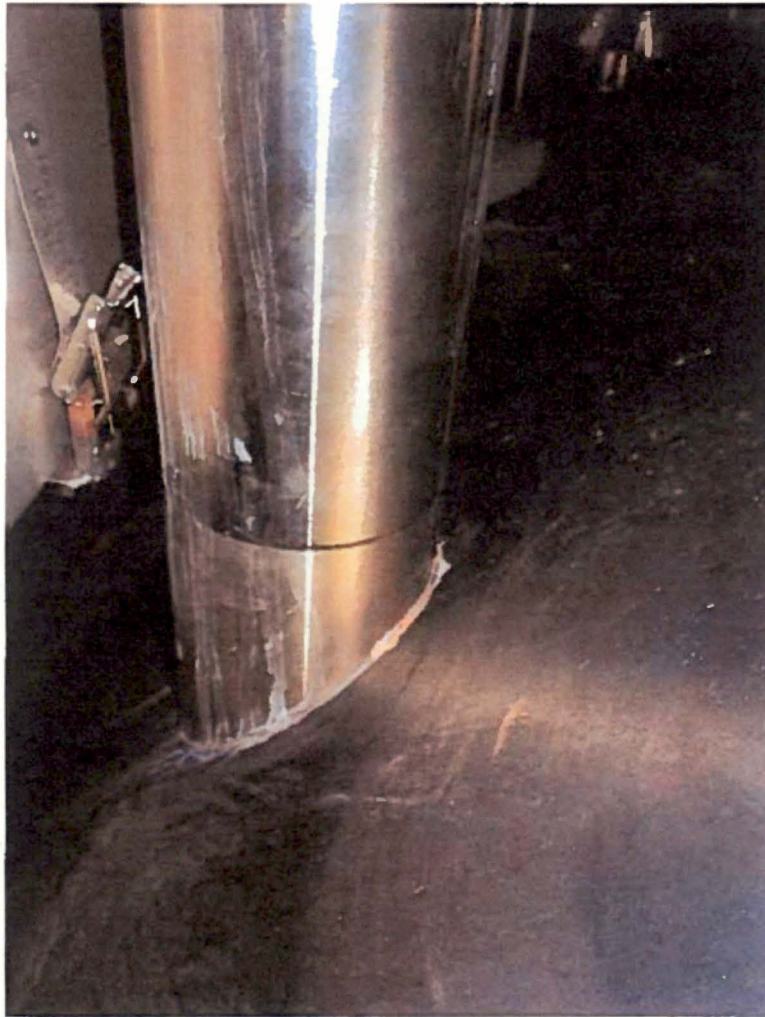
U1C30 RVCH Inspection Photos
Penetration Number 74

As Found Photo

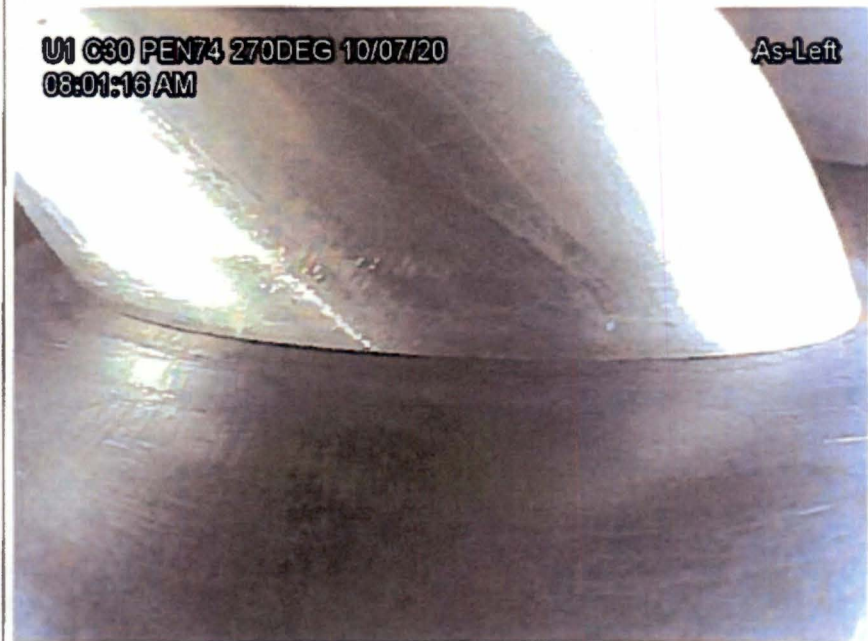
As Left Photo

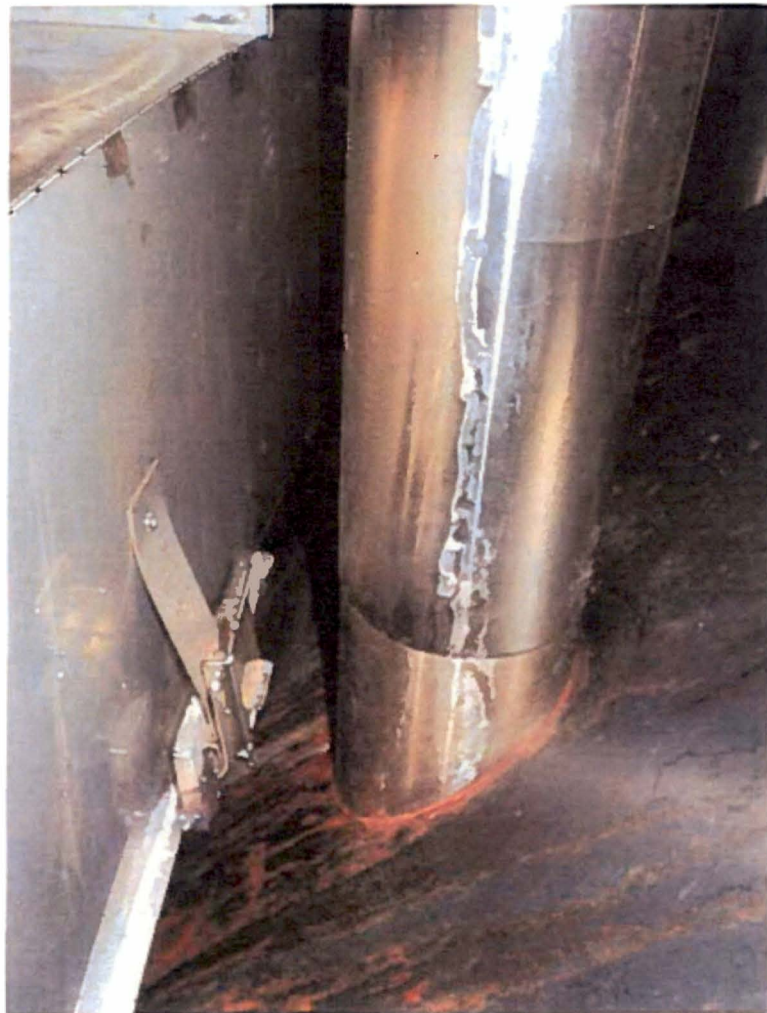
U1C30 RVCH Inspection Photos Penetration Number 75

As Found Photo

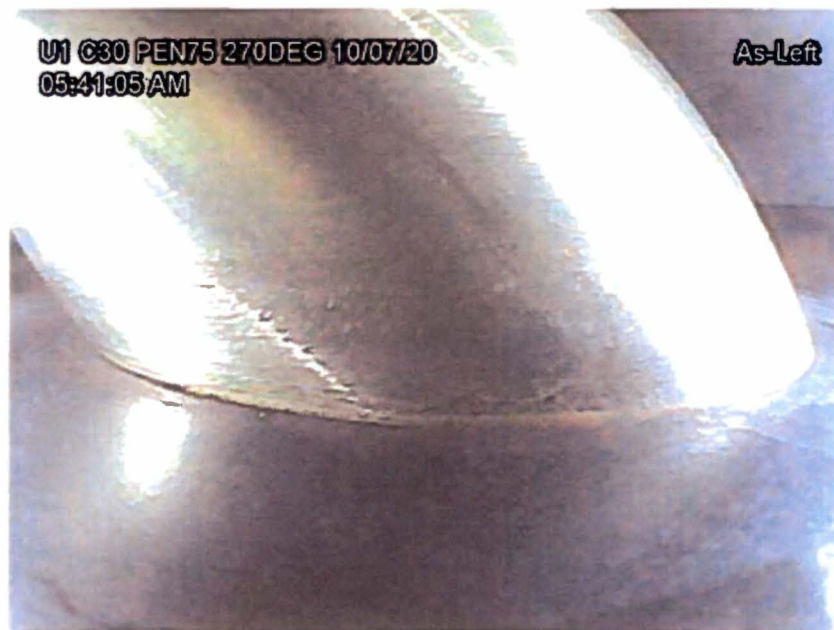
As Left Photo

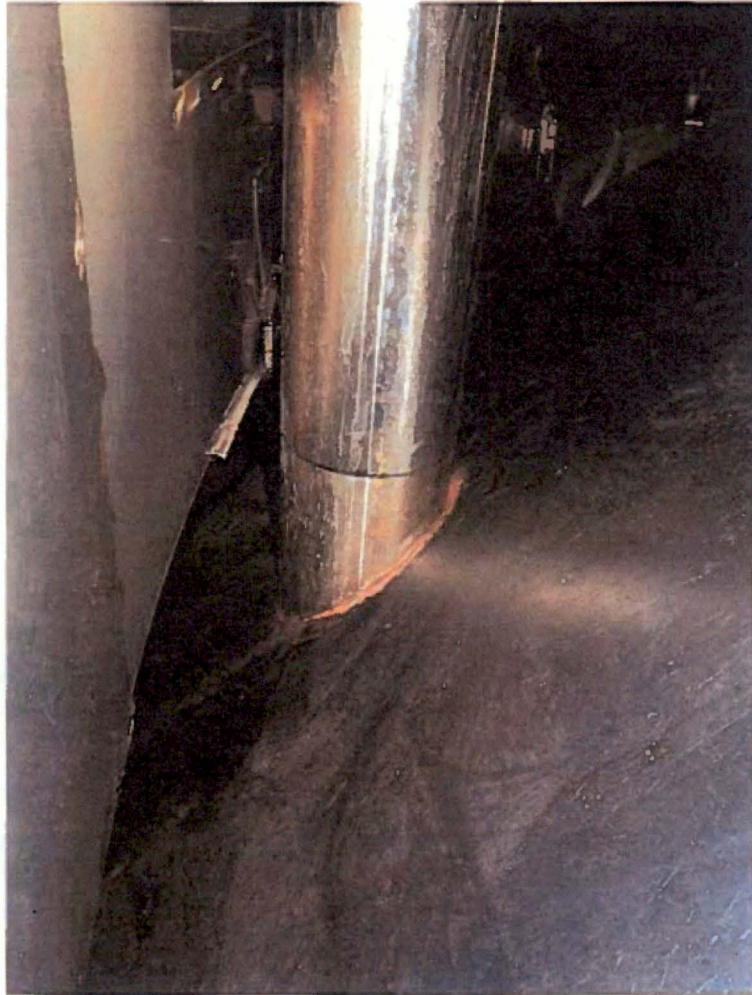
U1C30 RVCH Inspection Photos Penetration Number 76

As Found Photo

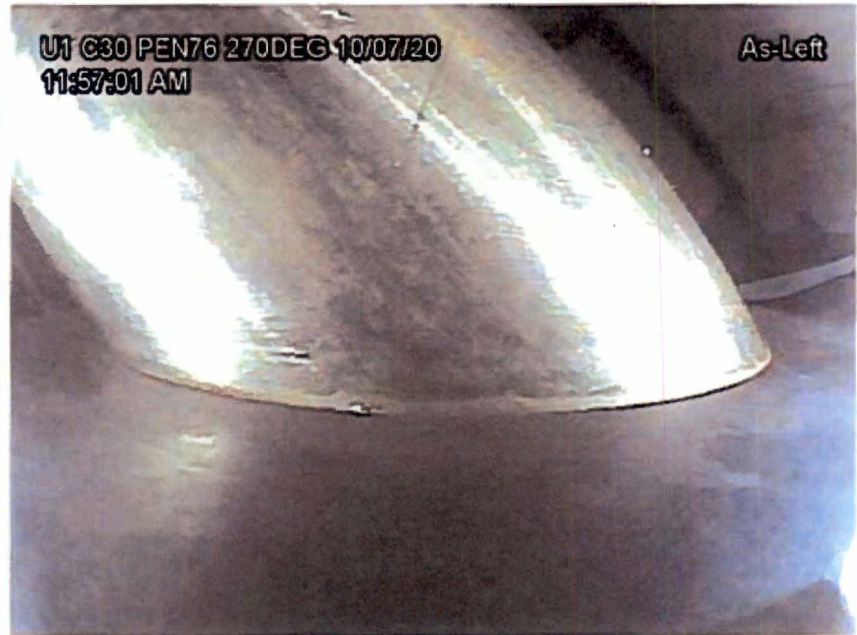
As Left Photo

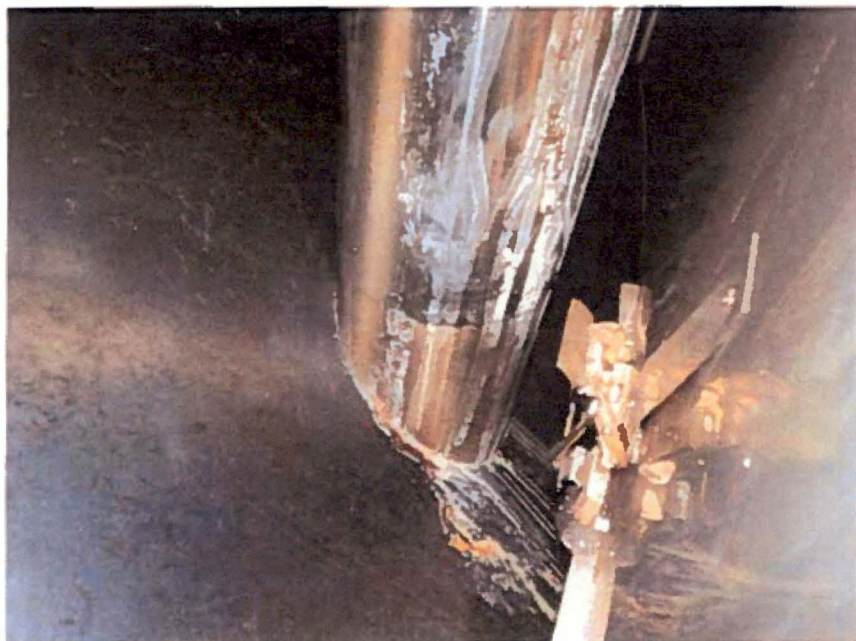
U1C30 RVCH Inspection Photos Penetration Number 77

As Found Photo

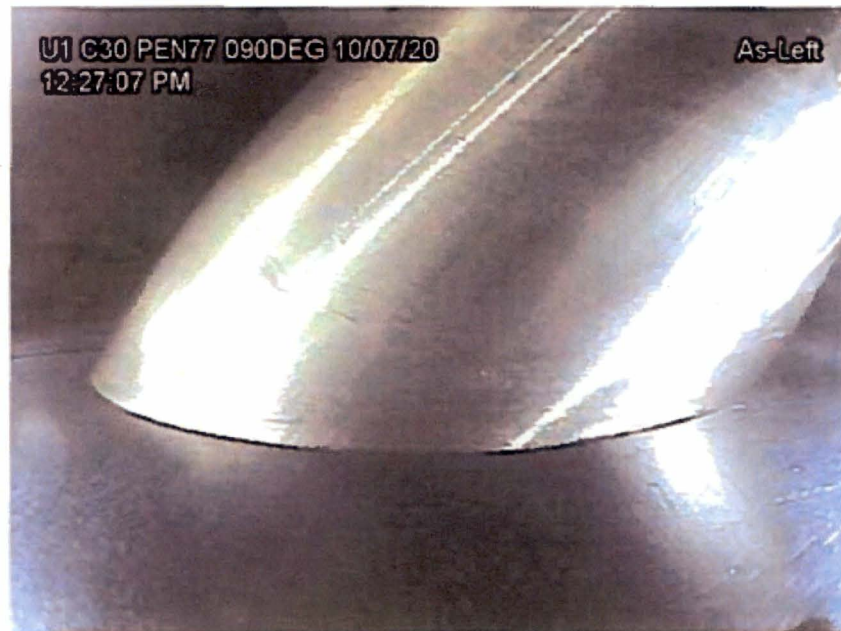
As Left Photo

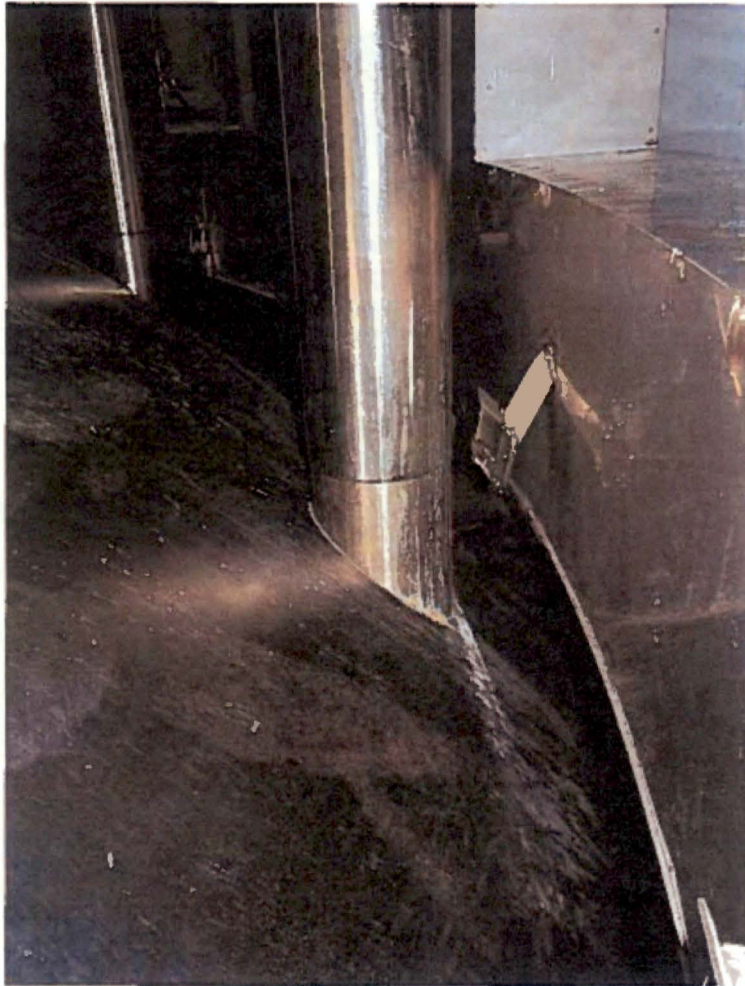
U1C30 RVCH Inspection Photos
Penetration Number 79

As Found Photo

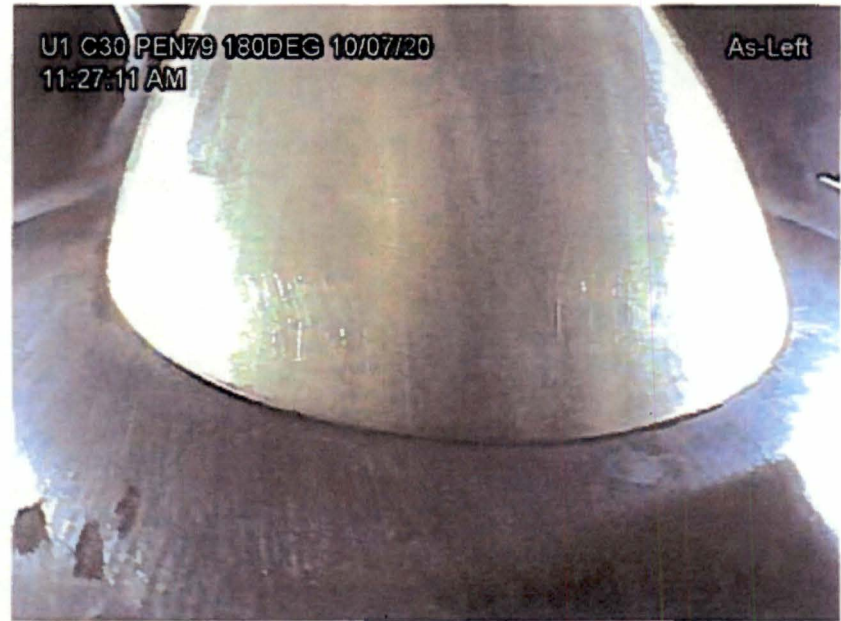
As Left Photo

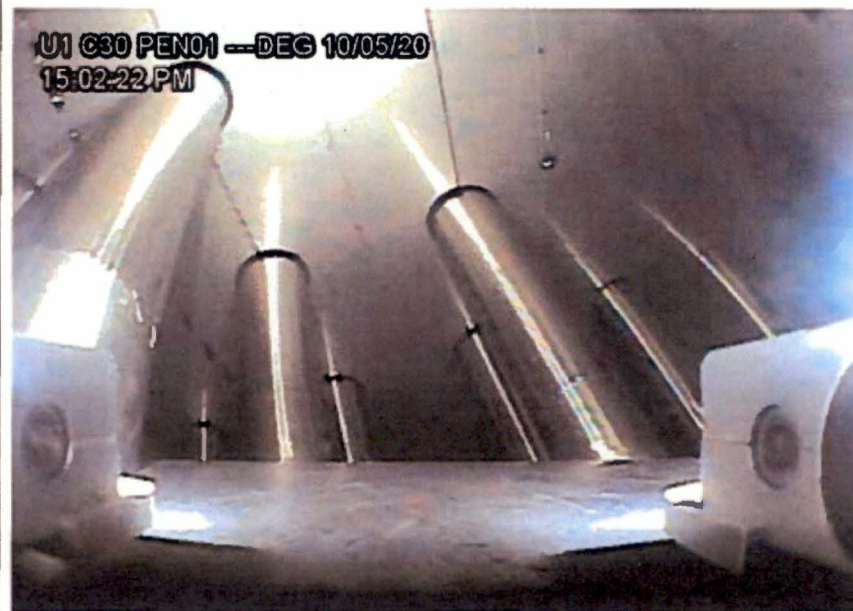
As Left Photo
