U.S. DEPARTMENT OF
ENERGY

Legacy
Management

2020 Annual Site Inspection and Monitoring Report for Uranium Mill Tailings Radiation Control Act Title II Disposal Sites

December 2020

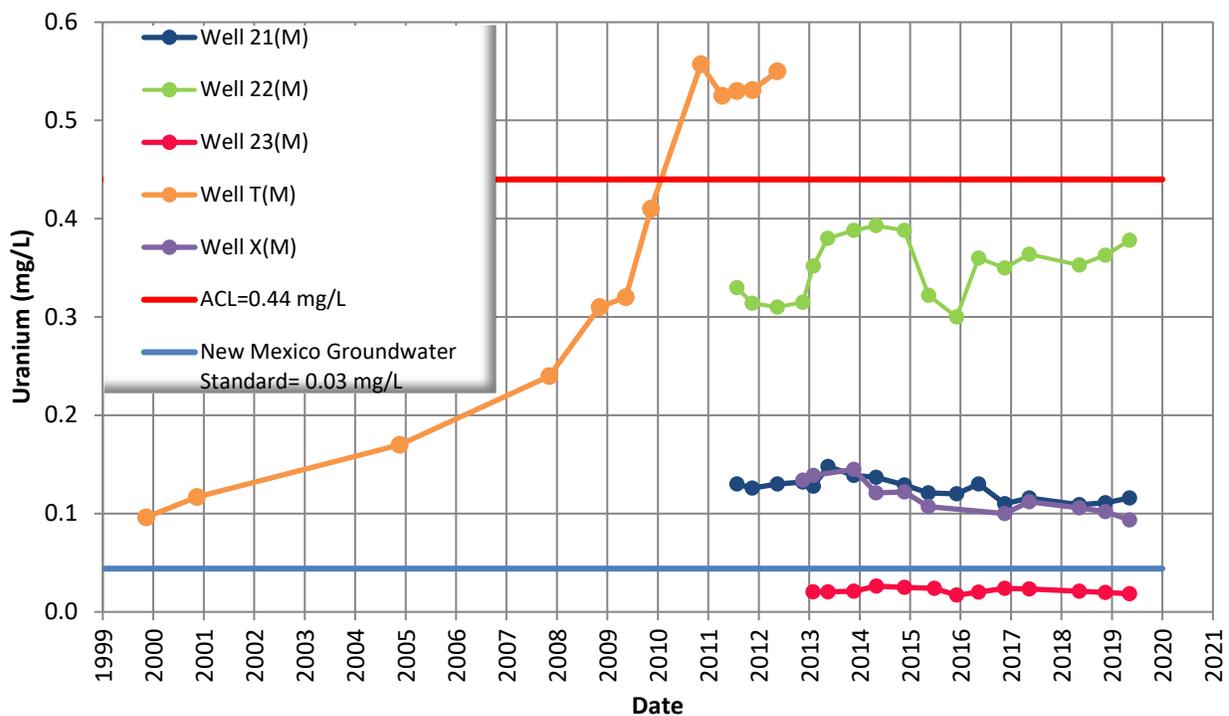
Figure 1-4. Uranium Concentrations in Alluvial Aquifer POC Well T(M) and Downgradient Wells at the Bluewater, New Mexico, Disposal Site

Figure 1-4 shows historical uranium concentrations measured at POC well T(M) and four additional wells screened in the alluvial aquifer. As this figure shows, the uranium concentration at well T(M) trended upward since LM began monitoring the well in 1999, and the November 2010 concentration of 0.557 mg/L was the first of five uranium concentrations that exceeded the ACL of 0.44 mg/L. LM notified NRC of the exceedance upon receiving the 2010 results from the laboratory. Well T(M) was sampled in May 2012 as declining water levels due to drought indicated it would soon go dry. Well T(M) has remained dry since 2012. Well 21(M) in the southeast corner of the site and POE well X(M) near the site's east boundary show a slightly decreasing trend in uranium concentration since 2013 (Figure 1-4). However, the elevated uranium concentrations at these two wells in recent years indicate that alluvial groundwater with uranium concentrations exceeding the New Mexico groundwater standard (0.03 mg/L) is discharging from the site toward the southeast. NRC requested that LM evaluate the performance of the main tailings disposal cell to assess whether seepage from the cell between 2005 and 2010 had increased to the extent it was responsible for the elevated uranium concentrations measured at POC well T(M) (see Figure 1-4) before it dried up. Based on an assessment of the disposal cell cover and an accompanying evaluation of the water balance for the main tailings disposal cell, the increase in uranium concentrations in well T(M) is not attributed to a compromise of the disposal cell's performance, and there was no surge of tailings-fluid seepage from the main tailings cell since it was closed (DOE 2014). It was further concluded that water levels in well T(M) decreased during the early 2000s below the contact between the alluvium and underlying Chinle Formation from 2008 to 2012. The simultaneous increase in uranium concentration was attributed to the declining water level and the influence of contaminated groundwater migrating through and interacting with weathered Chinle Formation materials, with the resulting fluids obscuring the water chemistry of groundwater in nearby portions of the alluvial aquifer that remained saturated (DOE 2014).

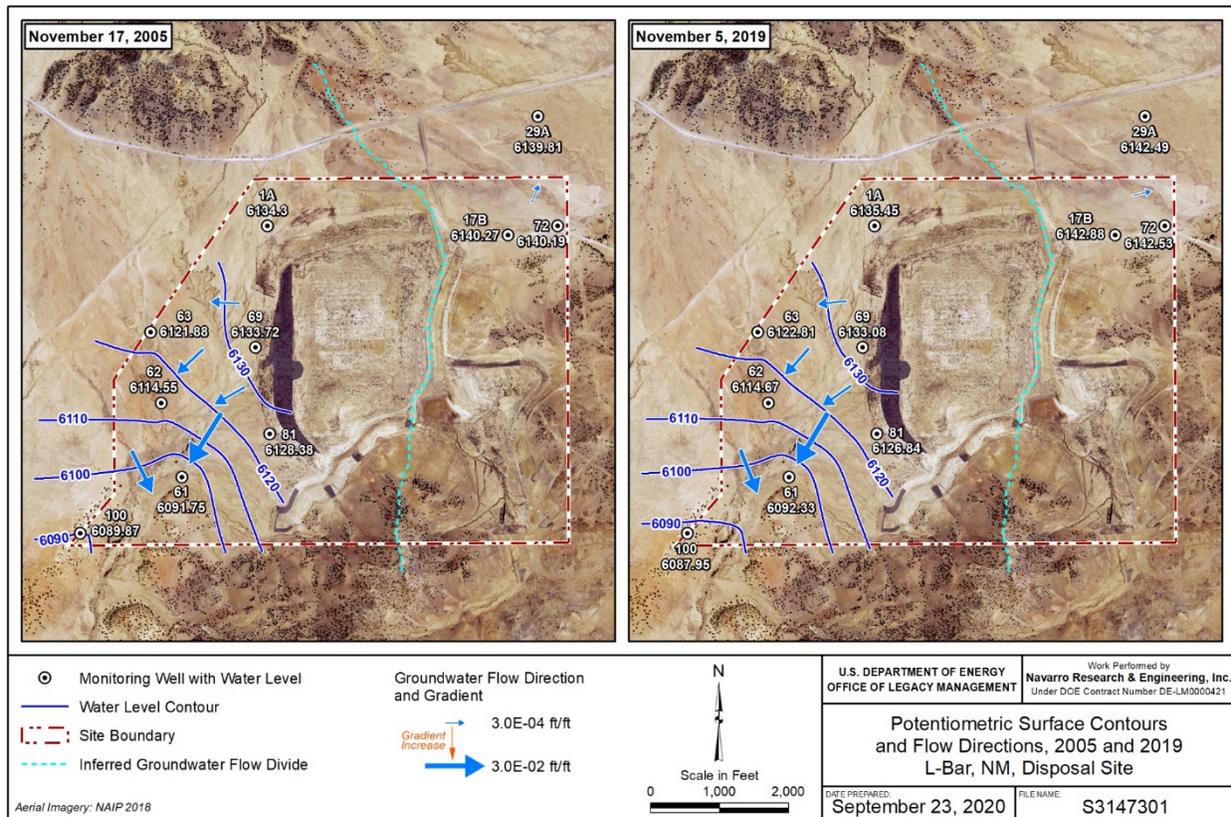
Figure 3-11. Potentiometric Contours and Groundwater Flow Directions in the FTH Sandstone in 2005 and 2019

east-northeast in 2019, but this was most likely resultant from having only one calculation with a very small gradient magnitude, rather than a significant shift in regional flow direction.

Water levels in the three wells northeast of the site have increased an average of 2.54 ft between 2005 and 2019. Wells 69 and 81 are nearest to the tailings impoundment to the west and each had an overall decrease in water elevation by about 0.5 and 1.3 ft, respectively. It is unknown whether the steady change in groundwater level is resulting from recharge from surface water diversions to the northeast, or water levels are continuing to equilibrate from mounding below the tailings impoundment. Water level trends southwest of the tailings impoundment do not suggest the latter.
