Indian Point Nuclear Generating Unit No. 3

Pre-Application Meeting

Relief Request No. IP3-IFI-RR-16

Code Case N-513-4 Periodic Inspection
Frequency Extension

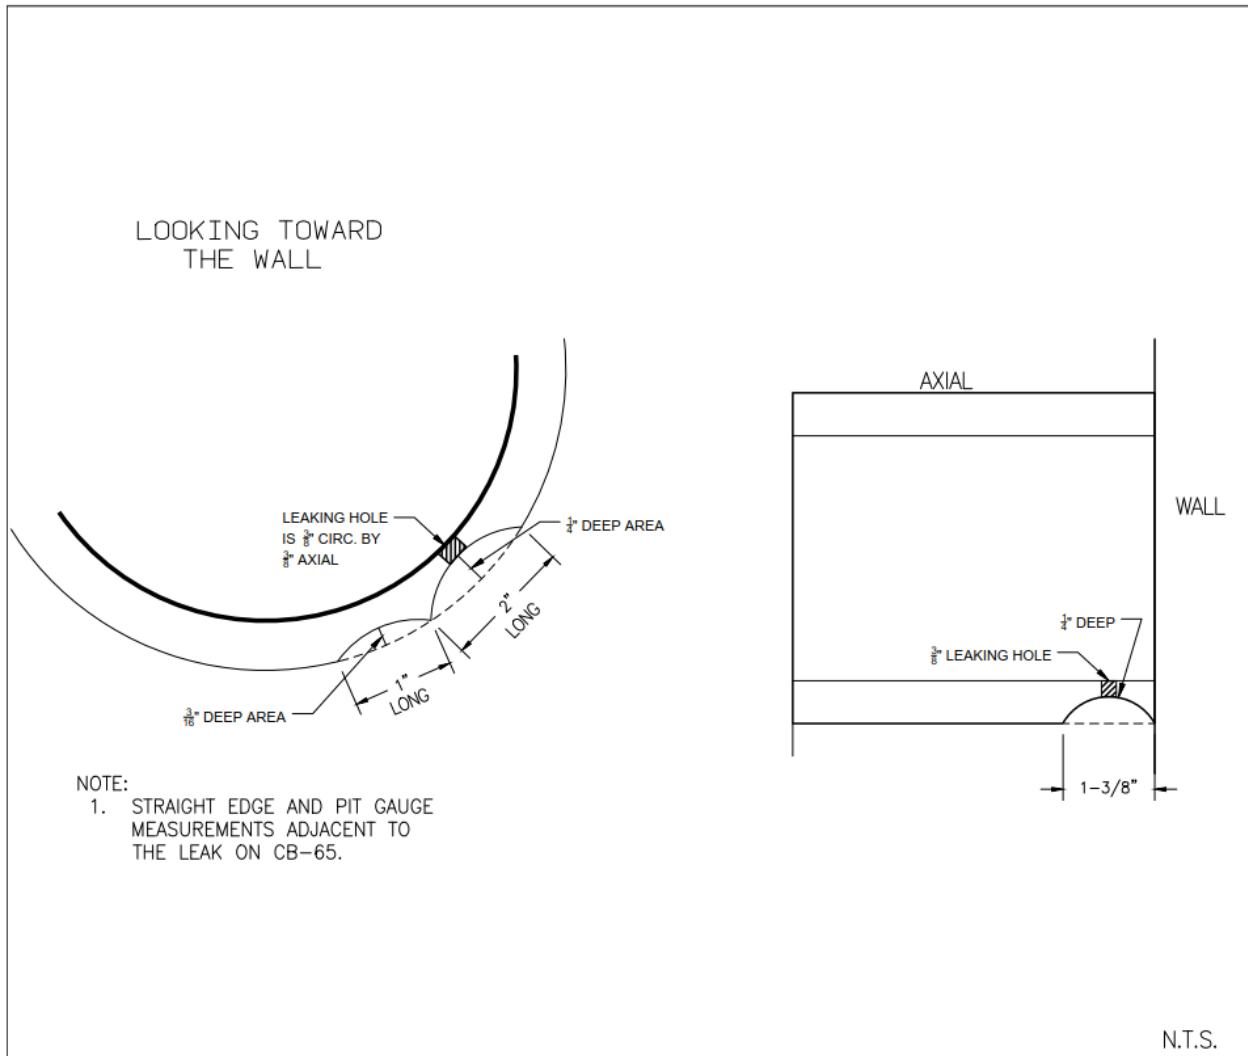
- The degraded area was characterized as an area approximately 3" in the circumferential direction by 1.375" in the axial direction.
 - See Figure 1 on next slide.
- The leaking defect was characterized as a through wall hole approximately 3/8" in diameter located within the degraded area.
- The degraded area is located at approximately the 5 o'clock position on the horizontal pipe.
- An investigation indicated that the cause of the degradation was external surface corrosion caused by periodic leakage from an adjacent vacuum breaker valve.
- External and internal visual examinations and well as UT examinations of the surrounding area did not indicate the presence of any active internal degradation.

- The original inspection identified wall thinning from corrosion measuring approximately 3" in the circumferential direction and approximately 1.375" in the axial direction. Note that the degraded area still had significant remaining thickness, with the exception of the 3/8" diameter leaking hole.

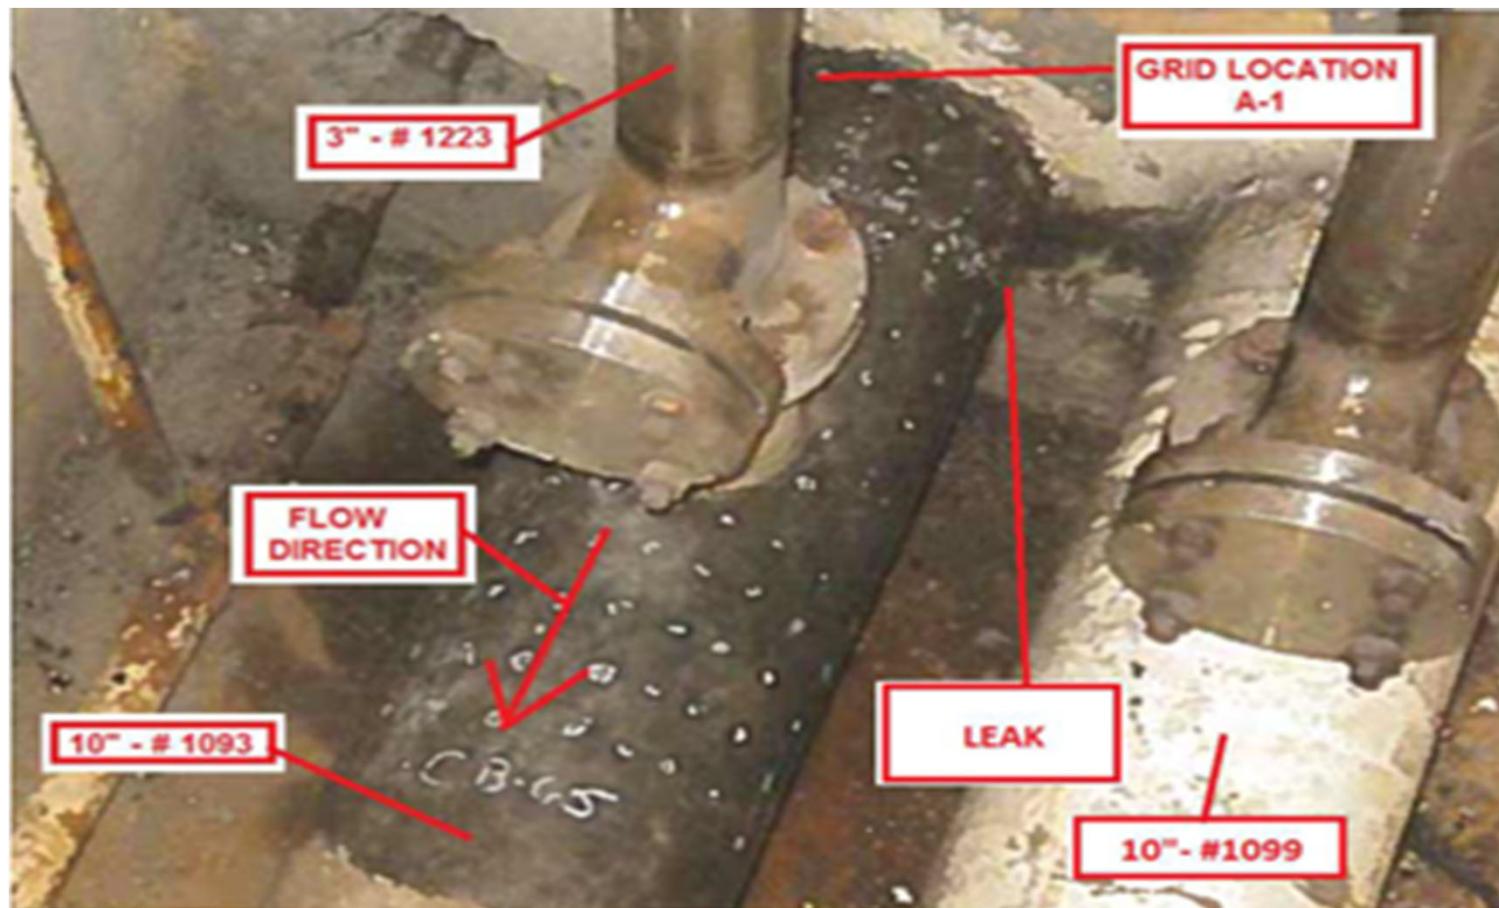
- Surface preparation was required prior to the original inspections to facilitate UT. Since the area has been encapsulated by the leak mitigation clamp, additional surface preparation is likely to be required during future inspections. This surface preparation could increase the size of the hole and increase the leak rate.
- Since the 15 GPM leak initiated from the area to be inspected, measures had to be implemented to reduce the spraying on the inspection personnel as well as on the NDE equipment. Since the leakage is likely to have increased since the original inspection, it is expected that future periodic inspections will be challenging.

- Since the temperature of the water has decreased from approximately 50 degrees Fahrenheit (°F) during the original examination to approximately 33°F currently, the anticipated higher leakage and lower temperatures will present a safety concern for the NDE personnel, as well as potentially impact the performance of the NDE equipment.
- The degraded area from where the leakage is originating is located at the bottom of the horizontal pipe, approximately 6" from the floor, adjacent to the wall which the pipe penetrates. In addition, there is another SW pipe in close proximity to line 1093, resulting in limited accessibility to the inspection area (see Figure 2 below). These interferences, coupled with the higher leakage of colder water, will increase the degree of difficulty of the inspection.
