LaSalle County Station, Unit 2
Renewed Facility Operating License No. NPF-18
NRC Docket No. 50-374

Subject: Relief Request I4R-12 Relief from Code Surface Examinations for 2B33-F060B
Valve Repair

**Relief Request I4R-12 Associated with Alternative Examination Requirements for
Repair of Reactor Recirculation Flow Control Valve**

LaSalle County Station (LSCS), Unit 2 valve 2B33-F060B ("B" Reactor Recirculation System Flow Control Valve).

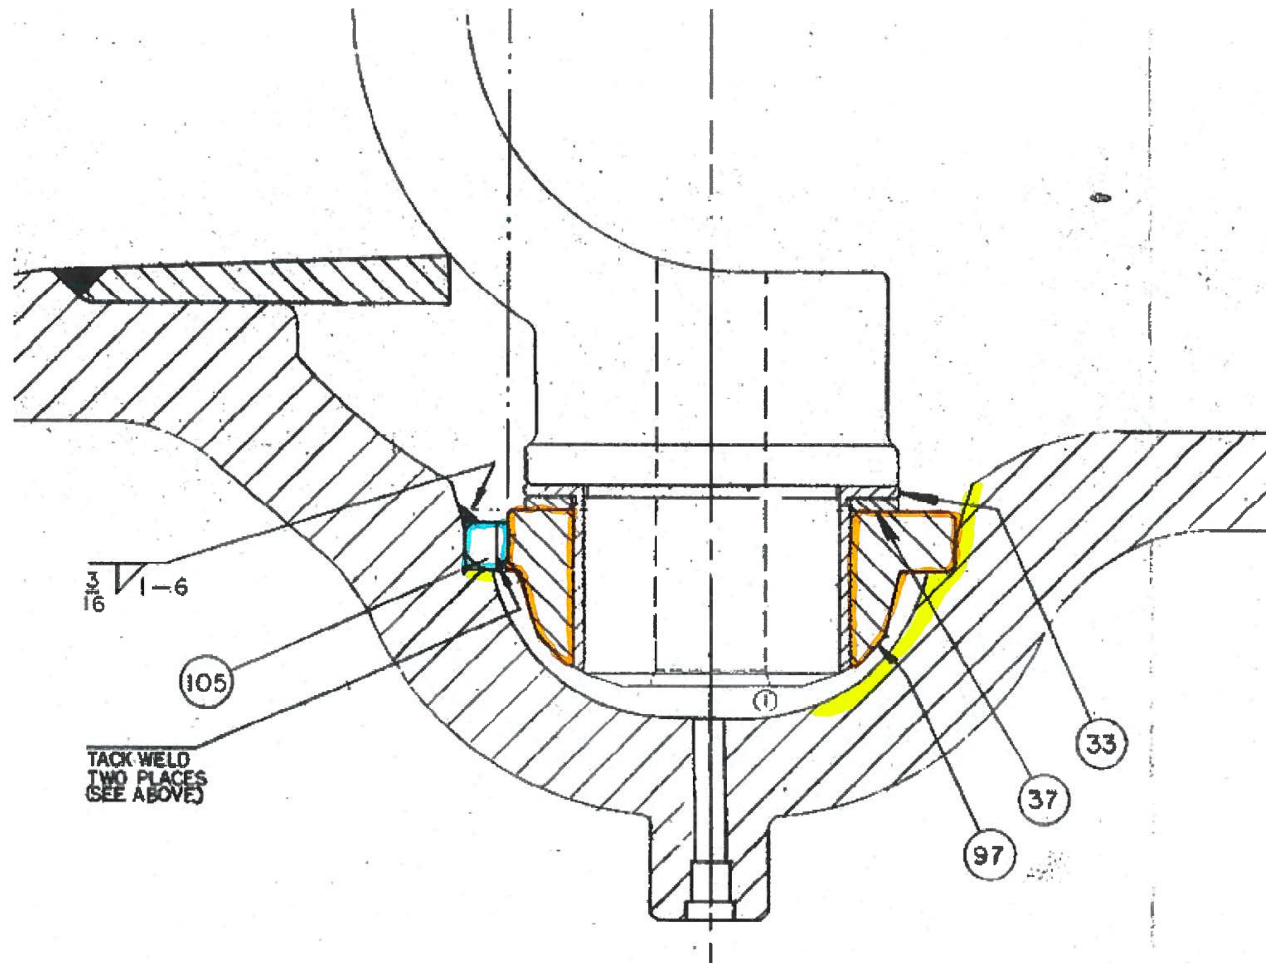
Drawings of the valve are provided in Attachment 2 (Figures I4R-12-1 and I4R-12-2). Figure I4R-12-1 is the drawing of the entire valve assembly, including the actuator. Figure I4R-12-2 is close-up drawings of the area of the valve body in question. Figure I4R-12-2 is highlighted in orange for the lower guide plug, blue for the guide plug anti-rotation segment, and yellow as the estimated area of wear in the valve body where material is missing due to the lower guide plug impact on the valve body.

The drawings of the valve do not provide thickness dimensions of the valve body itself. At this point in the refueling outage, LSCS has been unsuccessful in obtaining direct thickness measurements of the valve body in its current condition. Valve body thickness measurements were taken and documented in 1976 by the valve manufacturer after the valve was cast. Ultrasonic (UT) measurements were taken in several locations in the pocket area at the bottom of the valve close to where the work is being performed. The average of the thickness readings from this report is 3.7 inches. This value is taken as the nominal sectional thickness of the valve body in this area. This same report documents the valve specified minimum sectional thickness as 2.418 inches.

LSCS has been unable to explicitly quantify or measure the material lost in the valve body. This is due to the limited space of a person getting into the valve body and the radiological dose exposure internal to the valve body. Measurements have been obtained through contour gauge readings. This was done by taking a reading in an area where there was limited material loss and comparing it to another reading in a corresponding area where there was wall loss. Comparison of those readings shows the point where the most wall loss occurred measures approximately 0.75 inches of material. These readings are compared to the nominal wall thickness to assess if the wall thickness had decreased below the minimum required wall thickness, and therefore into the required pressure boundary design area. Based on this approach, LSCS determined that the operational wear on the valve body did not result in wall thickness decreasing below the minimum wall thickness value.

However, during the maintenance activities to restore the valve to an acceptable condition, measurements determined that the maintenance performed on the valve body for surface conditioning encroached into minimum wall thickness of the valve. LSCS determined the surface conditioning resulted in going approximately 0.06 inches below minimum wall thickness. As a result, this is a defect that must be removed in accordance with NB-2538. NB-2538 requires a liquid penetrant (PT) examination to be performed following removal of the defect. After removal of the defect, weld buildup using the machine Gas Tungsten Arc Welding process will be performed in accordance with NB-2539 to restore the minimum wall thickness. Following weld build up and in accordance with NB-2539, a PT examination must be performed of the weld surface.

Therefore, to restore the internal structure of the valve body to greater than minimum wall thickness and to properly house the lower guide plug, PT examinations for valve 2B33-F060B repair are required by the ASME Code.
