U.S. DEPARTMENT OF
ENERGY

2020 Annual Site Inspection and Monitoring Report for Uranium Mill Tailings Radiation Control Act Title I Disposal Sites

March 2021

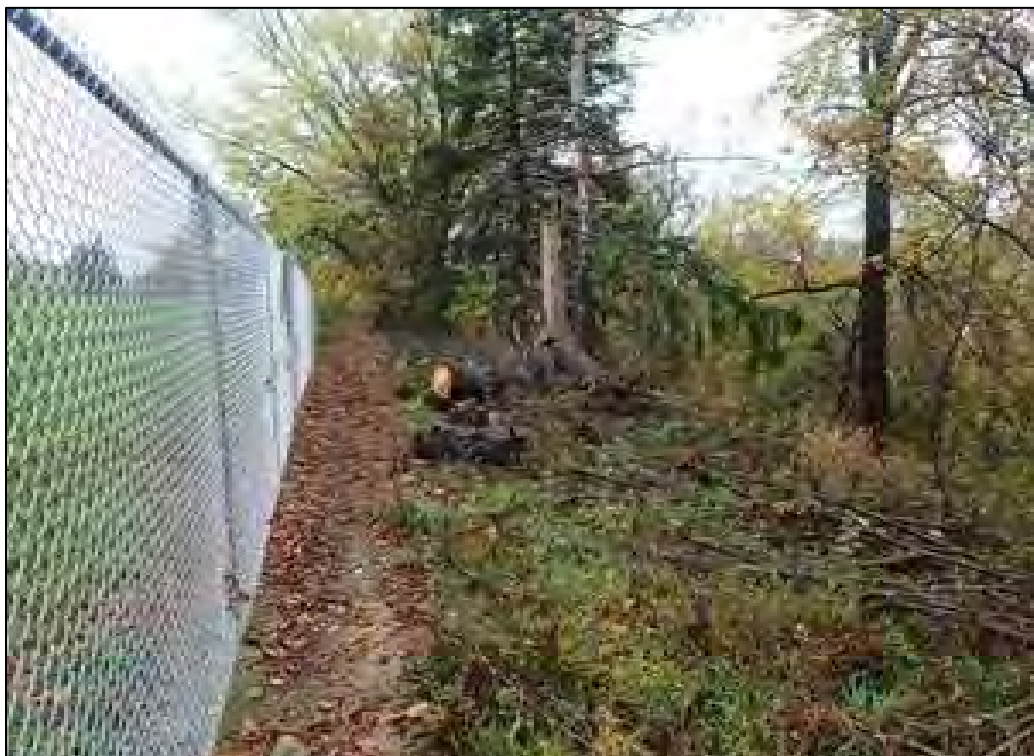
PL-2. Repaired Fence Line

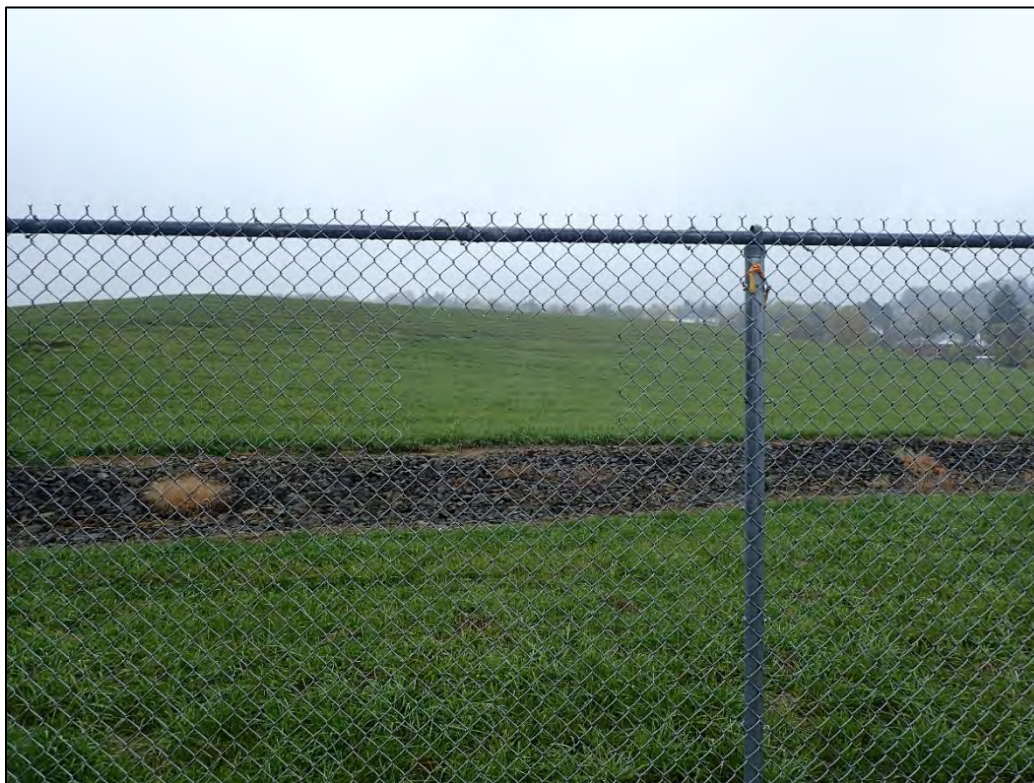
PL-3. Disposal Cell with Missing Perimeter Sign P1

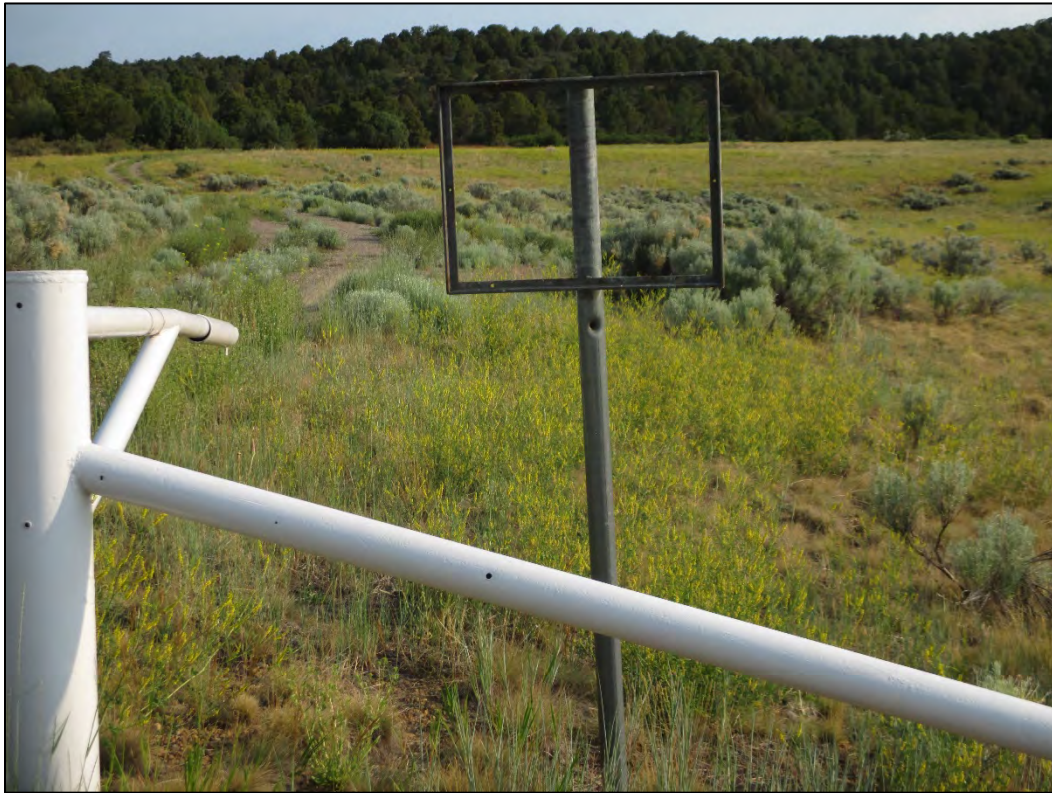
PL-1. Entrance Sign Missing

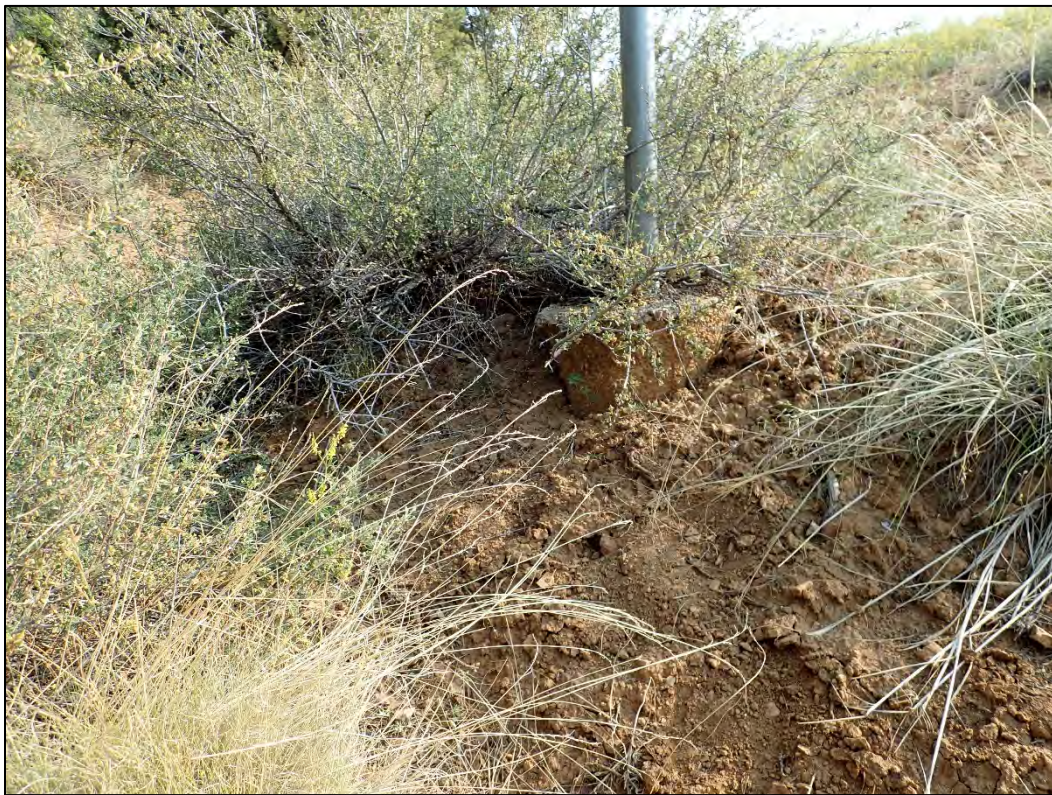
PL-2. Perimeter Sign P79 Undercut by Erosion

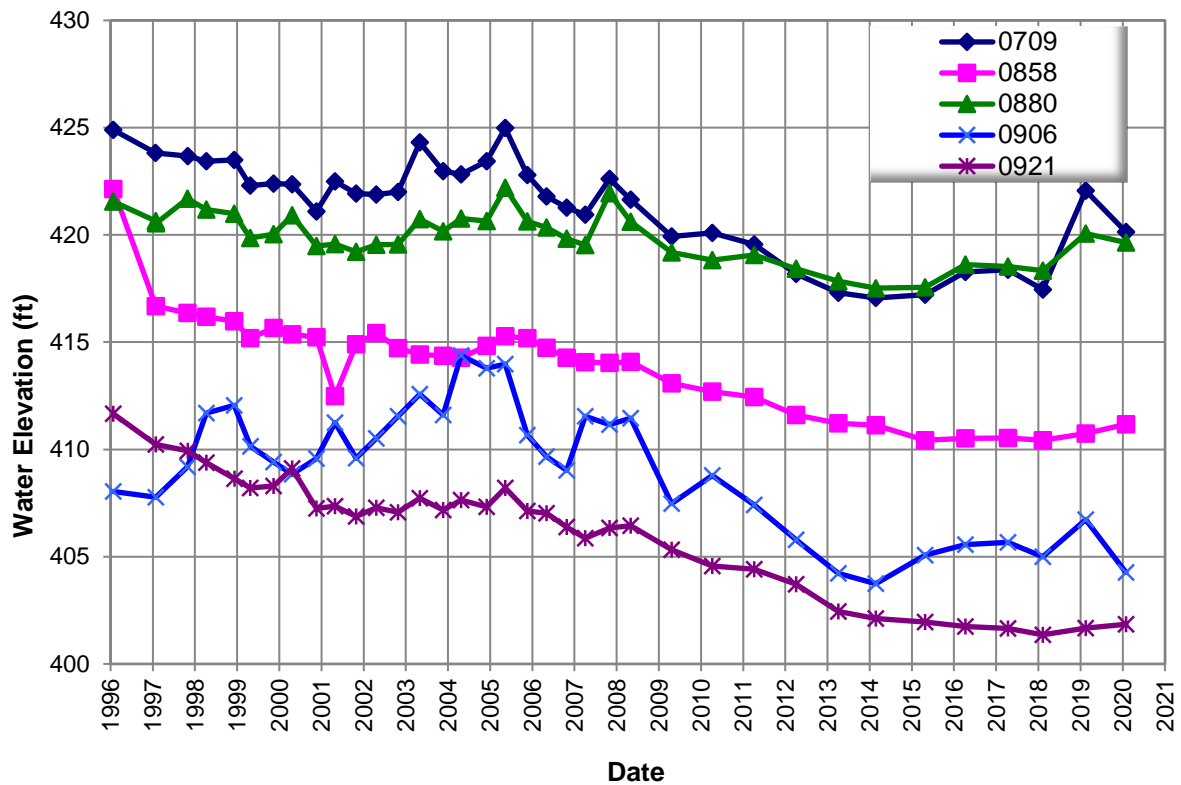
Figure 5-3. Water-Level Measurements at Disposal Cell Performance Monitoring Wells at the Falls City, Texas, Disposal Site

Water levels in all disposal cell performance wells had significant decreasing trends since 1996 based on Mann Kendall trend analyses (Figure 5-3). Water levels in these wells appear to have stabilized since 2014. Wells 0709, 0880, and 0906 have had apparent increase in water level since 2014. Groundwater compliance wells 0862, 0886, and 0963 had significant increasing water level trends since 1996, and wells 0891 and 0924 had no statistically significant trend (Figure 5-4). Wells with increasing water level trends each had a water elevation increase of about 5 ft since 1996.

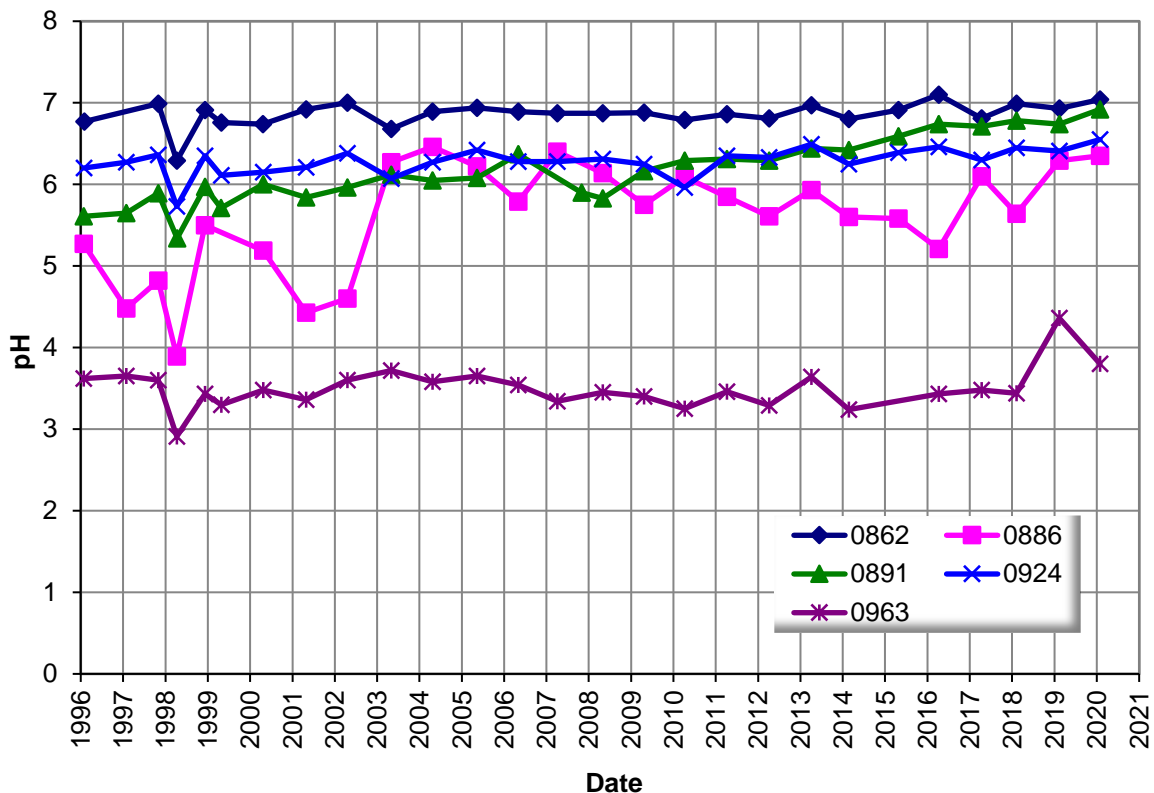
Figure 5-6. pH at Groundwater Compliance Monitoring Wells at the Falls City, Texas, Disposal Site

Statistically significant increasing trends in pH were in wells 0886, 0891 and 0924 since 1996, with no significant trends in wells 0862 and 0963 (Figure 5-6). The 2020 pH levels were within the range of historical values for all groundwater compliance monitoring wells. The pH in monitoring well 0963 historically has been lower than at the other groundwater compliance wells, with a pH of 3.8 in 2020 compared to between 6.0–7.0 in the other wells. Overall, groundwater in well 0963 had a similar pH to that of the tailings pore fluids, even compared to the wells adjacent to the disposal cell.

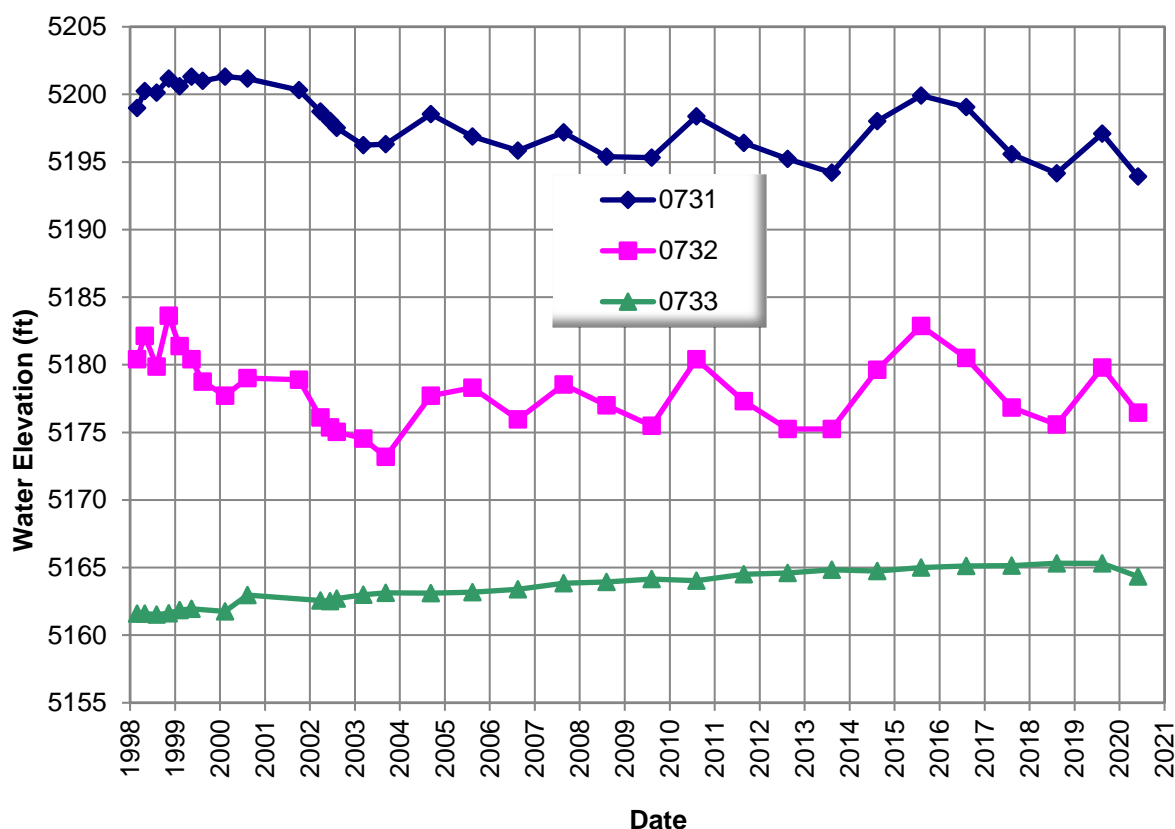
Figure 6-3. Water Level Measurements at the Grand Junction, Colorado, Disposal Site

Static water level measurements are obtained from each monitoring well before water quality samples are collected (Figure 6-3). Water levels in disposal cell monitoring well 0733 generally increased approximately 4 ft since 1998 and has remained lower than the adjacent water levels in the two paleochannel monitoring wells. Groundwater levels in wells 0731 and 0732 remained relatively constant with the same apparent trend in variability, suggesting the two paleochannel systems are influenced by the same upgradient recharge mechanisms. The 2020 sampling occurred in late May, whereas every previous sampling since 2003 occurred in August or early September. Consequently, water level measurements in 2020 may have a seasonal influence in relation to the historical data.

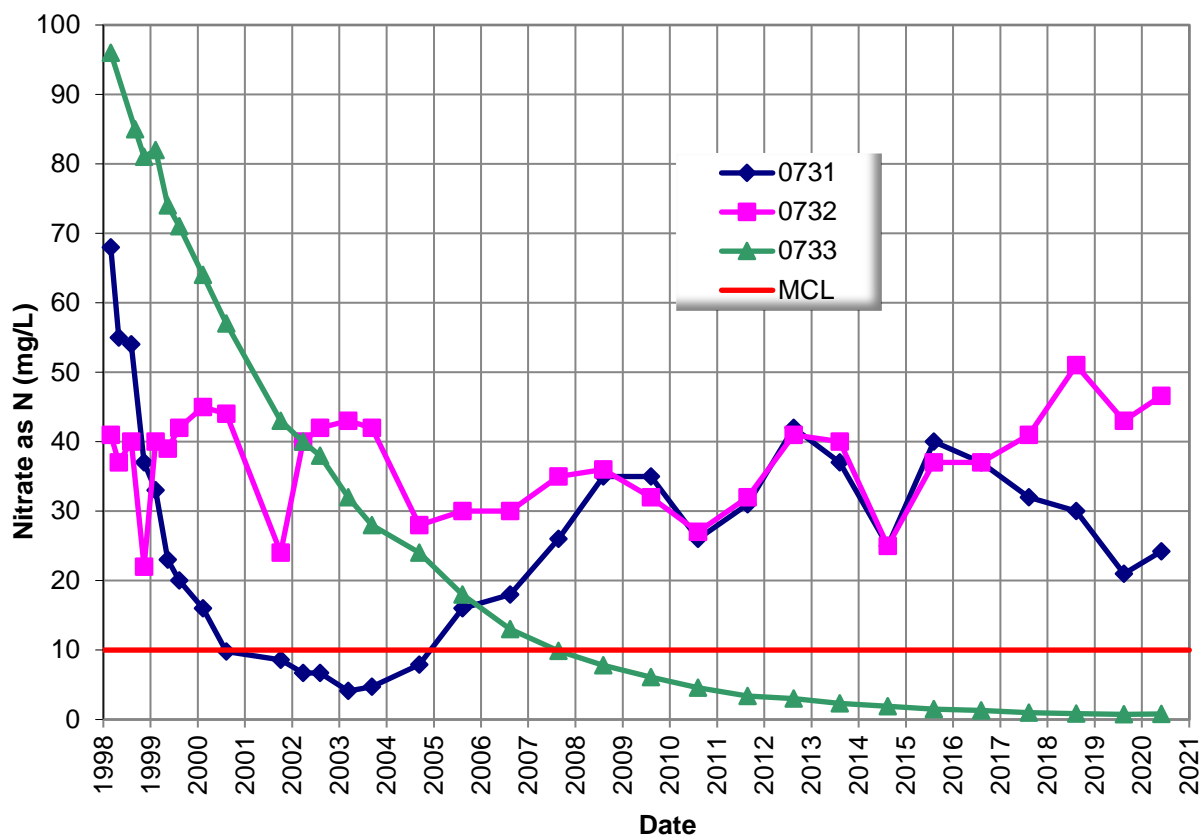
Figure 6-4. Nitrate (as Nitrogen) in Groundwater at the Grand Junction, Colorado, Disposal Site

Nitrate (as nitrogen) concentrations in disposal cell monitoring well 0733 continued to decline from 96 mg/L in 1998 to 0.8 mg/L in 2020, significantly below the MCL of 10 mg/L (Figure 6-4). Nitrate concentrations continued to exceed the MCL of 10 mg/L in the paleochannel monitoring wells 0731 and 0732. Concentrations in monitoring wells 0731 and 0732 increased slightly in 2020, with the concentration in monitoring well 0732 remaining near the historic high value, which is just above 50 mg/L.

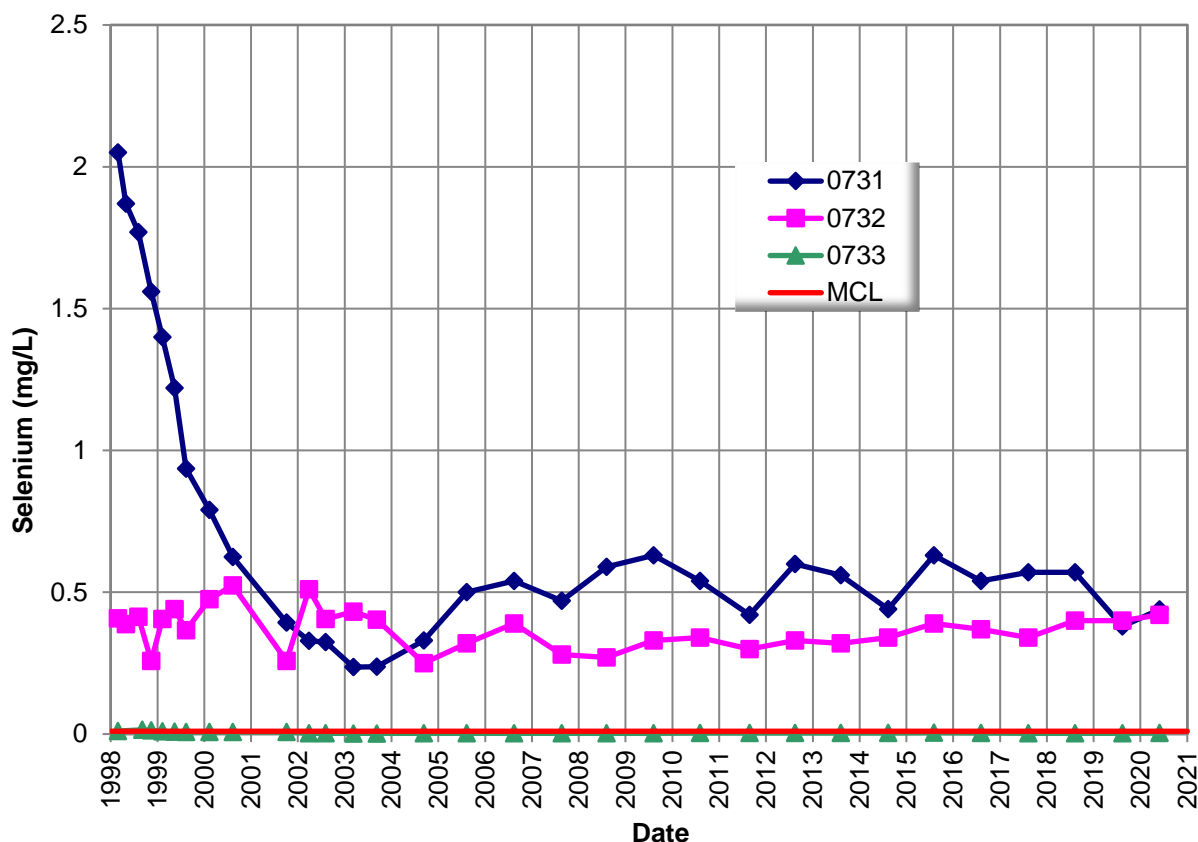
Figure 6-5. Selenium in Groundwater at the Grand Junction, Colorado, Disposal Site

Selenium concentrations continued to exceed the MCL of 0.01 mg/L in the paleochannel monitoring wells 0731 and 0732 (Figure 6-5). Selenium occurs naturally in the Mancos Shale deposits that underlie the disposal cell at concentrations slightly greater than the MCL of 0.01 mg/L. Paleochannel monitoring wells 0731 and 0732 are screened at the Mancos Shale unconsolidated soil contact with the alluvium. Background groundwater quality in these wells is brackish, with elevated TDS levels ranging from 870 to 7010 mg/L; this supports the theory that the shale is the source of the elevated selenium concentrations in both paleochannel monitoring wells. Disposal cell monitoring well 0733 is not screened in the weathered Mancos and selenium concentrations remain below the MCL.

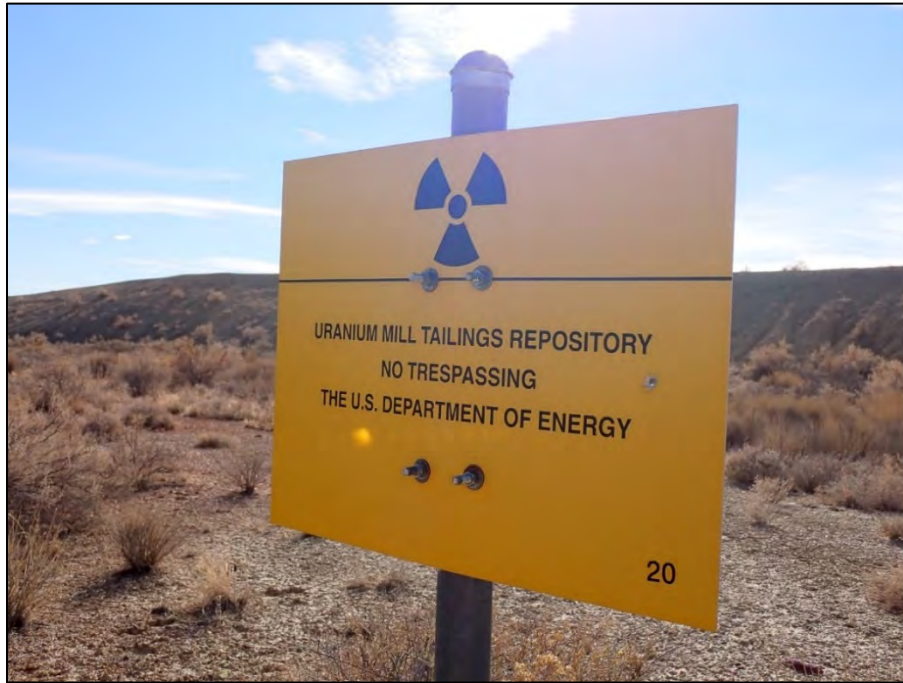
PL-5. Perimeter Sign P20 with Bullet Damage

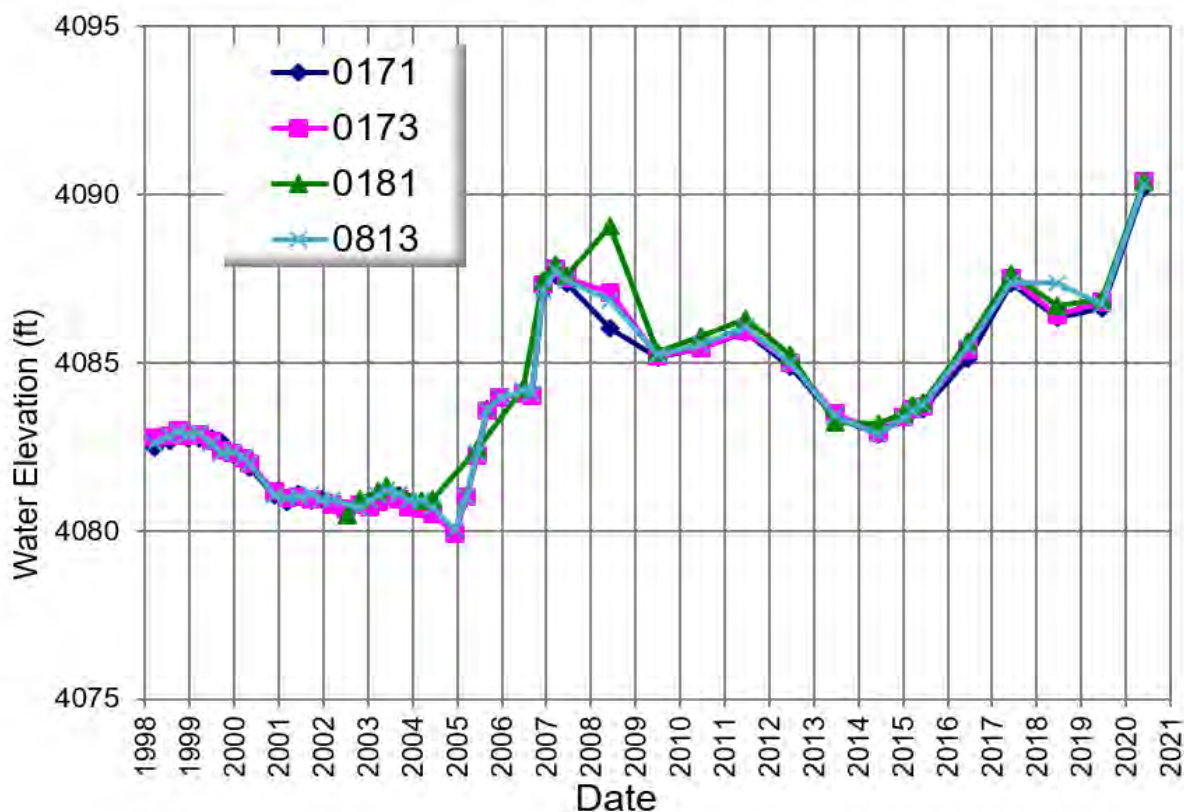
Figure 7-3. Groundwater Elevations at the Green River, Utah, Disposal Site

Water levels have been measured manually every year in the POC wells since 1991. Water levels in the POC wells decreased slightly from 2017 to 2018 (Figure 7-3). Historically, the groundwater levels in these wells decreased approximately 3 ft overall from 1998 through 2004 and then increased approximately 8 ft between 2004 and 2007. Water level decreases ranged from 4 to 5 ft from 2007 through 2014. From 2014 to 2019, the water levels increased to elevations near the 2007 levels.

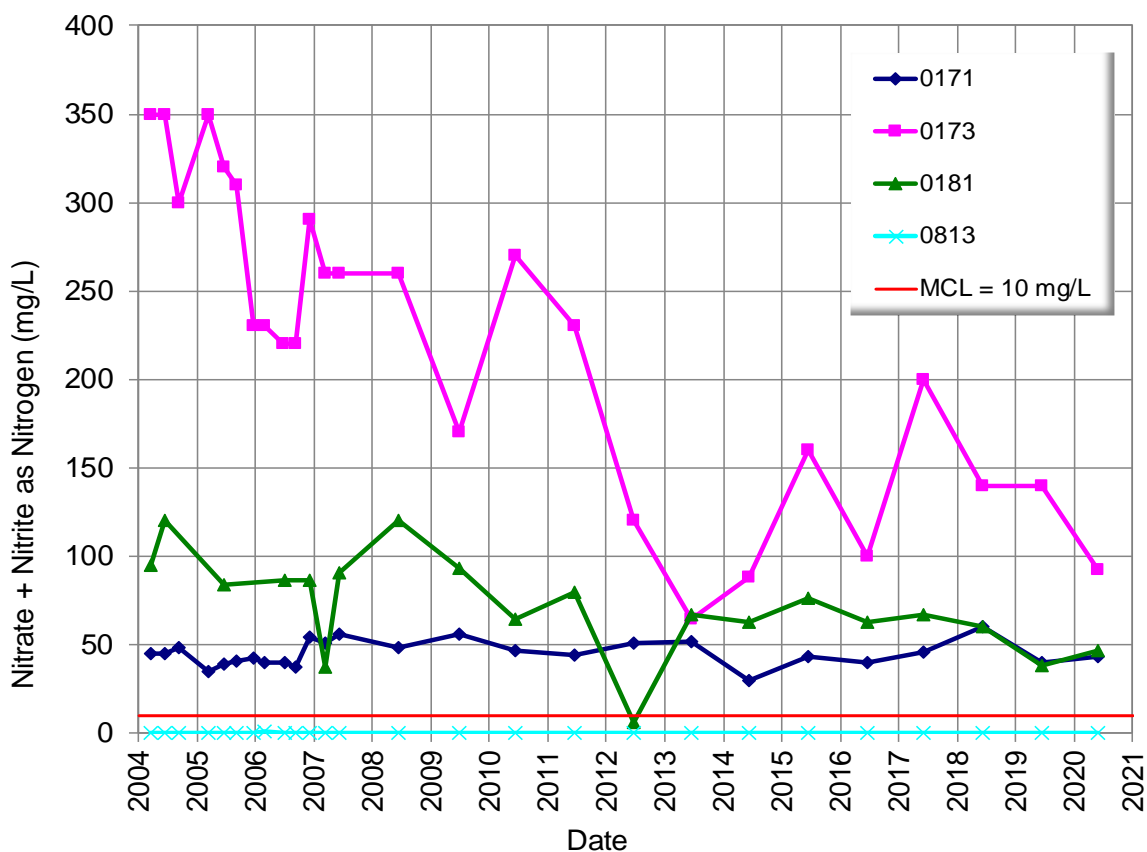
Figure 7-4. Nitrate at Point-of-Compliance Wells at the Green River, Utah, Disposal Site

Nitrate concentrations continue to exceed the MCL in POC wells 0171, 0173, and 0181. The 2020 nitrate concentrations were within the range of historical values for all POC wells (Figure 7-4).

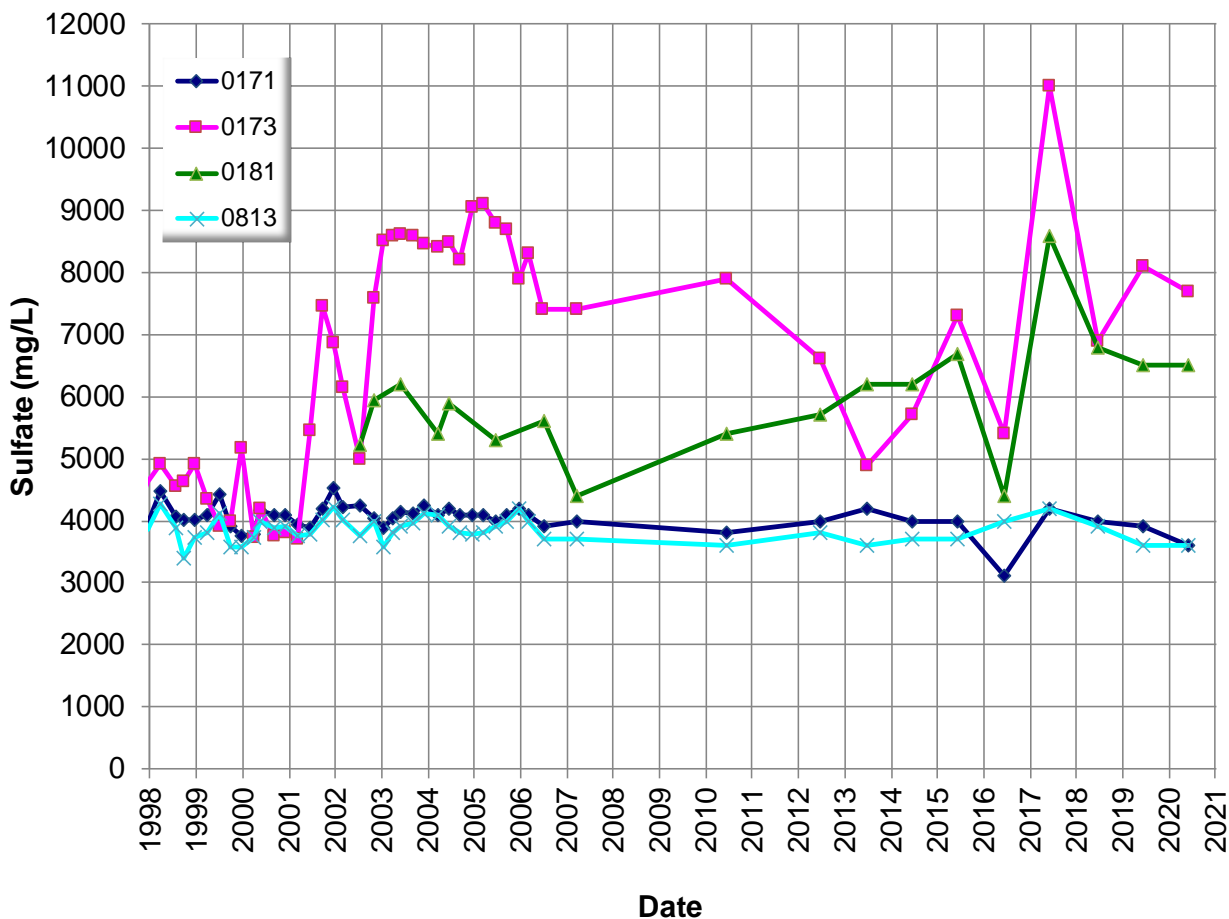
Figure 7-5. Sulfate at Point-of-Compliance Wells at the Green River, Utah, Disposal Site

Sulfate concentrations exceeded the LTSP background concentrations in all POC wells (Table 7-3) except POC well 0813. The 2020 sulfate concentrations were within the range of historical values for all POC wells (Figure 7-5).

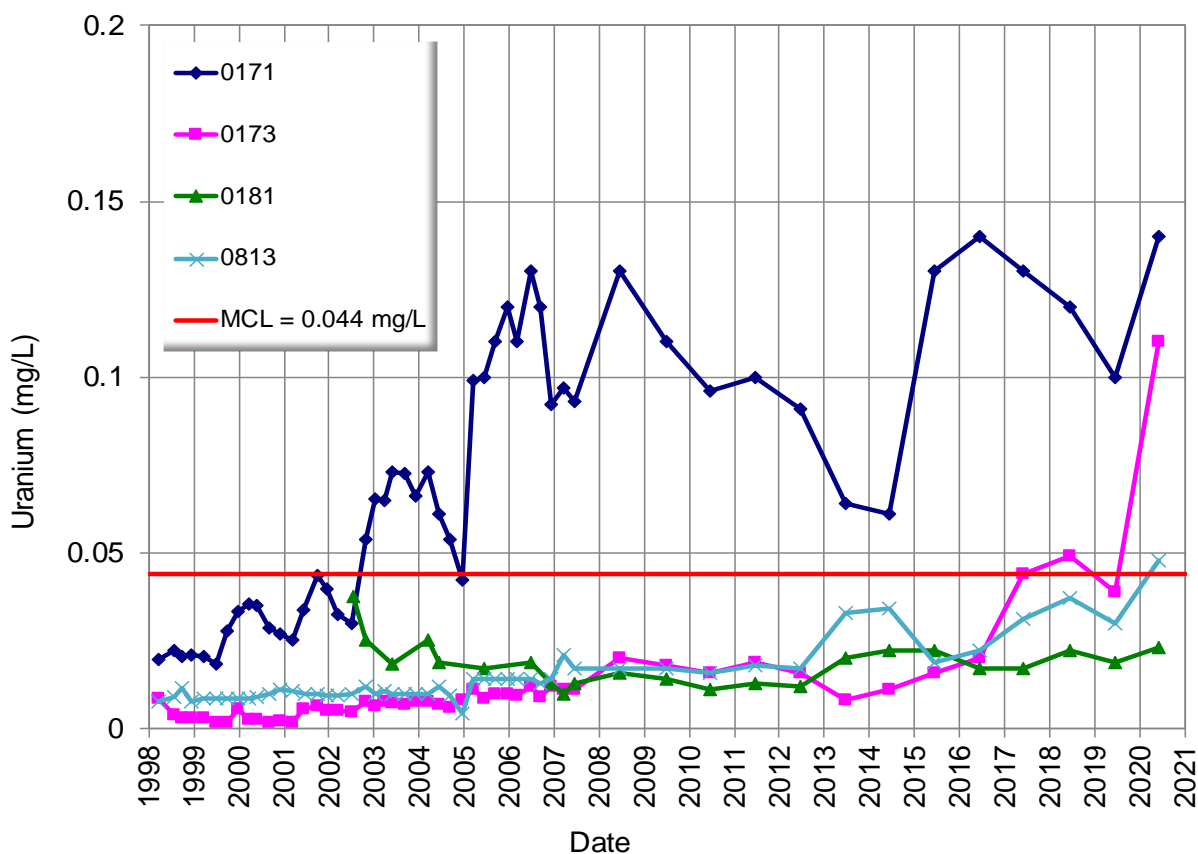
Figure 7-6. Uranium at Point-of-Compliance Wells at the Green River, Utah, Disposal Site

Uranium concentrations in POC well 0171 routinely exceed the UMTRCA and LTSP concentration limits, while the other POCs remain mostly below the MCL. Well 0173 exceeded 0.044 mg/L in 2018 and 2020 (Figure 7-6). Well 0181 remains below the uranium concentration limit. The uranium concentration at well 0813 exceeded the standard for the first time in the 2020 event. Uranium concentrations in POC well 0171 have varied considerably, ranging from a low of 0.0184 mg/L in 1999 to a high of 0.14 mg/L in 2016. The 2020 uranium concentrations are within the range of historical values in POC wells 0171 and 0181 and exceed the highest historical values in POC wells 0173 and 0813.

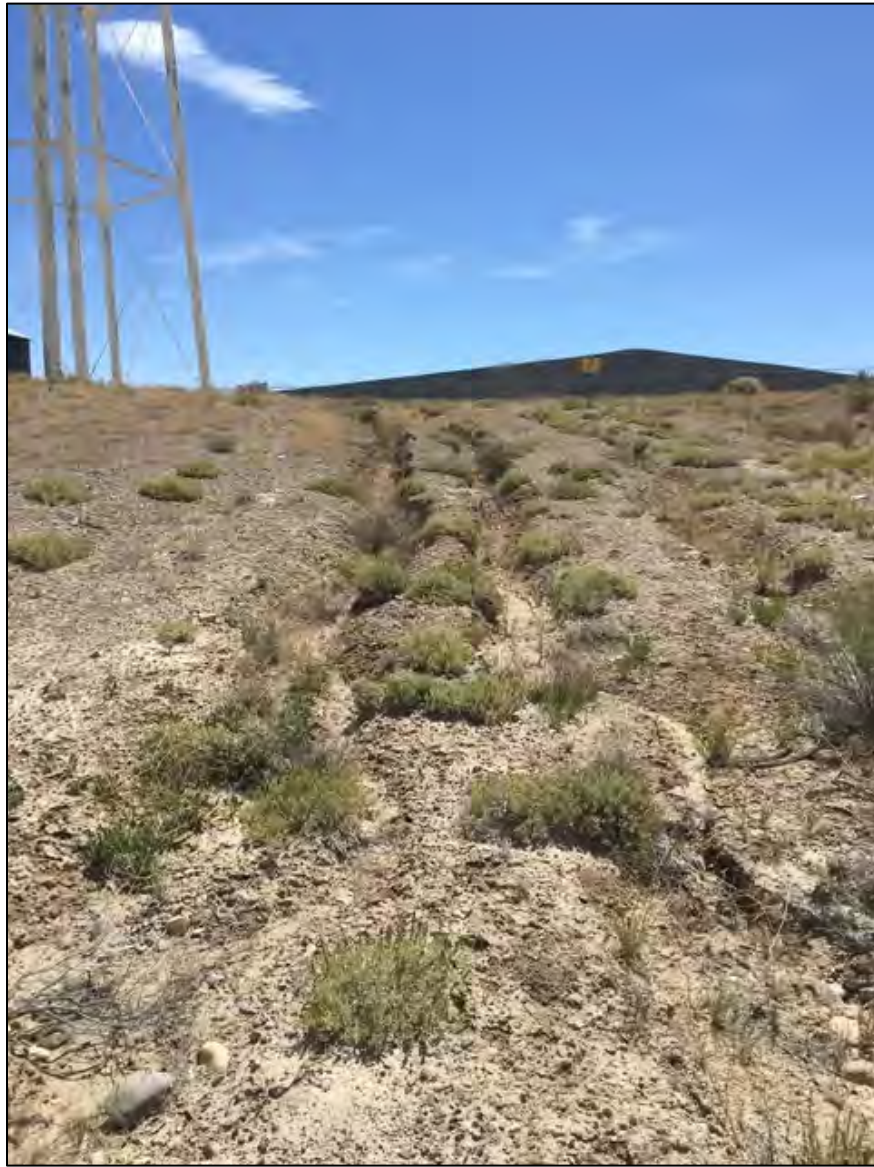
PL-11. Gullies Downslope of Water Tower (Offsite)

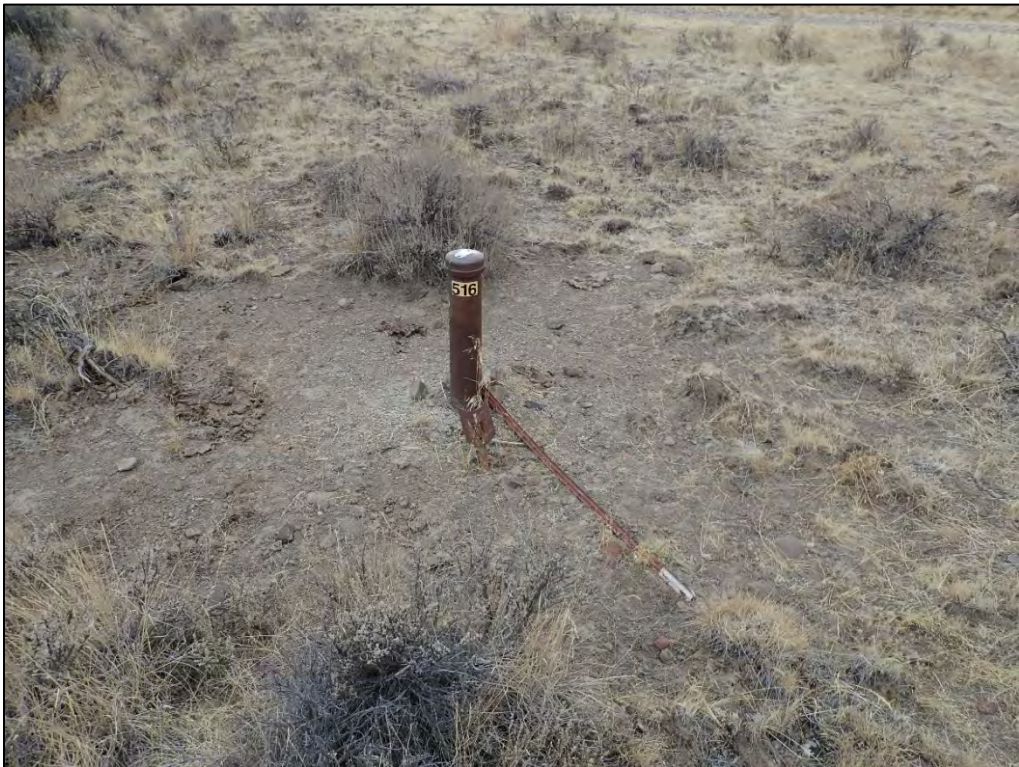
PL-6. Broken T-Post near Monitoring Well 0516

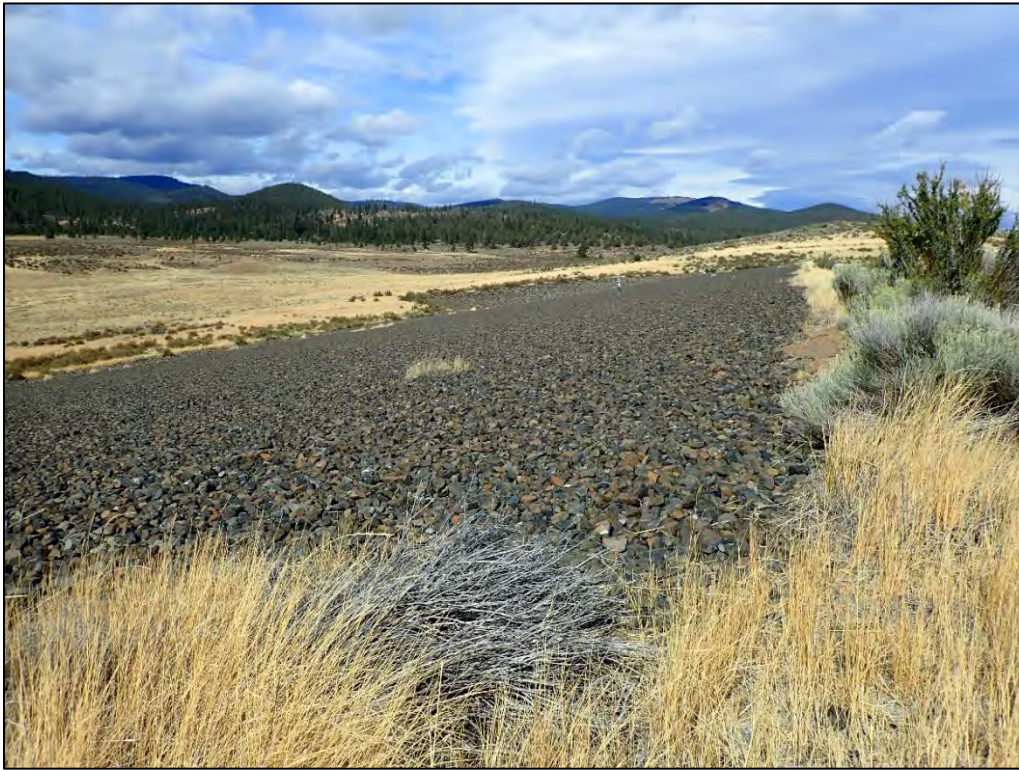
PL-7. Contact Boundary West Side Slope and South Top Corner with Encroaching Vegetation

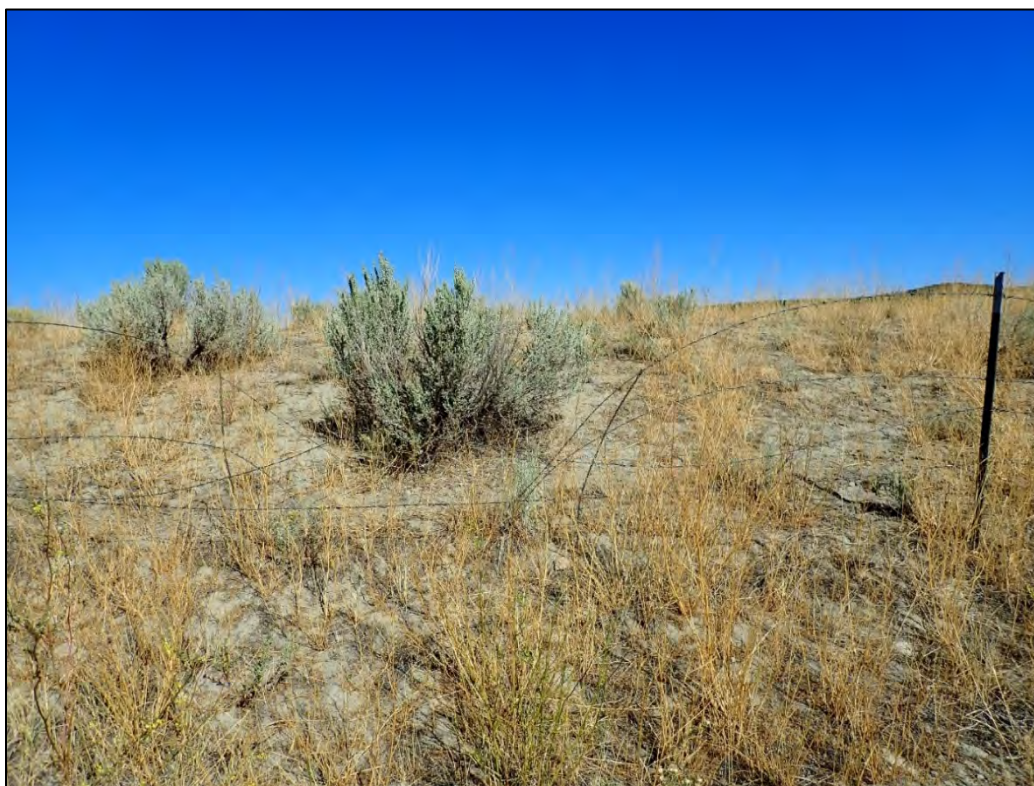
PL-2. Broken Fence Strands Along Northern Perimeter Fence

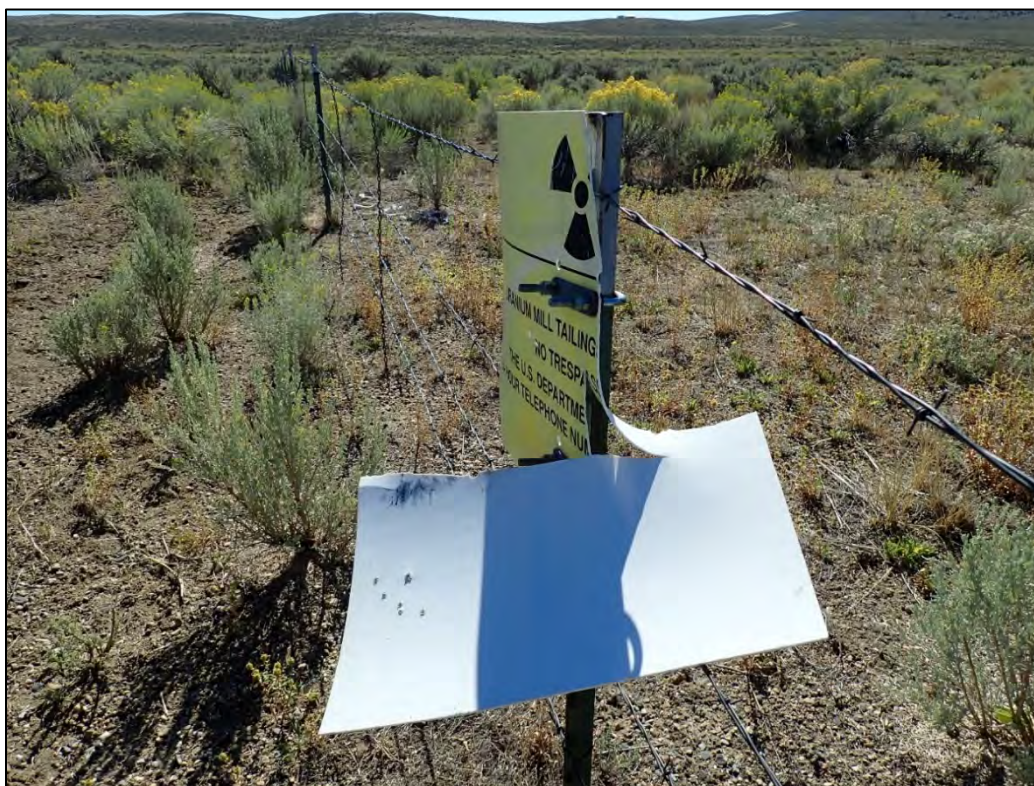
PL-4. Damaged Perimeter Sign P25

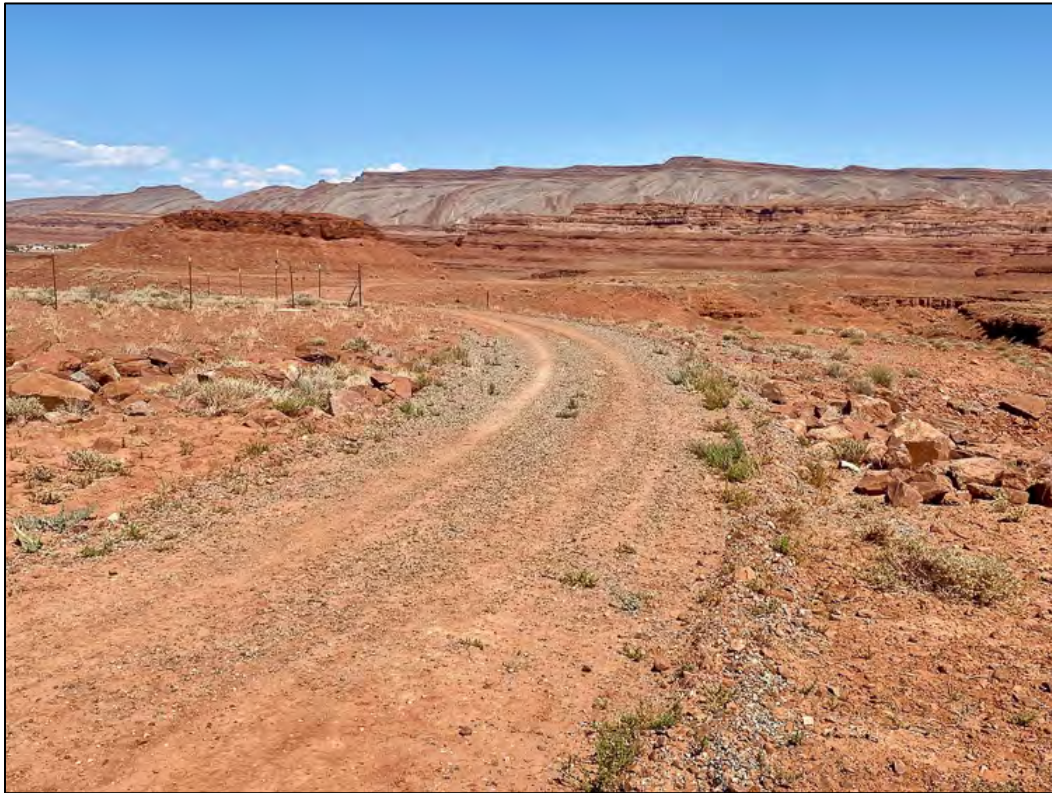
PL-13. Road Repair Area

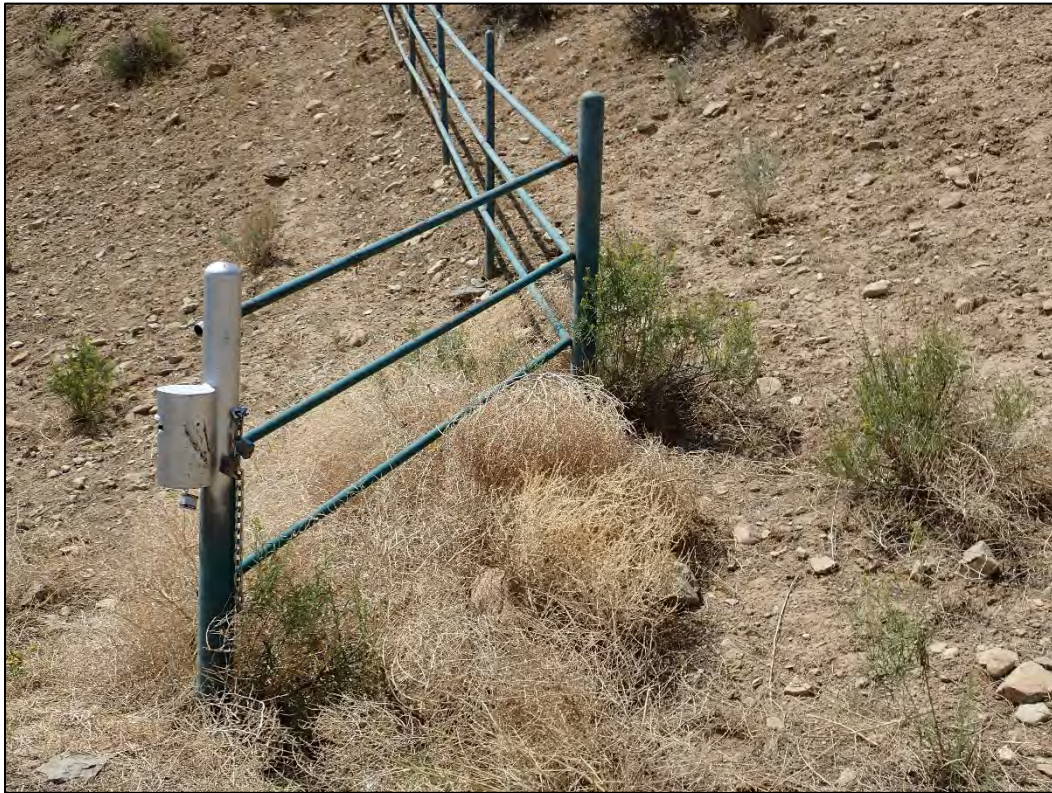
PL-1. Tumbleweed Accumulation Near Outer Gate

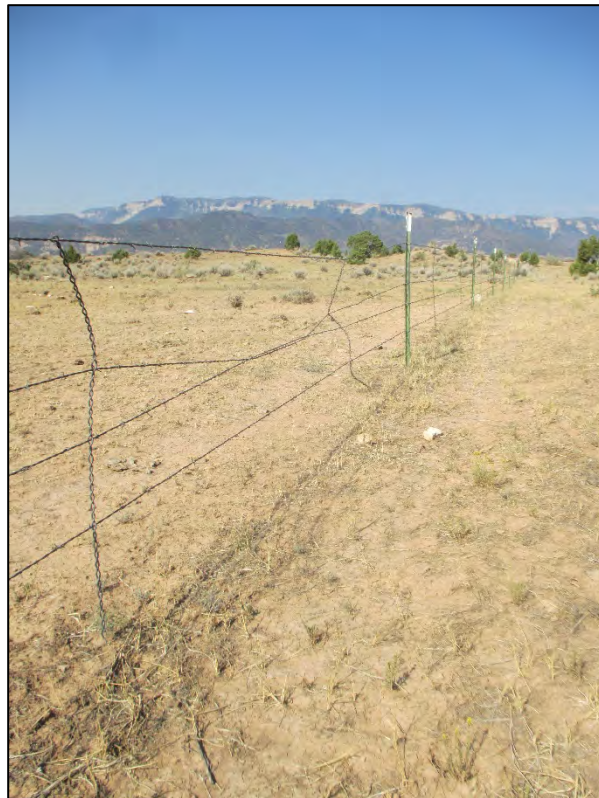
PL-2. Fence Damage

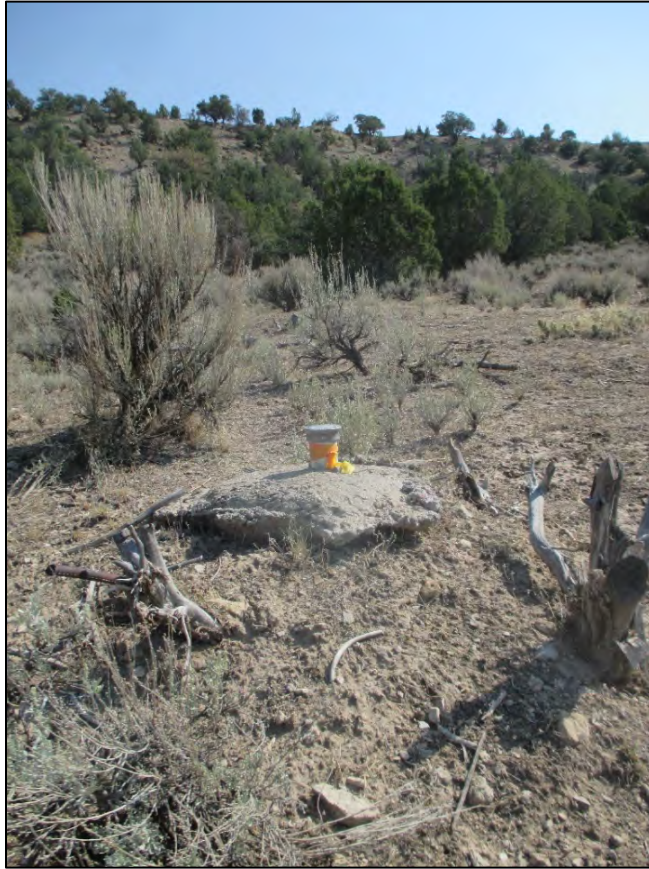
PL-3. Boundary Monument BM-18 with Undercutting

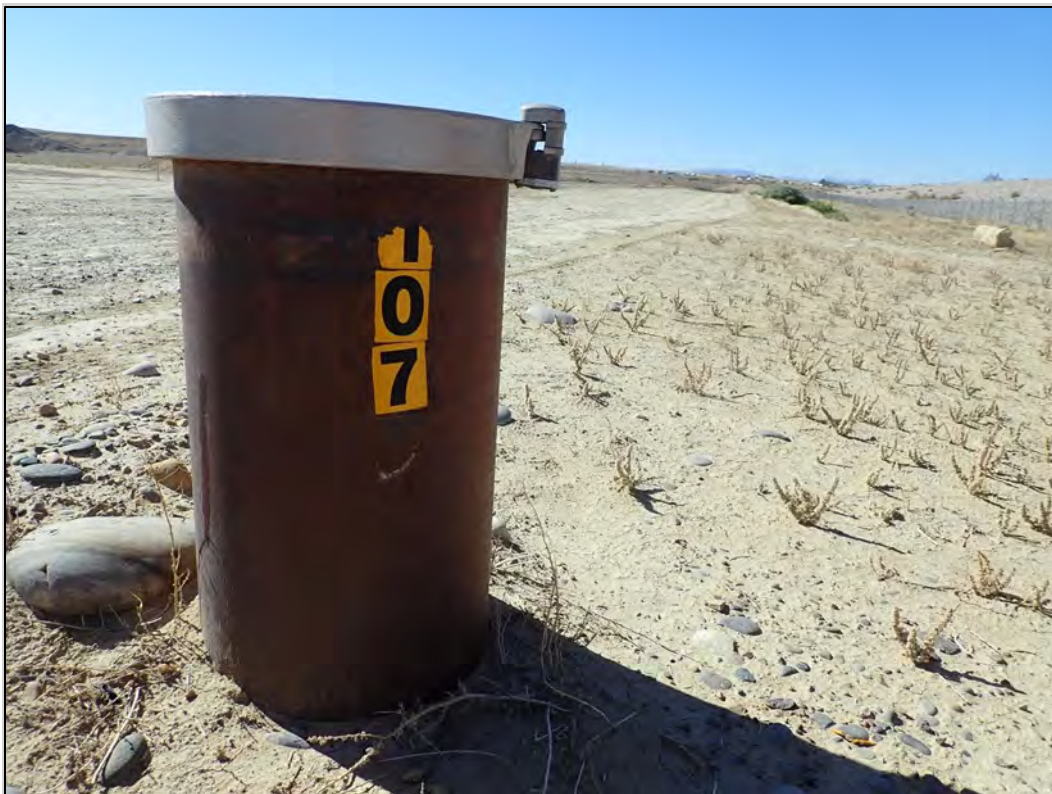
PL-8. Missing ID Stickers on Monitoring Well 1074
