LaSalle County Station, Unit 2
Renewed Facility Operating License No. NPF-18
NRC Docket No. 50-374

Subject: Relief Request I4R-12 Relief from Code Examinations for 2B33-F060A and 2B33-F060B Repairs

**Relief Request I4R-12 Associated with Alternative Examination Requirements for
Repair of Reactor Recirculation Flow Control Valves 2B33-F060A and 2B33-
F060B, Revision 1**

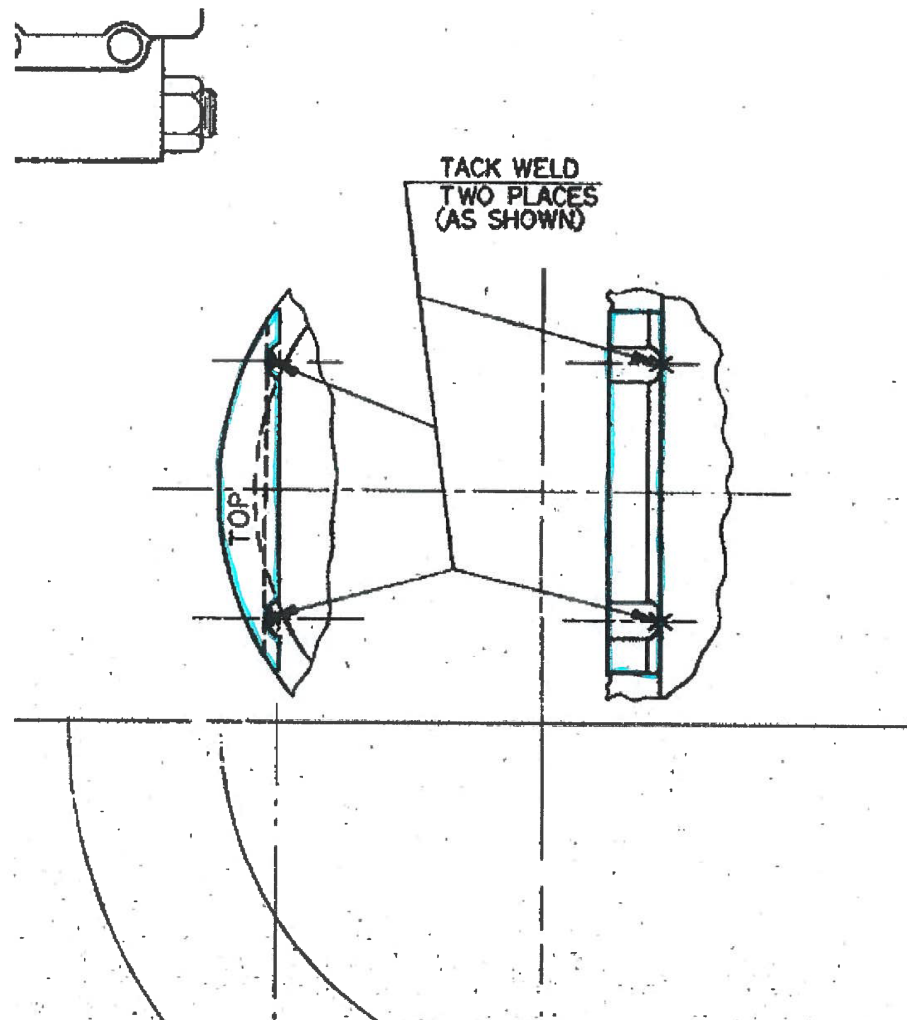
Drawings of the 2B33-F060A and 2B33-F060B valves are provided in Attachment 2. Figures I4R-12-1 and I4R-12-3 are the drawings of the entire valve assembly, including the actuator for 2B33-F060B and 2B33-F060A, respectively. Figure I4R-12-2 is a close-up drawing of the area of the 2B33-F060B valve body in question. Figure I4R-12-2 is highlighted in orange for the lower guide plug, blue for the guide plug anti-rotation segment, and yellow as the estimated area of wear in the valve body where material is missing due to the lower guide plug impact on the valve body. Figure I4R-12-4 is a close-up drawing of the area of the 2B33-F060A valve body in question. Figure I4R-12-4 is highlighted in yellow as the estimated area of wear in the valve body where material is missing due to the lower guide plug impact on the valve body.
