SUBJECT: TRANSMITTAL OF FINAL NORTH ANNA POWER STATION, UNIT 1 –
ACCIDENT SEQUENCE PRECURSOR REPORT (LICENSEE EVENT
REPORT 338-20-001)

ASP Analysis for LER 338-20-001

Accident Sequence Precursor Program – Office of Nuclear Regulatory Research		
North Anna Power Station, Unit 1	Degraded Upper Cylinder Piston Pin Bushing Discovered during Maintenance Activities on Emergency Diesel Generator	
Event Date: 2/18/2020	LER: 338-20-001 IR: 05000338/2020003	ΔCDP = 5×10^{-6}
Plant Type:	Westinghouse Three-Loop Pressurized Water Reactor (PWR) with a Large, Dry Containment	
Plant Operating Mode (Reactor Power Level):	Mode 1 (100% Reactor Power)	
Analyst: Gary Wang	Reviewer: Chris Hunter	Completion Date: 3/2/2021

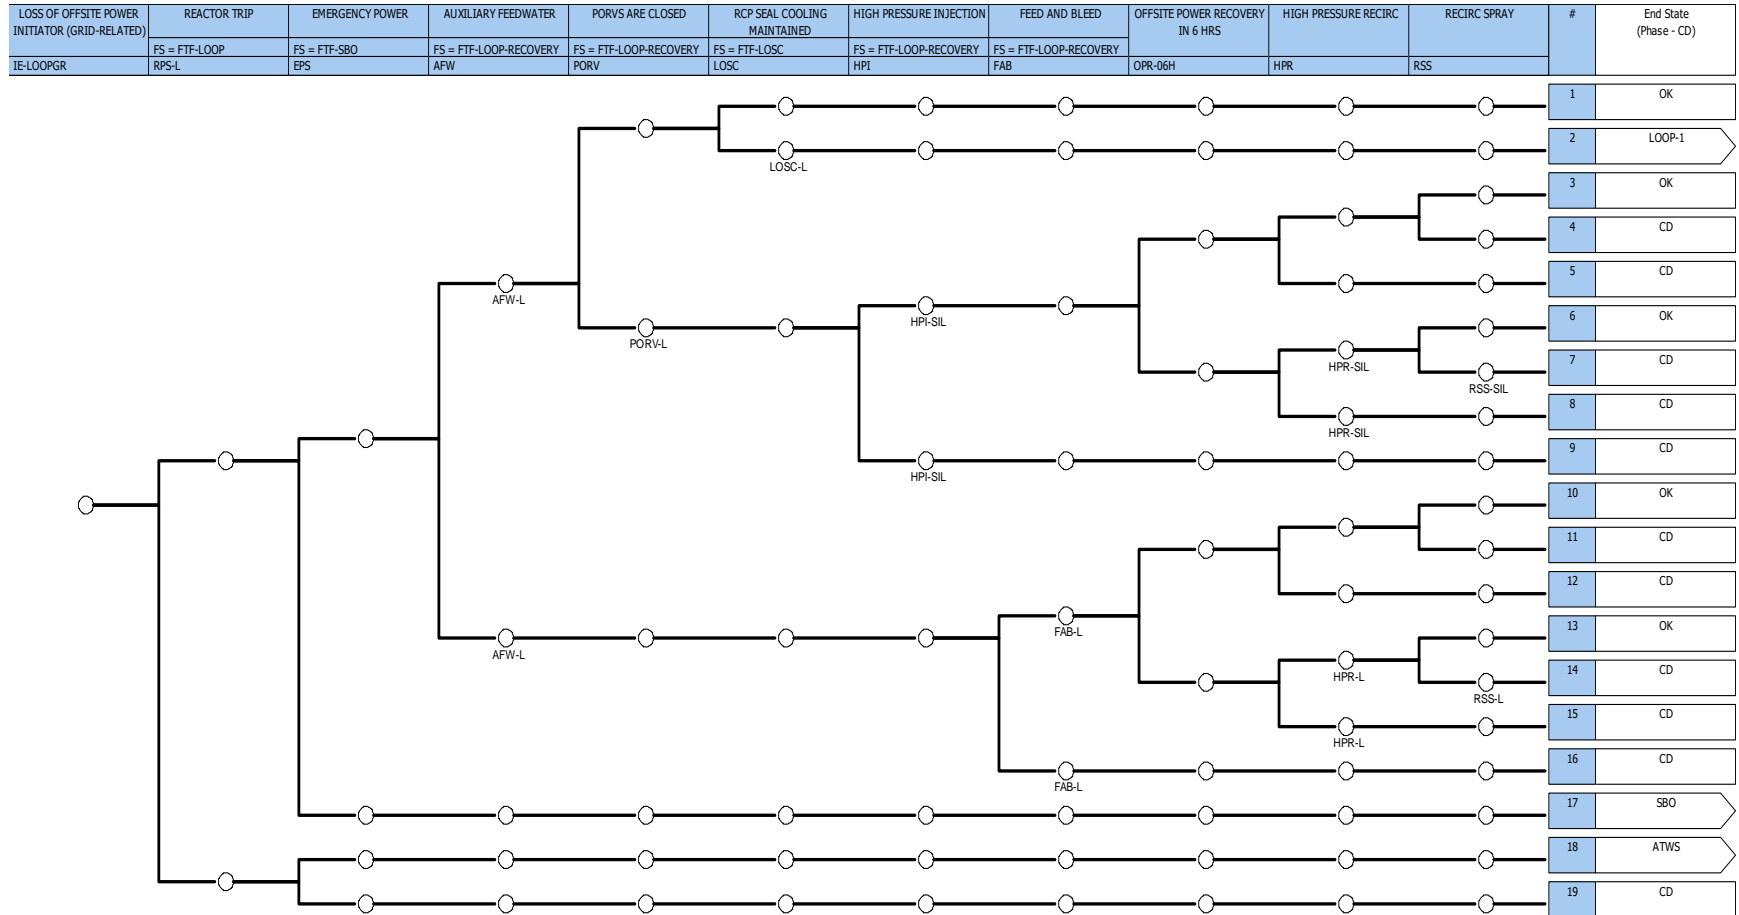
Figure A-1. North Anna LOOP Event Tree

The dominant accident sequence is LOOP sequence 17-12 ($\Delta\text{CDP} = 1.0 \times 10^{-6}$, which contribute approximately 31 percent of the total ΔCDP . The dominant sequences are shown in the table below and graphically in Figures A-1 and A-2 in [Appendix A](#). Accident sequences that contribute at least 5 percent of the total ΔCDP .

Sequence	ΔCDP	%	Description
LOOP 17-12	1.0×10^{-6}	31.0%	LOOP initiating event; emergency power system failure results in SBO; AFW fails; operators fail to restore AC power within 1 hour results in core damage.
LOOP 17-03-03	9.8×10^{-7}	30.5%	LOOP initiating event; emergency power system failure results in SBO; AFW successfully operates; operators fail to restore AC power prior to normal battery depletion (2 hours); operators declare ELAP; FLEX diesel generators successfully charge batteries; FLEX SG pumps successfully provide inventory makeup to the SGs; FLEX reactor coolant system (RCS) makeup pumps fail; core damage is assumed if operators fail to restore AC power within 24 hours.
LOOP 17-03-09	4.5×10^{-7}	14.0%	LOOP initiating event; emergency power system failure results in SBO; AFW successfully operates; operators fail to restore AC power prior to normal battery depletion (2 hours); operators declare ELAP; FLEX diesel generators fail to charge batteries is assumed to result in core damage (no credit for continued operation of AFW without DC power is provided).

LOOP 17-06	2.0×10^{-7}	6.3%	LOOP initiating event; emergency power system failure results in SBO; AFW successfully operates; reactor coolant pump (RCP) seal failure results in loss-of-coolant accident (LOCA); operators fail to restore AC power within 1 hour results in core damage.
