DOMINION ENERGY NUCLEAR CONNECTICUT, INC.
MILLSTONE POWER STATION UNIT 2
RESPONSE TO REQUEST FOR ADDITIONAL INFORMATION FOR PROPOSED
LICENSE AMENDMENT REQUEST TO REVISE THE MILLSTONE UNIT 2
TECHNICAL SPECIFICATIONS FOR STEAM GENERATOR INSPECTION
FREQUENCY

**Response to Request for Additional Information for the
Proposed LAR to Revise TSs for Steam Generator Inspection Frequency**

**MILLSTONE POWER STATION UNIT 2
DOMINION ENERGY NUCLEAR CONNECTICUT, INC.**

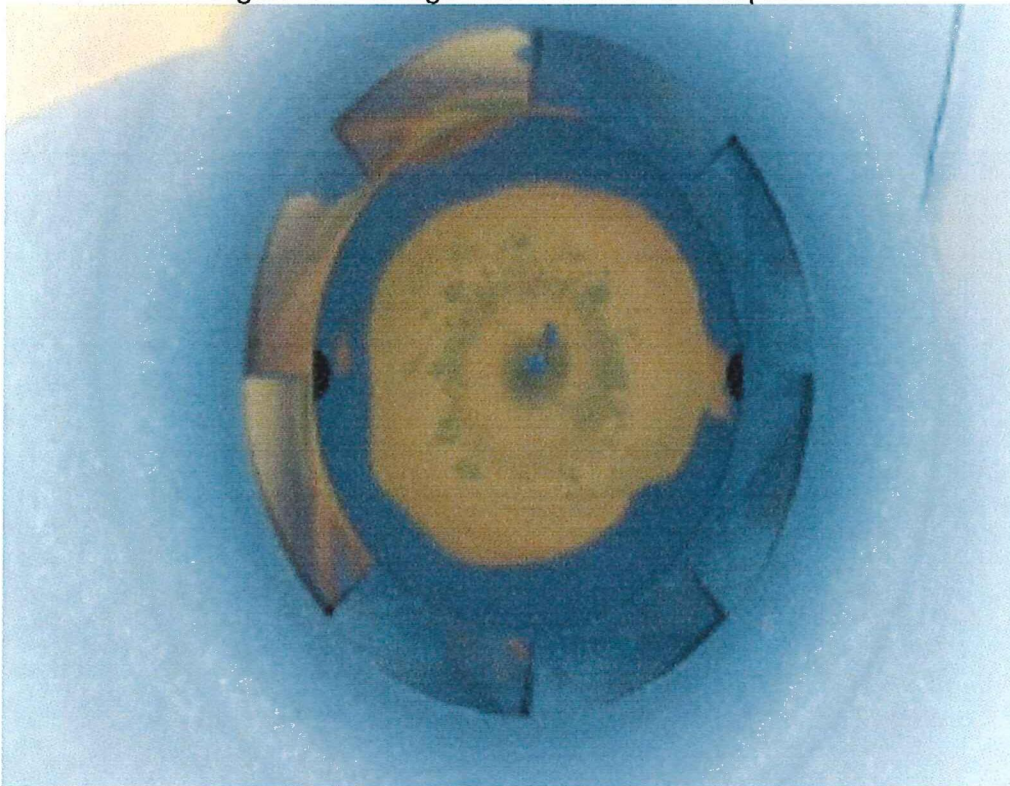
up at the baseplate from below the secondary deck). Some regions of the separators exhibit a lack of magnetite, with no apparent loss of material thickness. This occurs most notably on the lower cylinder sidewalls and skimmer slots and occurs to a lesser extent on the baseplates and swirl vanes. These are the locations where the formation of orange oxides has been noted. These findings affect a small population of the secondary separators, mostly on the hot-leg side of the SGs. Figures 1 thru 4 below provide examples of these locations:

Figure 1 – Orange Oxide on SG-2 Baseplate

Video images were obtained of all secondary separators from above the secondary deck during EOC25. Of the 170 separators (per SG) inspected, approximately 25 showed a lack of tightly adhering magnetite (as evidenced by orange discoloration). Where discoloration was observed on the skimmer vanes, lower cylinder assembly sidewalls, swirl vanes, or baseplates, the visual inspectors scrutinized the discolored location for evidence of perforations or visible material loss. No perforations or visible material loss were evident, and the affected sidewalls and baseplates were smooth.

The contracted TIE reached the conclusions documented in Reference 4 based on review of still images of the discolored secondary separators. Minor material loss is difficult to assess based on photo images alone, and concluding that the existence of orange oxide represents "evidence of early state flow assisted corrosion" is considered an overly conservative conclusion by DENC, as the existence of orange oxide alone does not indicate a condition that is either unsatisfactory or degraded.

In the unlikely event that perforations develop in the future, they are not expected to significantly affect moisture carryover and will not affect the structural integrity of the secondary separators due to the robust design aspects of the MPS2 SGs. DENC intends to continue to monitor the condition of the MPS2 secondary separators each inspection interval through visual inspection and implement more quantitative methods to monitor material degradation as warranted by visual inspection results.

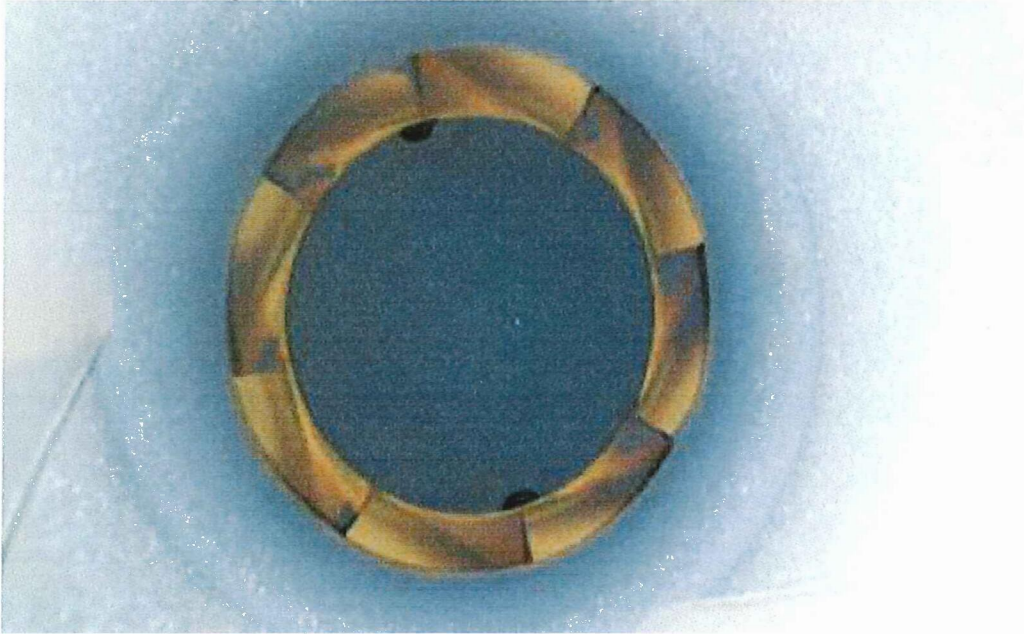
Figure 2 – Orange Oxide on SG-1 Swirl Vanes

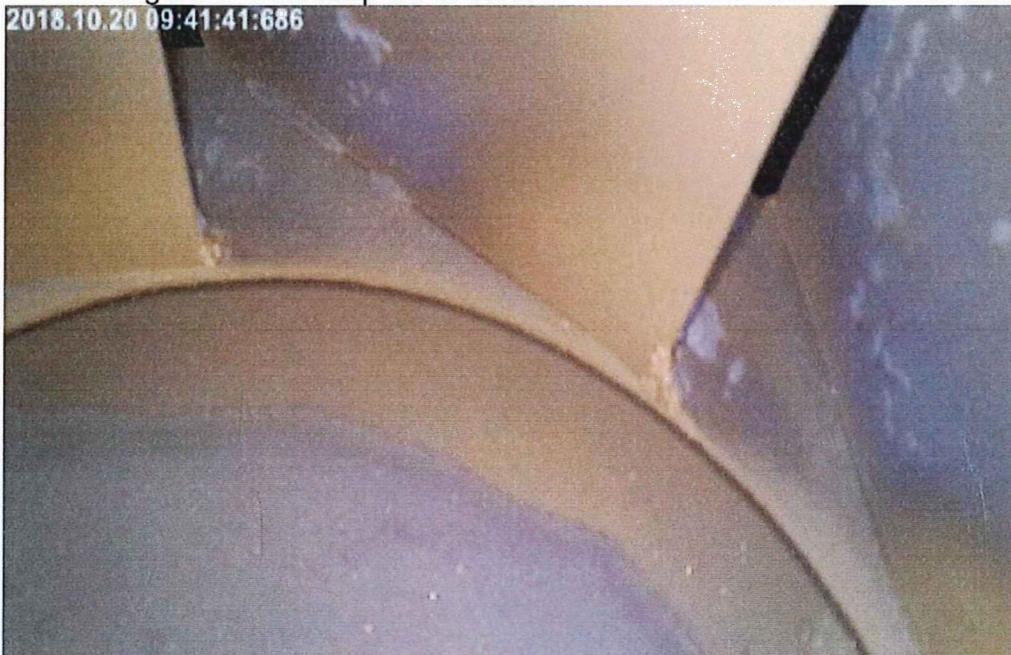
Figure 3 – Closeup SG-2 Visual Examination from EOC25

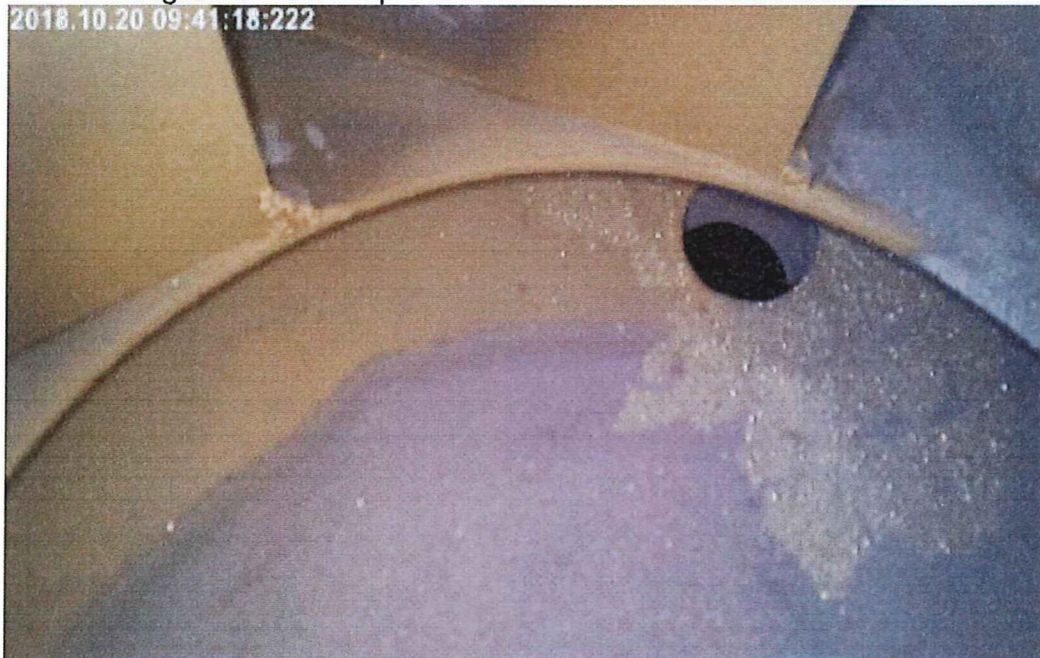
Figure 4 – Closeup SG-2 Visual Examination from EOC25

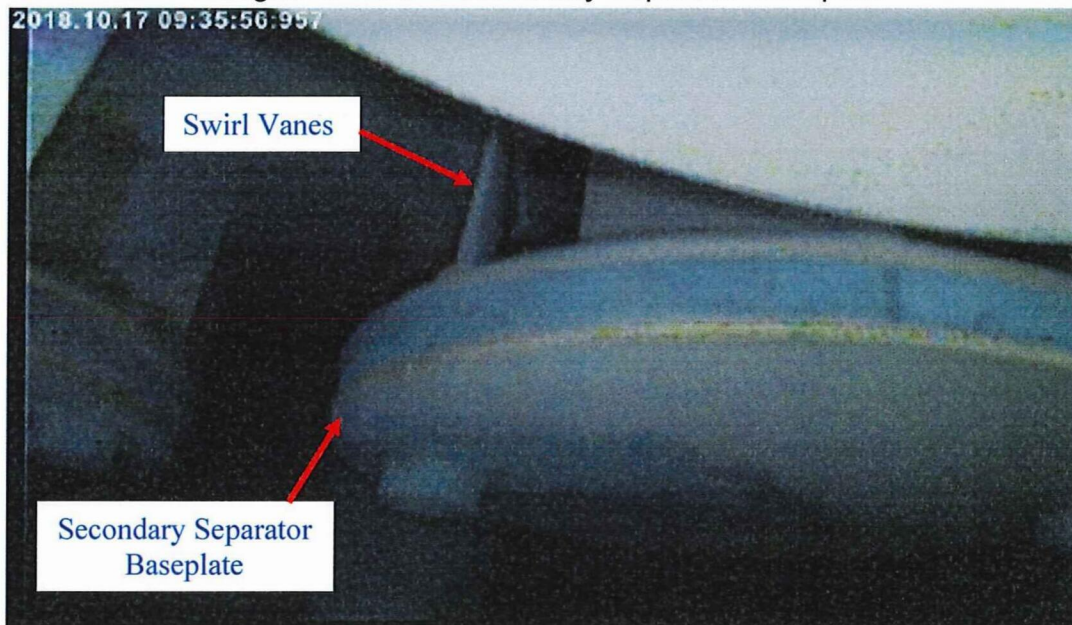
According to the SG manufacturer (BWXT), the robust design of MPS2 secondary separators makes them less susceptible to perforation resulting from baseplate degradation when compared to other secondary separator designs. Figure 5 and Figure 6 below show the robustness of the MPS2 secondary separator baseplates.

Figure 5 – SG-1 Secondary Separator Baseplate

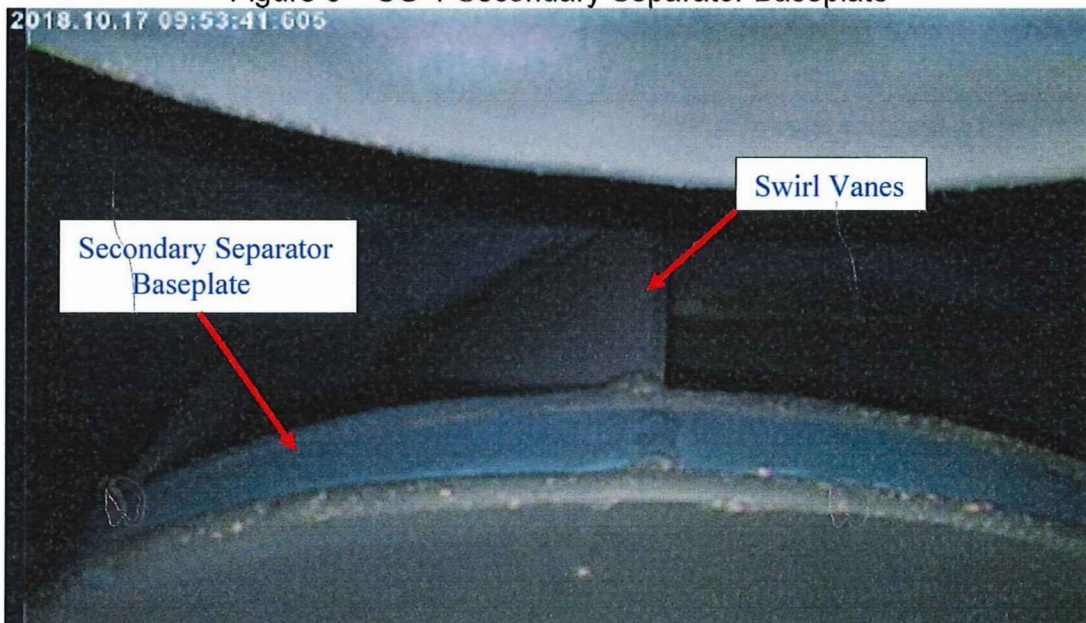
Figure 6 – SG-1 Secondary Separator Baseplate
