**Technical Letter Report
TLR-RES/DE/CIB-2021-06**

**Technical Assistance to Review American Society of
Mechanical Engineer's Boiler and Pressure Vessel Code
Case and Licensee Relief Requests for Carbon Fiber Repairs
Task-3: Mockup Testing and Physical Evaluation of Proposed
Carbon Fiber Reinforced Polymer Repair
Technical Letter Report**

Engineering Mechanics Corporation of Columbus (Emc²)
3518 Riverside Drive - Suite 202
Columbus, OH 43221-1735

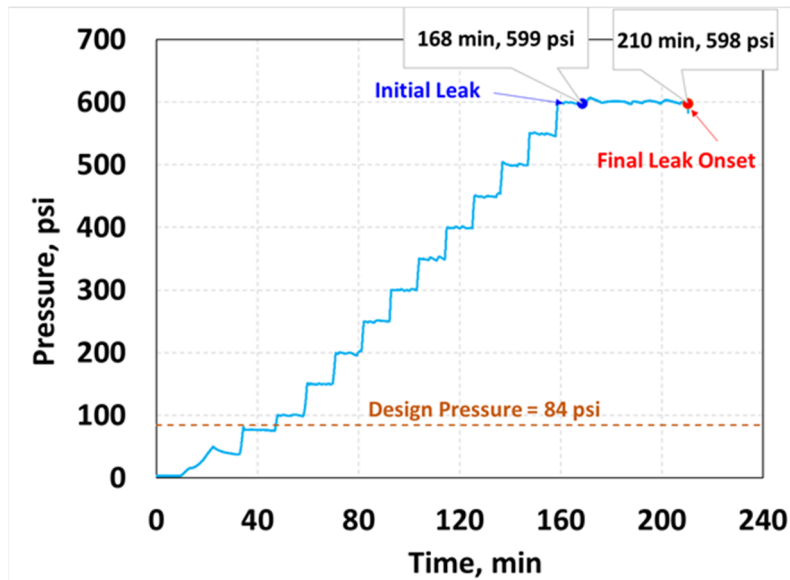
Figure 29 shows the pressure versus time plot for the full-scale hydrostatic test which took about four hours to complete. As seen in the figure, the onset of initial leak started at 600 psi after about 168 minutes. At initial failure, a low energy water leak occurred through a small pinhole near the edge of the cut-out between Corner 1 and 4 as shown in Figure 30 (a). After initial leak, the pressure was held at 600 psi (leak pressure) for another 40 minutes when a significant cracking noise in the matrix was heard followed by the observation of several pinhole type leaks in the area between Corner 1 and 2 as shown in Figure 30 (b). At this stage, the pressure started to drop and at around 580 psi, the release valve was opened to quickly drain the water to preserve the failure modes in the CFRP for post-test analysis. This failure was designated as final leakage failure. The failure mode for the full-scale hydrostatic test with CFRP repair was designated as a “leak” preceded by significant matrix cracking noise, and the failure (leak) pressure for this test was 600 psi. A summary video of the full-scale hydrostatic test is also attached with the report.

Figure 29 Pressure versus time data from the full-scale hydrostatic test

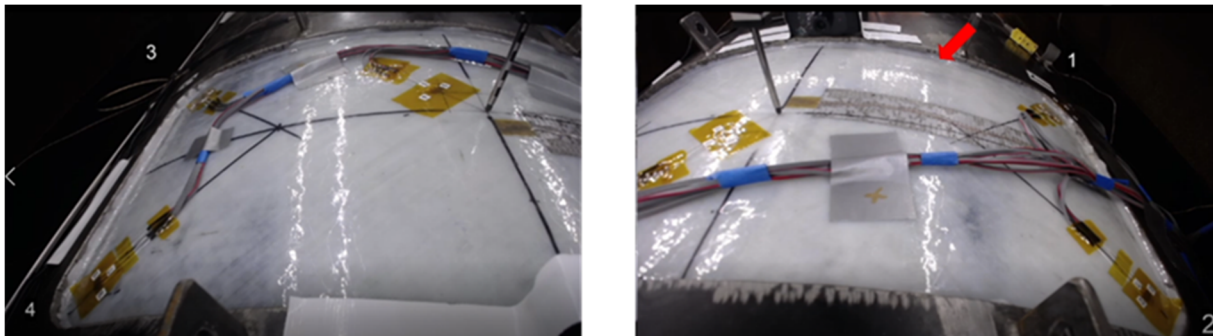
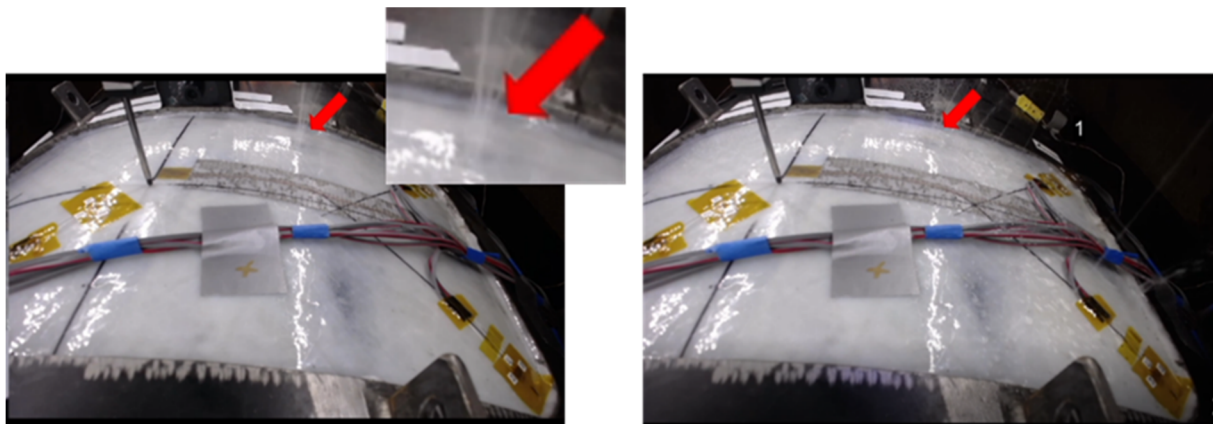
Figure 30 Onset of initial and final leak during the hydrostatic test

(a) Onset of initial leak

(b) Onset of final leak

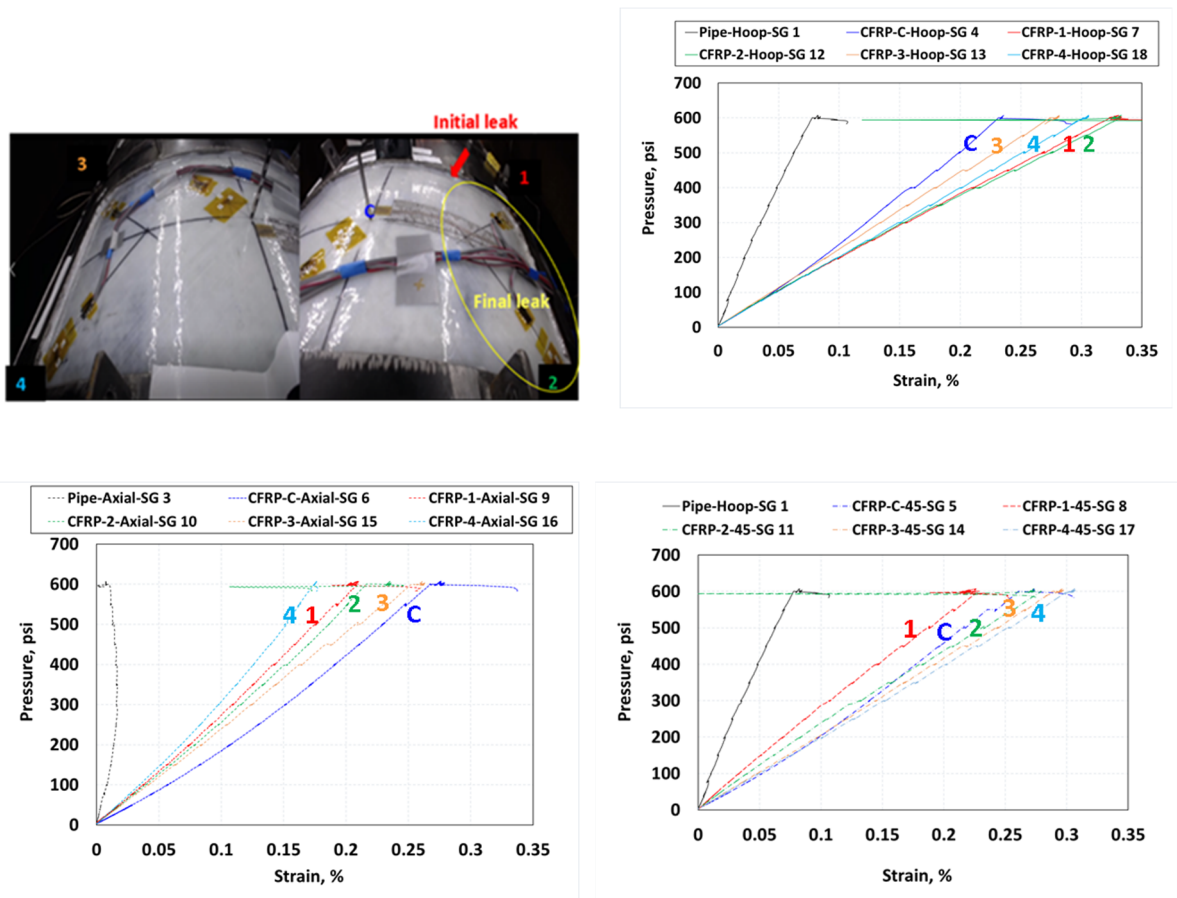
Strain gage data on both host steel pipe and CFRP system as a function of pressure is shown in Figure 33. Figure 33(a) shows the photograph of CFRP repair system through cut-out indicating the locations of initial and final leak as well as the identifications of four corners where strain gages were mounted. Figure 33 (b), (c), and (d) show pressure versus strain plots for host steel pipe and four corners of CFRP in hoop, axial, and 45° directions respectively. As seen in the figure, strain values were less than 0.1% for both axial and hoop directions for steel pipe ensuring that the pipe material did not yield (0.2% yield strain) during the hydrostatic test. Note that one strain gage (45° direction) on the pipe was lost before starting the hydrostatic test. At all four corner locations for CFRP repair system, hoop strains were the largest and dominating with a range of 0.27%-0.33% whereas the axial strains were within a range of 0.17-0.26%. The initiation of leak occurred at a location near Corner 1 (see Figure 30) and final leak occurred in the vicinity of Corner 1 and 2 where the hoop strains (for both Location 1 and 2) were maximum (about 0.33%). These strain data coupled with matrix cacking noise indicate that the matrix of CFRP repair system cracked at a strain value of around 0.33%, potentially creating a leak path through the matrix, CFRP and GFRP watertightness layers. Post-test analysis of the test specimen revealed several river-like cracking marks on the CFRP repair system on the inner or top (from inside the pipe) surface of the CFRP repair system behind the cut-out area (especially near Corner 1 and 2) indicating that the potential failure mode was matrix cracking and hence, leak through the CFRP system (see Figure 34). There was no evidence of water found near the edge at the bonded area between the host pipe and CFRP repair suggesting that the leak did not occur within the bond. Also, no evidence of fiber breakage was noticed at 600 psi leak failure pressure.

Figure 33 Strain gage data on host pipe and CFRP during the hydrostatic test

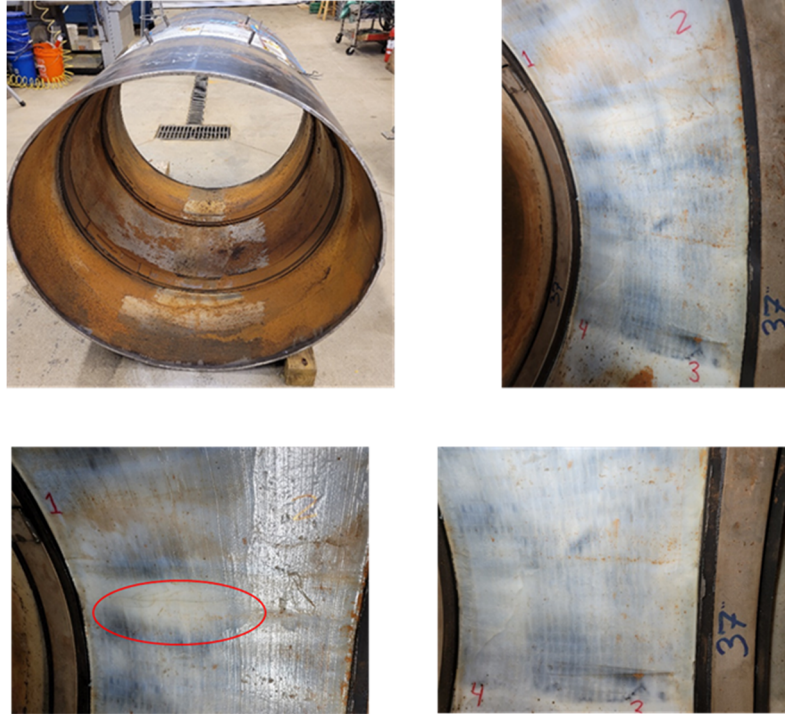
Figure 34 River-like matrix cracking on CFRP system inside the pipe after hydrostatic test
