Turkey Point Unit 3 ICW Pipe Leak Repair Plan Potential Relief Request

NRC NRR Turkey Point PM and Tech Staff Briefing
August 25, 2021

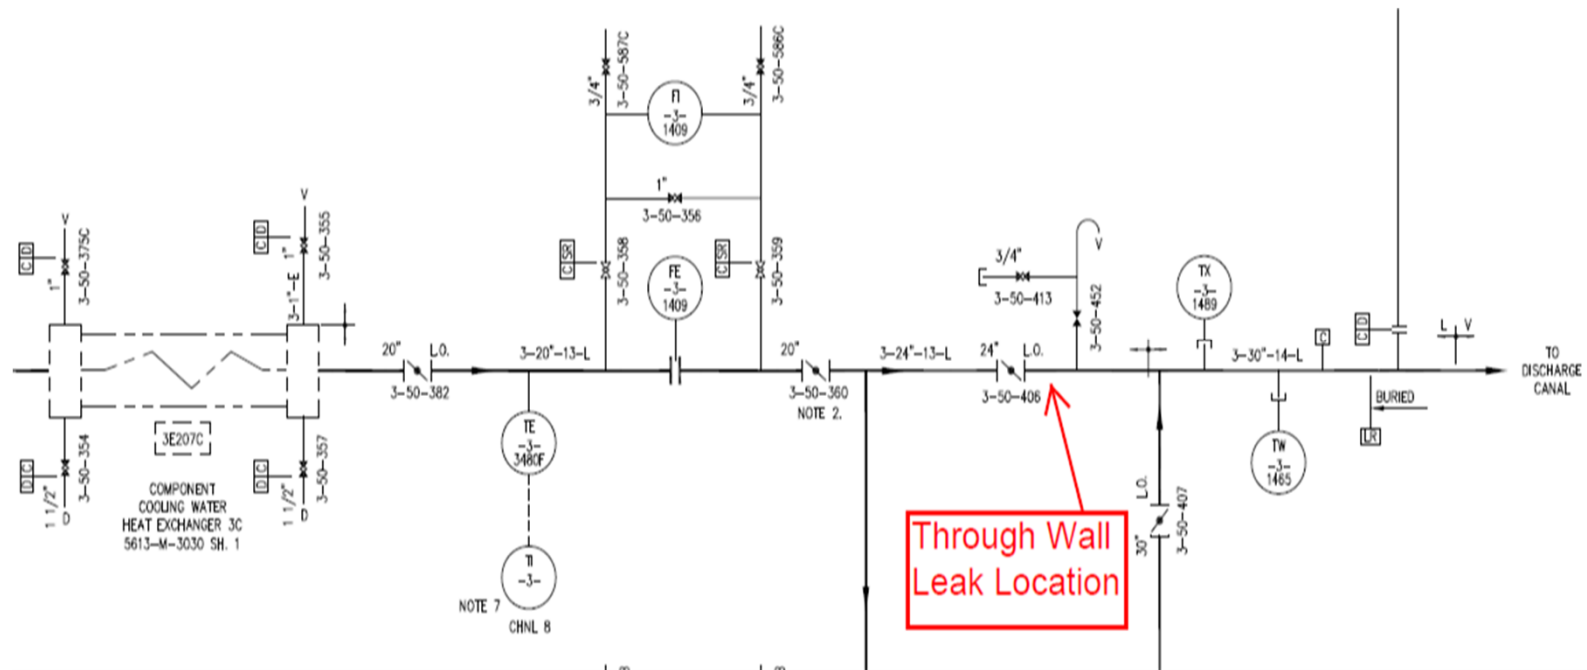
ICW Leak Location

- On 3/5/2020, during surface preparation for metalizing / coatings applications, a through-wall leak was discovered on a 24" diameter Intake Cooling Water (ICW) safety related piping.
- The non-planar wall loss was identified under the pipe coatings, downstream of valve 3-50-406, the ICW manual isolation valve from the CCW heat exchangers.
- The flaw is approximately 12 feet from the underground piping directed to the discharge canal and is located in the Unit 3 CCW heat exchanger room.

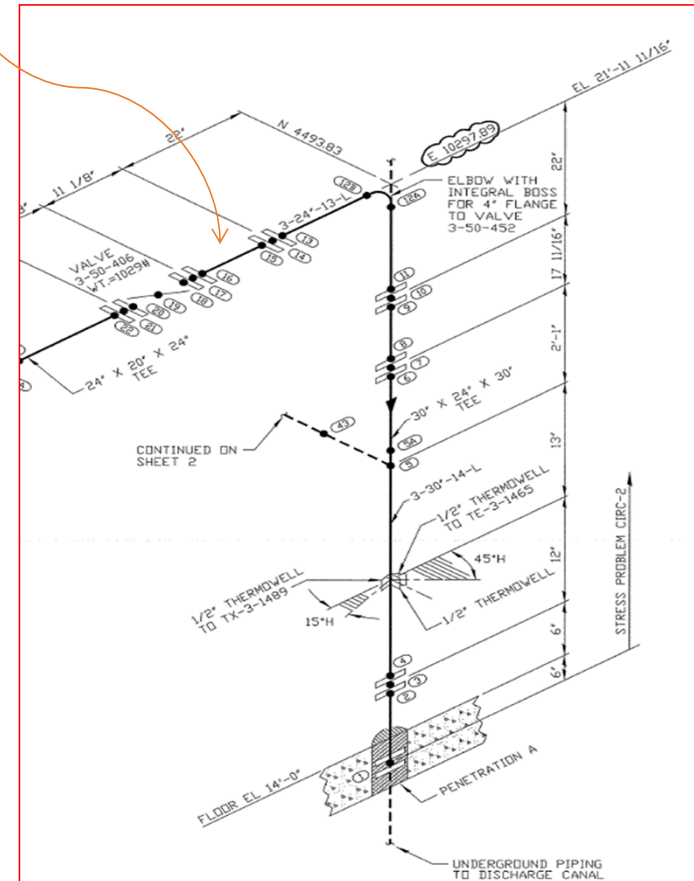
See 11-1/8 inch-Long spool piece Directly Downstream of Valve 3-50-406 (5613-P-820-S, Sheet 1 of 2)

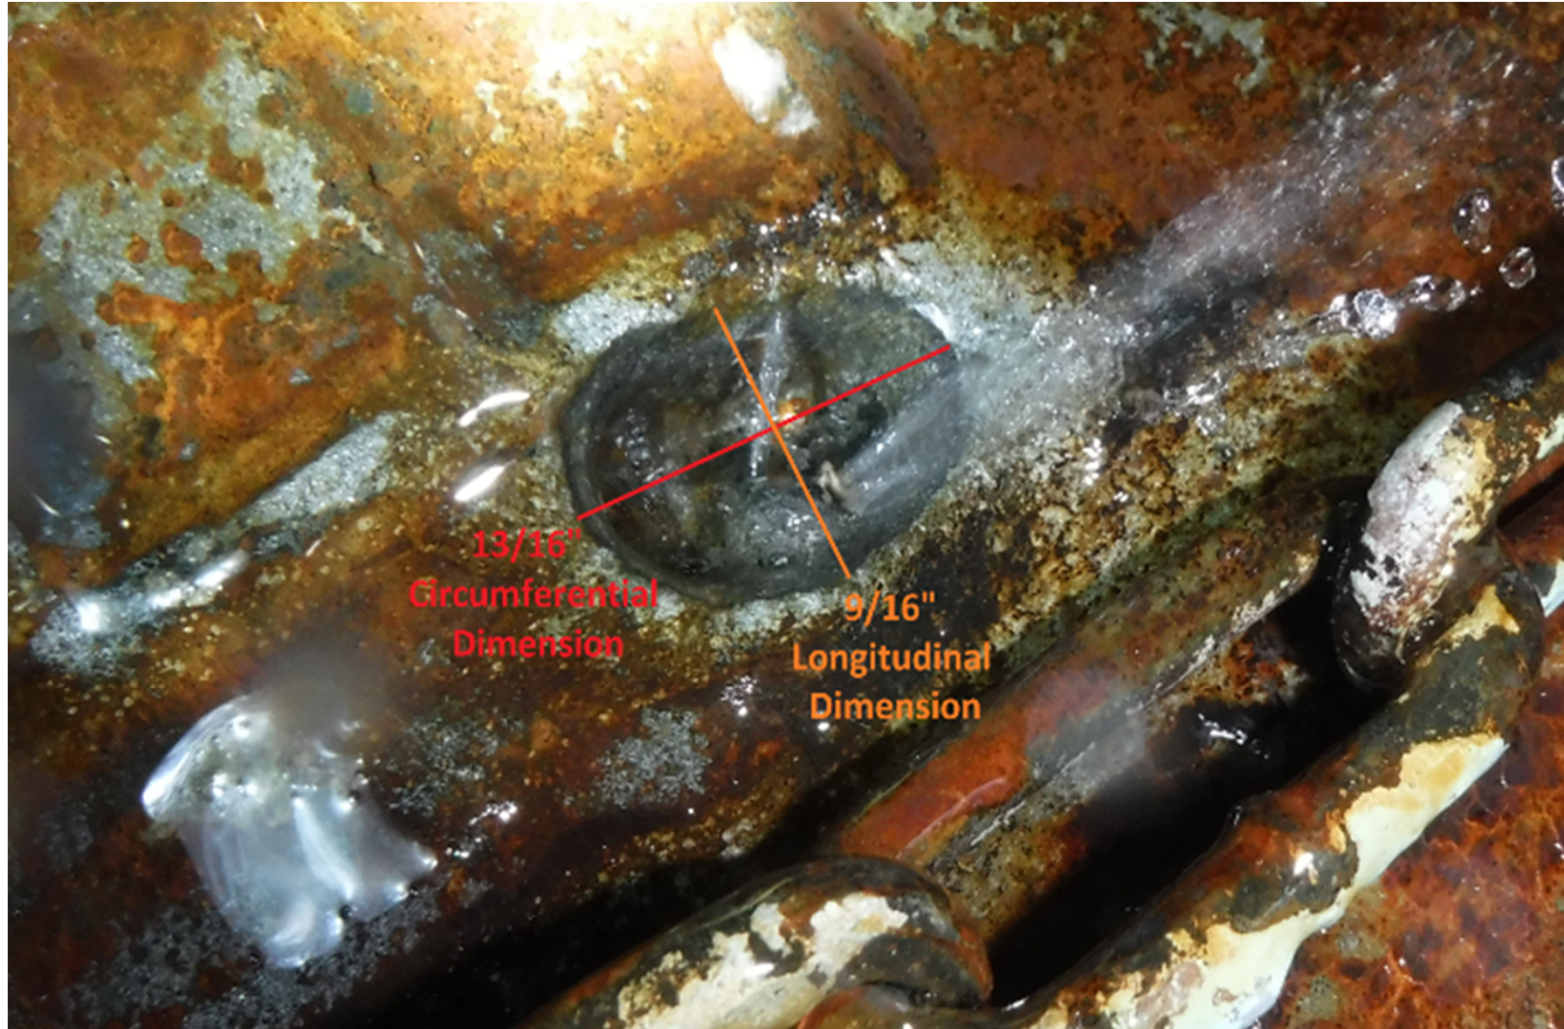
- The ICW safety related piping affected is classified as Quality Group C and treated as ASME Section XI Class 3 piping
- The ICW piping section of concern is 24" nominal diameter, with a specified nominal wall thickness of 0.73".
- The pipe is Cast Iron ASA 21.6, Class 150, Cement Lined ASA 21.4 with .25" thickness.
- Maximum operating parameters are $T = 120 \text{ degF}$ and $P = 25 \text{ psig}$.

- The flaw is shaped like a crater with two small, through-wall weep holes inside. The size of the flaw OD is 9/16" longitudinal and 13/16" circumferential
- Measured leakage is ~ 5 GPH with the subject ICW line pressurized. Leak fluctuates between 0 and 10 GPH (depending on system cleanliness and lineup).
- Both leakage rate and the flaw size are monitored in accordance with ASME XI code case N-513 and have not grown since initial identification in March 2020
